## **Appendix B – 11: South Hood Canal Sub-Region**

# **South Hood Canal Sub-Region**

## **Sub-Region Summary**

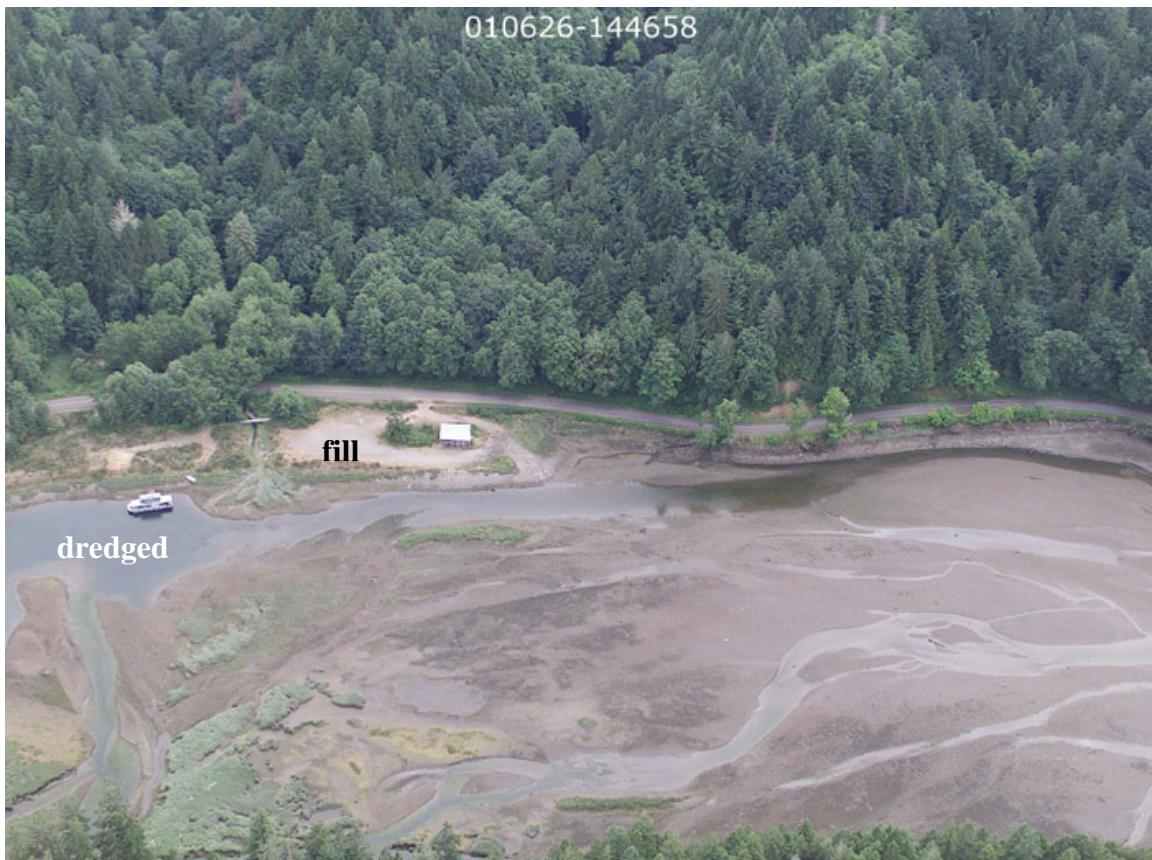
**Figure 8. 2001 WDOE oblique photo showing dredged and filled tide flat associated with an old oyster plant in Dewatto Bay. Note the small stream entering the bay near the boat.**

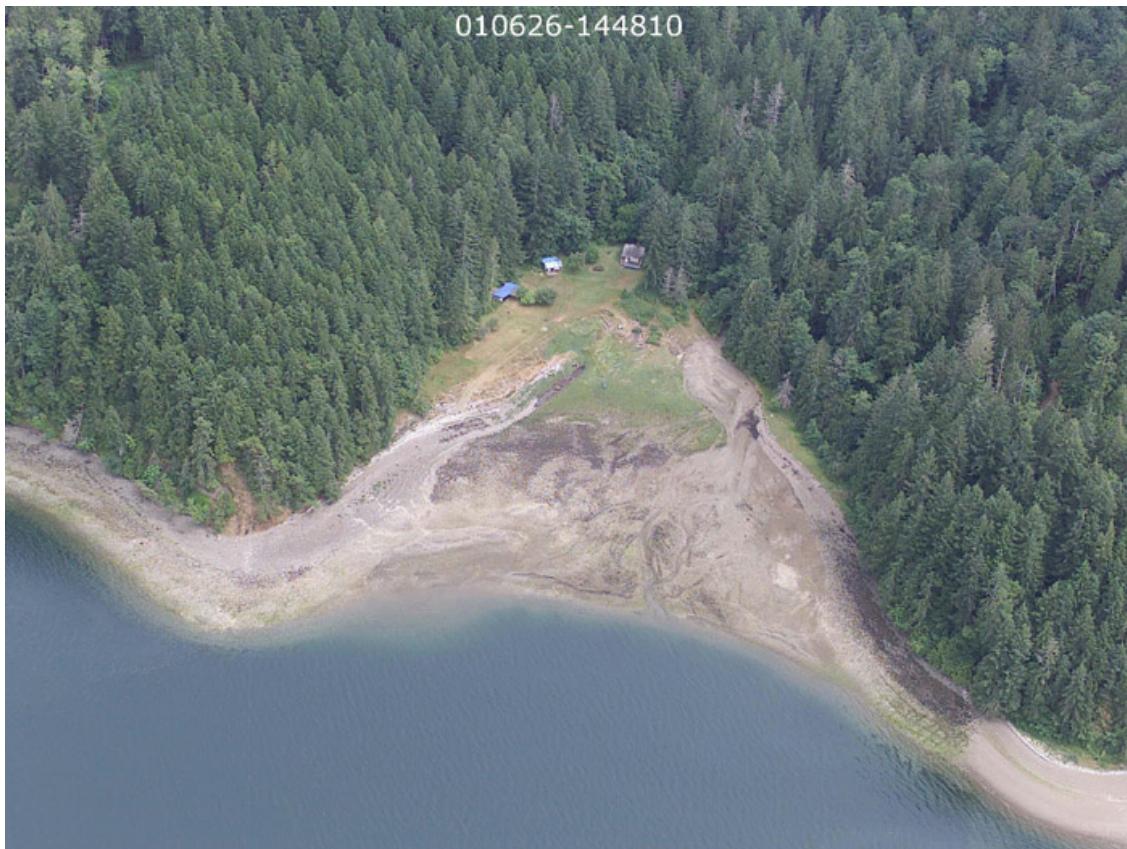
**Figure 10. 2001 WDOE oblique photo of the Little Dewatto Creek habitat complex.**

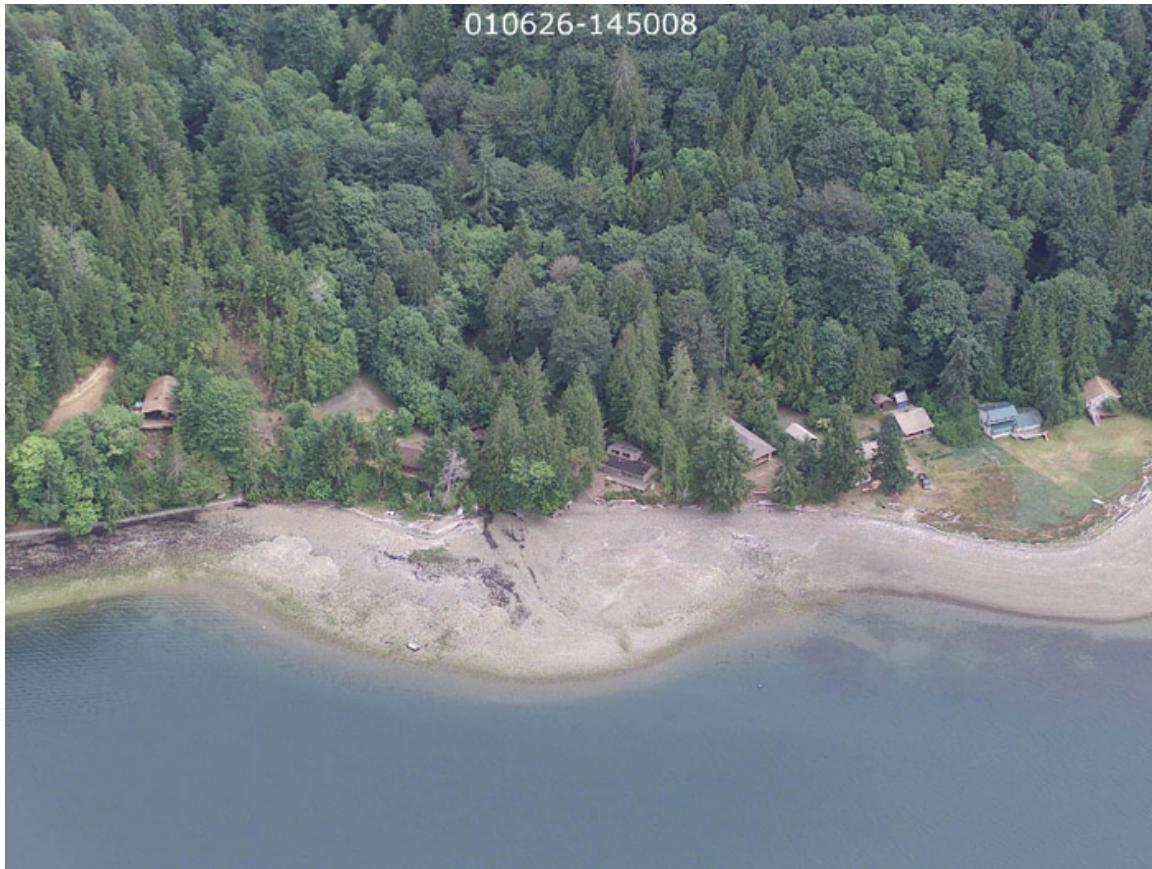
**Figure 13.** 2001 WDOE oblique photo of the Cougar Spit habitat complex (at the right side of the image). A small stream, as evident by the presence of a delta fan, enters Hood Canal left of the marsh.

Oblique air photos from 1977, the 1993, and 2001 (WDOE on-line series) indicate a few homes adjacent to or built on the former marsh, and it appears some of the historical salt marsh is now lawn. The tiny lagoon evident in the 1884 T sheet is no longer present (Figure 13 and Table 4 for a quantitative summary of historical habitat changes). Drift logs occur along the narrow berm of the spit. We estimate that bulkheading occurs along at least 50% of the shoreline up-drift (to the south) of Cougar Spit (based on informal review of Hirschi et al. 2003 and unpublished PNPTC data), although most of this bulkheading and a roadbed occur in the stretch between the divergence zone and Rendsland Creek.

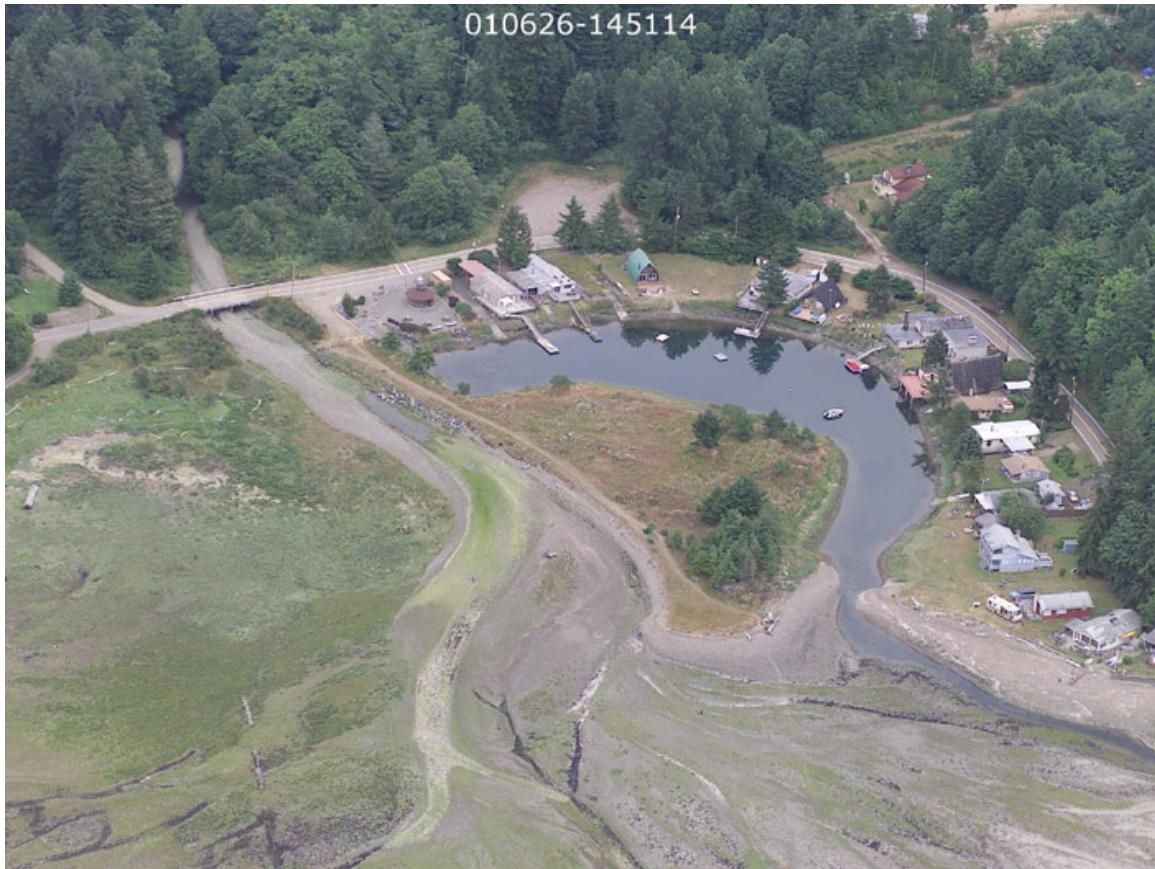
**Figure 15.** 2001 WDOE oblique photo of the Rendsland Creek habitat complex. The artificially-dredged “lagoon” is separated from the creek channel and tidal marsh by the large isthmus of fill in the center of the image. This photo was taken in late June and notice the channel is mostly dry. The 1861 GLO surveyors also found no water at the mouth in the month of September.

Based on a substantial loss of historical tidal marsh habitat, and severe impairment of overall connectivity in this estuary, we consider the relative condition “Severely Impaired”.

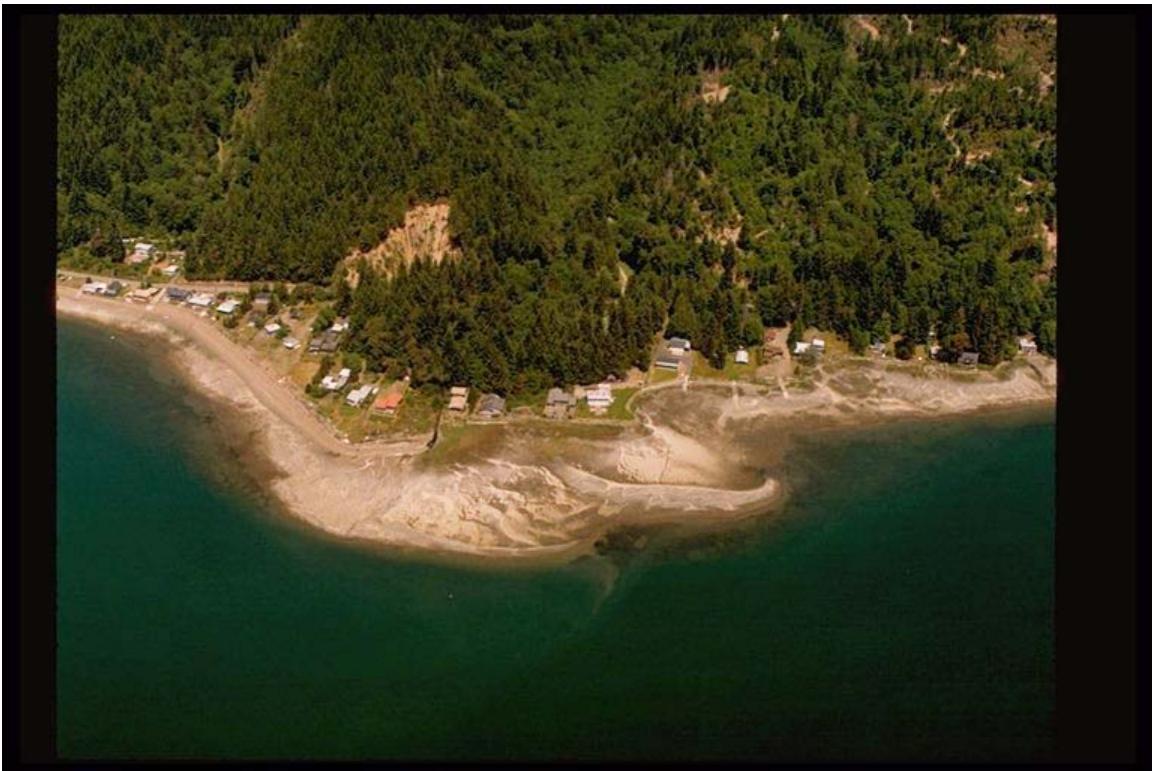
**Figure 17. 1993 WDOE oblique photo showing the Brown's Point Marsh complex. Brown's Creek can be seen entering Hood Canal just left of the center of the image.**

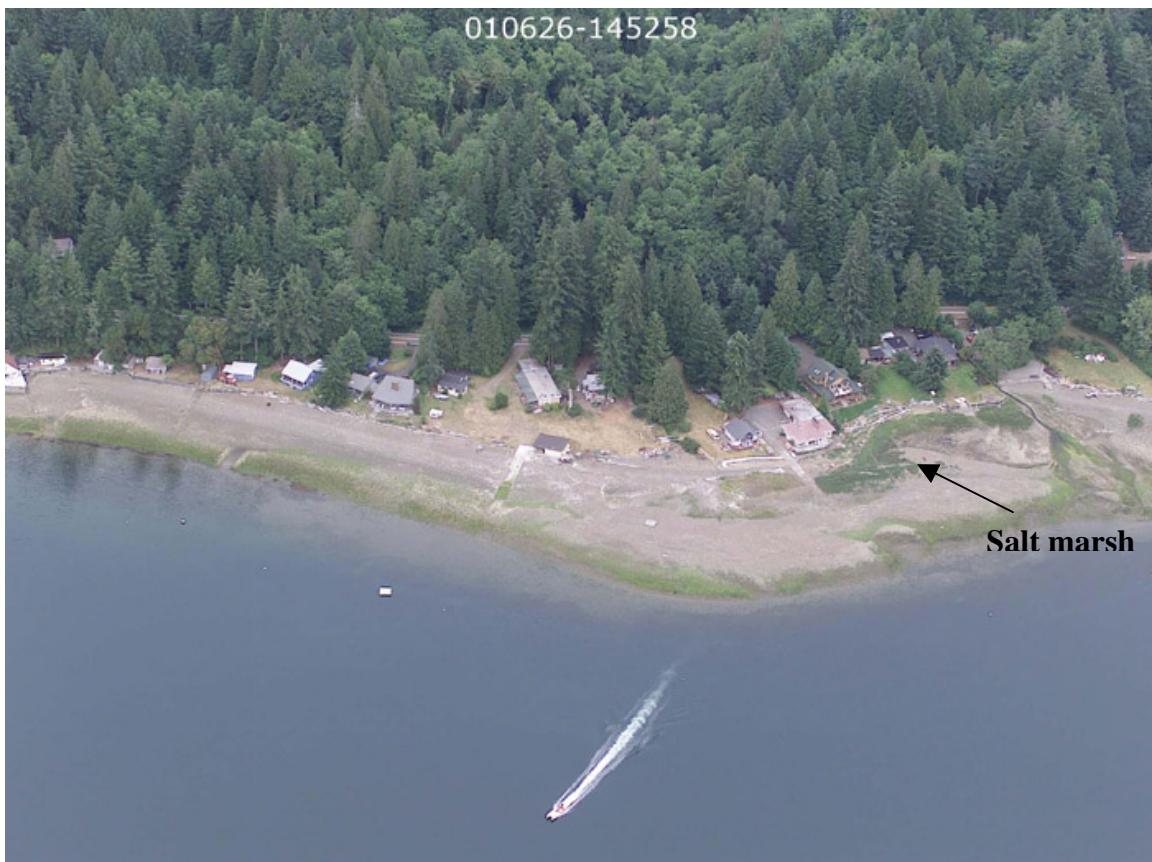
**Figure 19. 2001 WDOE oblique photo of the Hall Marsh habitat complex, showing low-elevation salt marsh growing seaward of the shoreline.**

This marsh has been filled over for residential development (Figure 19). A remnant or newly emerged salt marsh (0.21 hectares), evident at least as far back as 1977 (WDOE oblique photo) appears out in front of a bulkheaded and partly driftwood-strewn shoreline. The drift cell between Ayres Point at a divergence zone and its termination at Tahuya Bay has been bulkheaded along 55% of its length (Hirschi et al. 2003). The North Shore Road occurs along much of this shoreline.

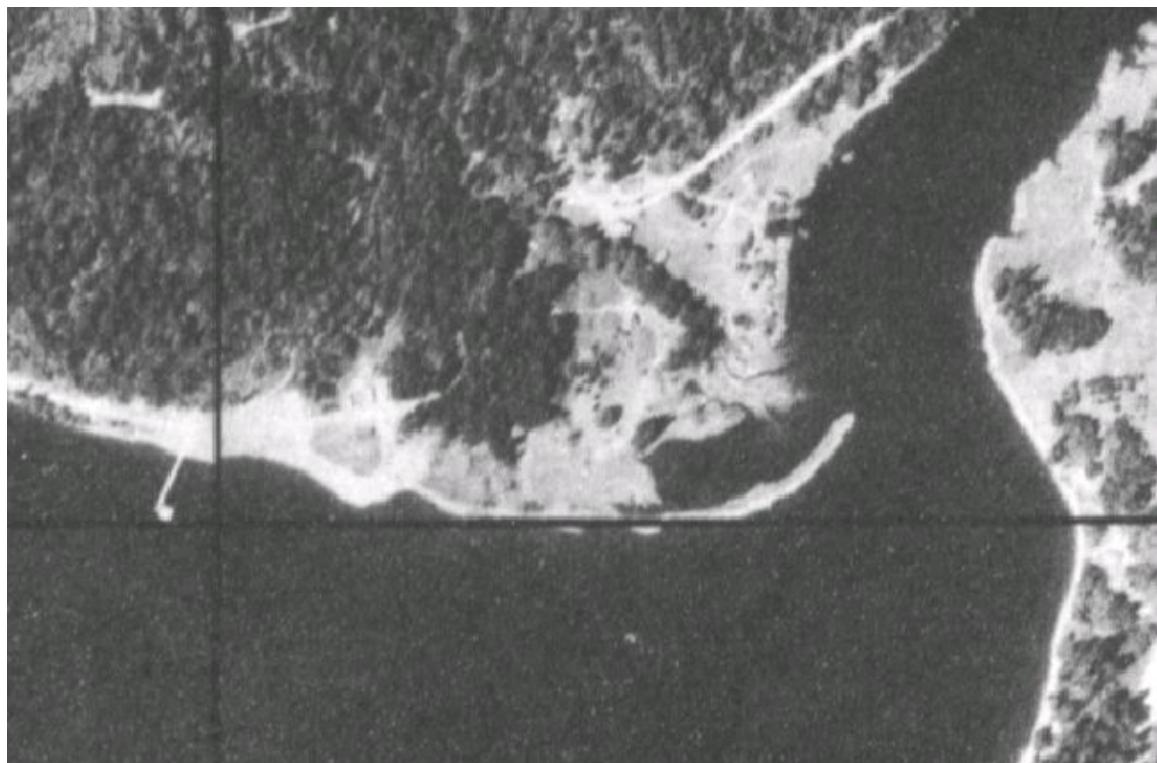
**Figure 21. 1942 U.S. Army air photo showing Hogan's Spit and associated tidal marsh to the north associated with Caldervin Creek prior to major development of this site.**

in 1884, and there is reason to believe that little development had occurred at the site (Figure 21). By 1977 (WDOE oblique photo), however, the salt marsh had been entirely filled, and the tide flat and salt marsh behind the spit had been filled for houses (Figure 22). Habitat changes at the Hogan's Spit/Caldervin Creek complex are summarized in Table 7.

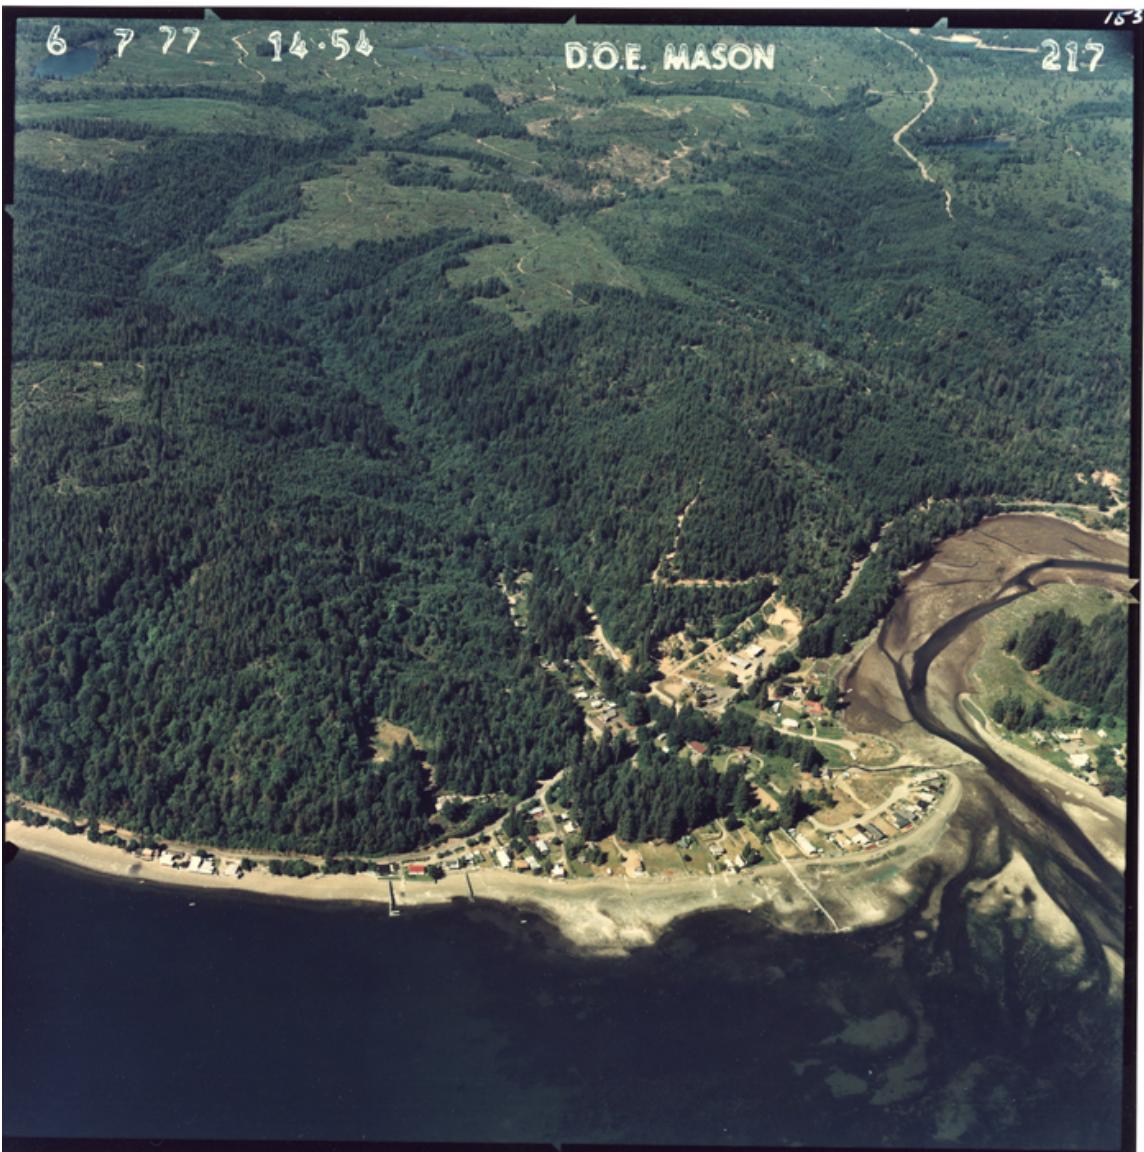
**Figure 22. 1977 WDOE oblique photo showing the Hogan's Spit/Caldervin Creek habitat complex at the entrance to Tahuya Bay (compare with the 1942 air photo – Figure 21, and 1884 T sheet – Figure 20, both shown above).**

Based on the complete loss of the historical spit and marsh, we consider the relative condition of this complex as “Lost”.

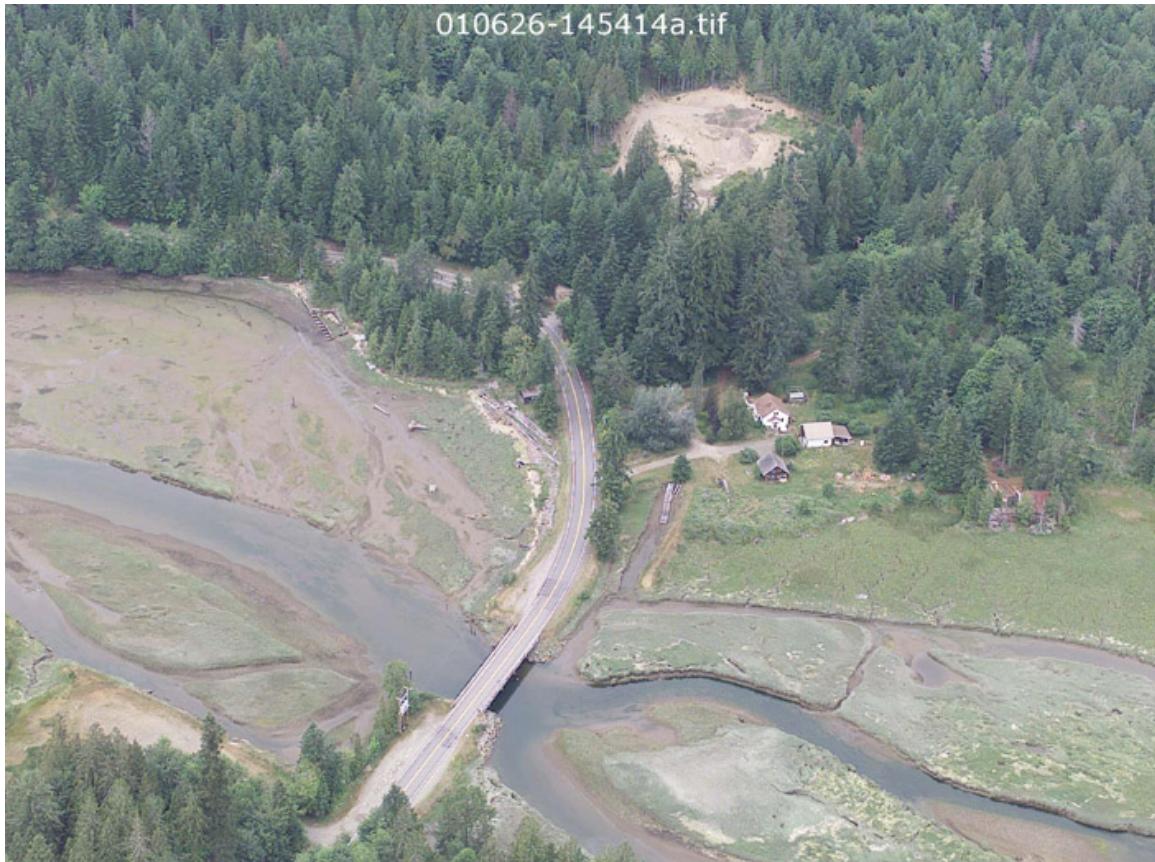
It appears that the estuary upstream of the bridge crossing may be filling in with salt marsh in places that were formerly tide flat, which could be the result of a reduction in tidal exchange through the bridge causeway. A 1942 air photo indicates channel patterns and major salt marsh patches that resemble those seen in the 1884 T sheet. Though the bridge was certainly in place by the early 1940s, the bridge opening may have been narrowed since that time with a causeway.

**Figure 24. 2001 WDOE oblique photo of the bridge crossing and causeway in the Tahuya River estuary.**

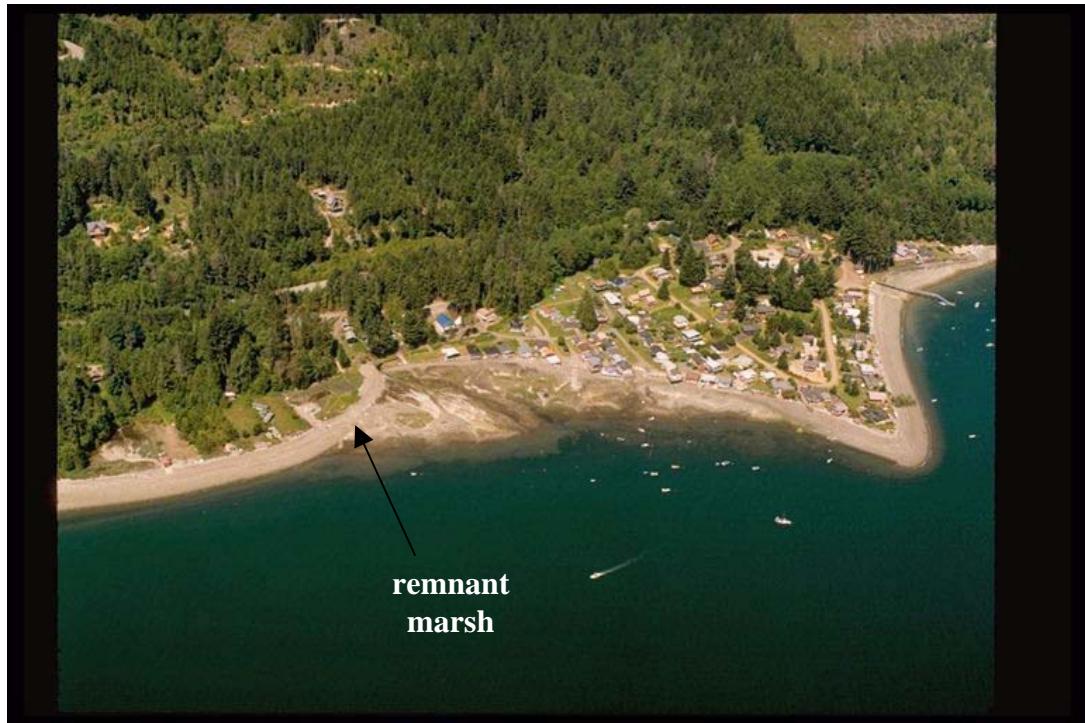
**Figure 26. 1993 WDOE oblique photo of the Ayock Point Marsh habitat complex.**

Overall historical habitat changes are summarized in Table 9. A 1942 air photo, though lacking detail, suggests that most of this complex probably was in a condition resembling the 1884 map at the time. By 1977, however, the entire Ayock Point spit had been developed for houses, and all of its former marsh had been filled. A remnant marsh exists today in association with the stream channel, though it appears fragmented and surrounded by houses and yards (Figure 26).

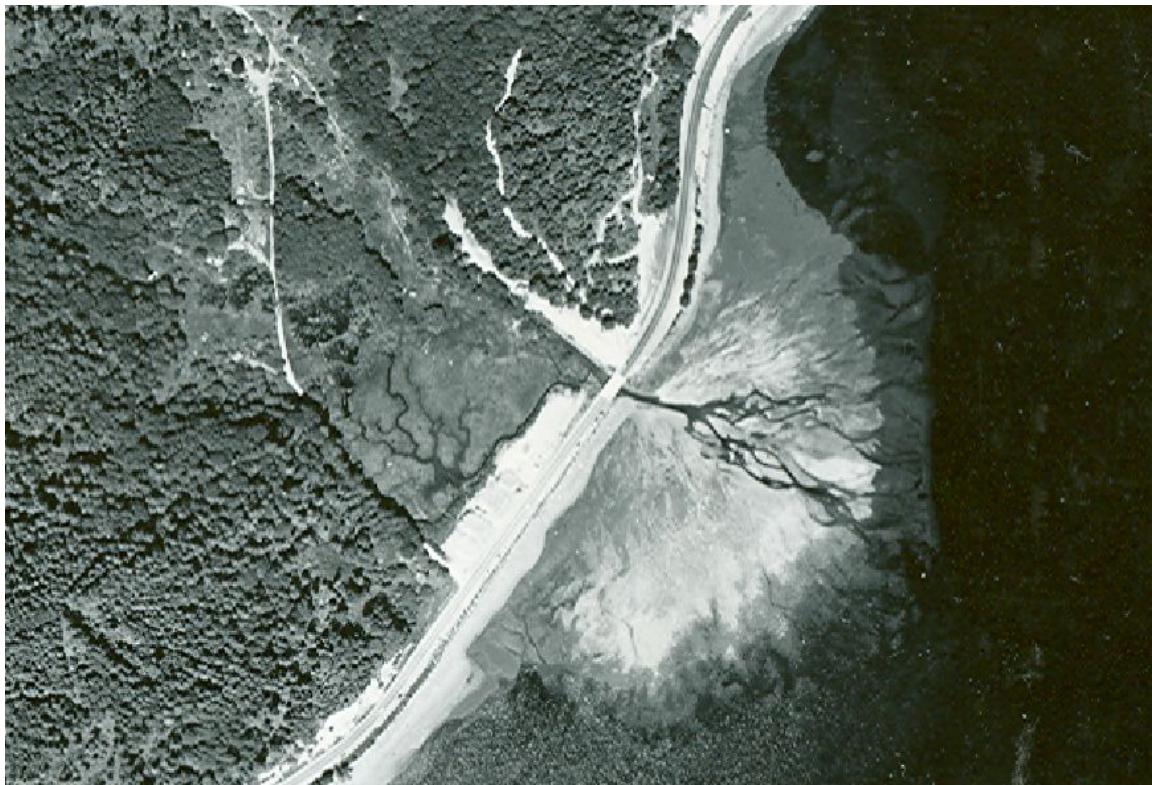
**Figure 28. 1957 air photo of the Eagle Creek habitat complex when the marsh upstream of Highway 101 was probably still tidally influenced.**

It appears that Highway 101 may have been the first major direct impact to this estuary. Air photos from 1942 and particularly 1957 (Figure 28) indicate filling along the former spit and a bridge crossing at the creek mouth, and substantial filling immediately landward of the highway in historical salt marsh. A comparison of oblique photos from 1977, 1993, and 2001 indicate even more extensive filling even since 1993, resulting in what appears to be the near complete elimination of the former salt marsh. Sometime since 1993 a road was built through part of a marsh that was historically tidally influenced and is now apparently entirely freshwater marsh and disconnected from the tides (Figure 29). The potential exists to reconnect this currently freshwater wetland to the tides and Eagle Creek. Overall, both the extent of salt marsh (Table 10) and the overall connectivity have been severely impaired at Eagle Creek.

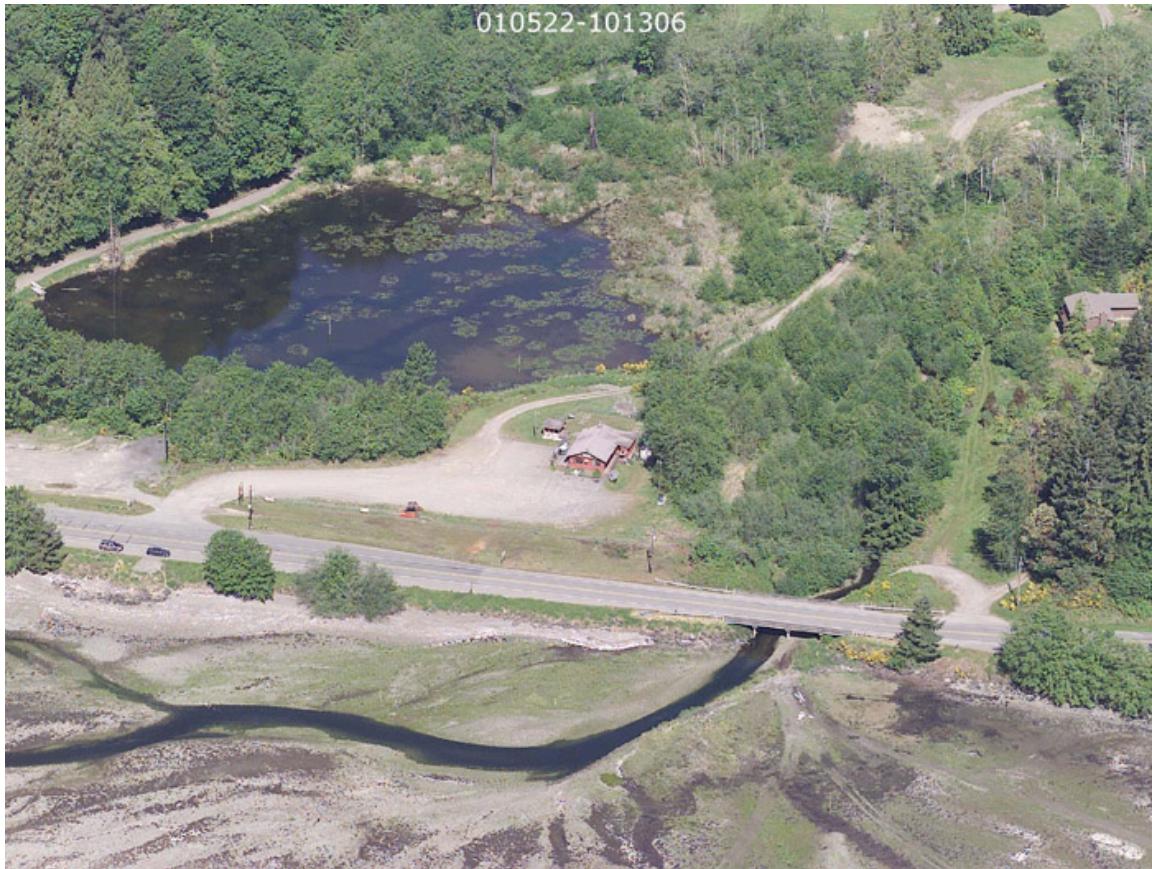
**Figure 29.** 2001 WDOE oblique photo showing the Eagle Creek habitat complex. The large marsh and pond visible in the image was shown as a salt marsh in the 1884 T sheet (see Figure 27 above), and is now a freshwater wetland.

Because nearly all historical tidal wetland has been eliminated at this complex, we consider the relative condition “Severely Impaired”.

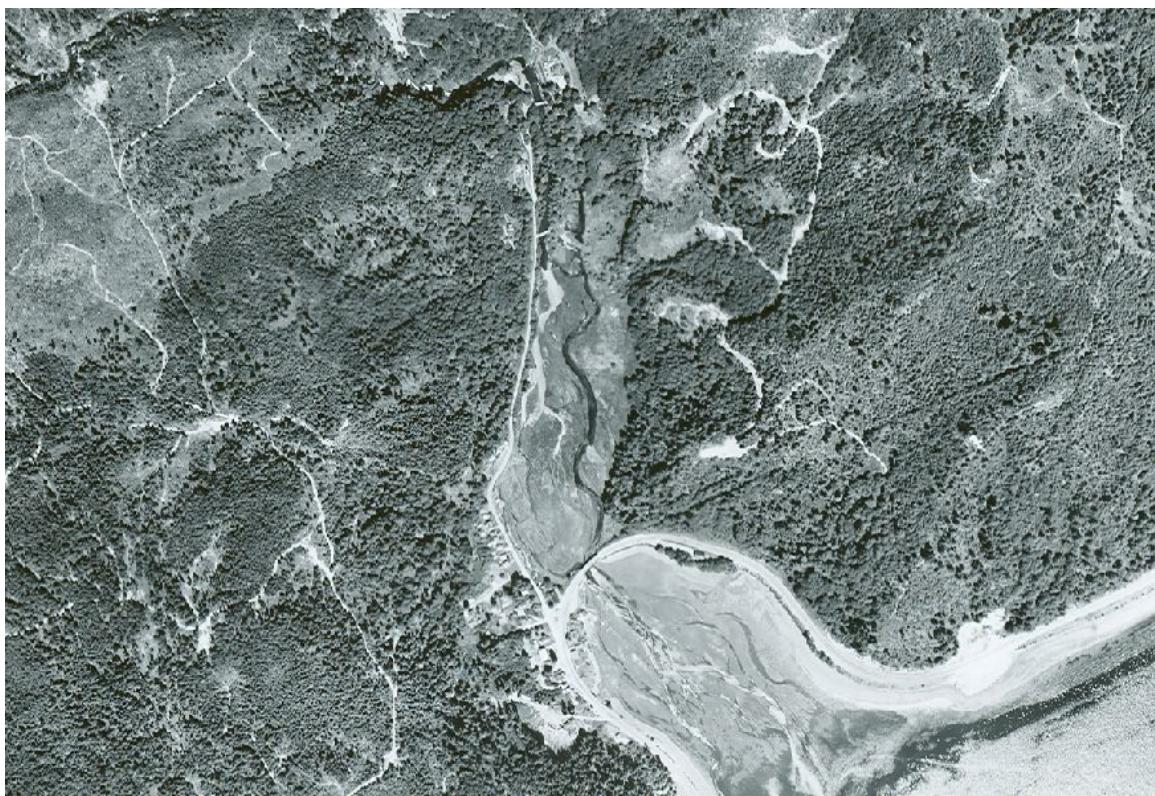
**Figure 32. 1958 air photo of the Lilliwaup Creek habitat complex.**

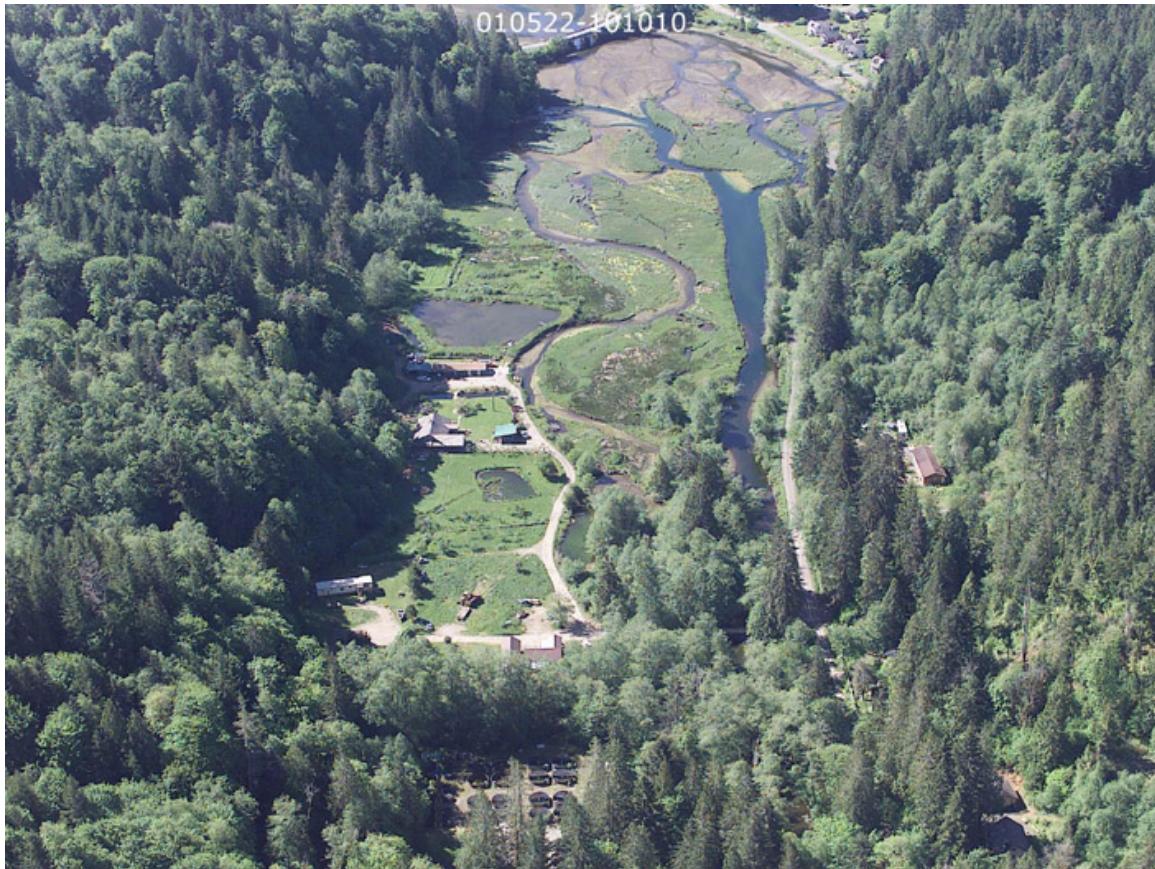
**Figure 33. 2001 WDOE oblique photo of the Lilliwaup Creek estuary, looking downstream. The Highway 101 Bridge crossing is at the top of the image. The left side (north side) of the estuary is largely diked and filled for roads and a few residences. The 1884 T sheet also indicates this area was being grazed and cultivated and possibly diked off at the time, though this is not corroborated by other sources.**

Though considerable gains in tidal marsh since 1884 are estimated, most of this gain is probably owing to a progradation of salt marsh at the expense of tidal flat. In addition, the connectivity of the estuary has been impaired by the Highway 101 Bridge and causeway and by diking of salt marsh and channel dredging in the estuarine reach. For these reasons, we consider the relative condition “Moderately Impaired”.

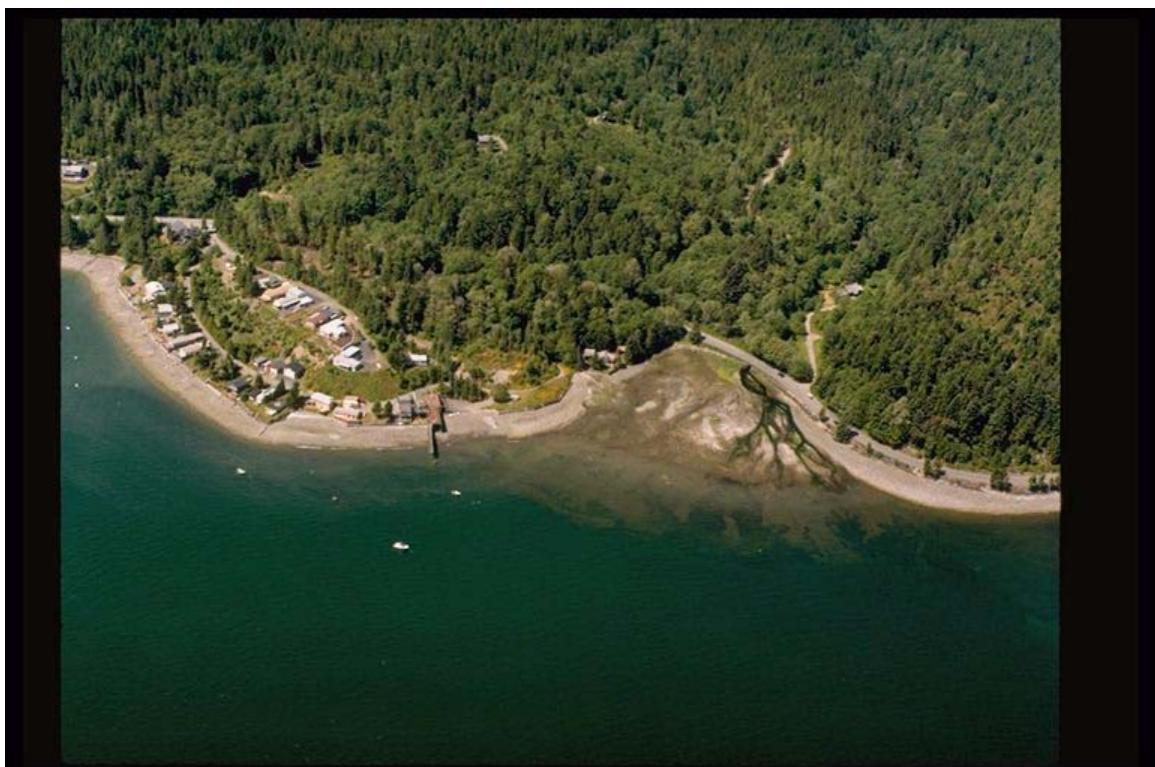
It is difficult to apply a relative condition rating where there is so little habitat to consider and virtually no saltmarsh. However, because the upper tidal portion of the delta has been filled by the highway we consider the stream delta complex “Moderately Impaired”.

**Figure 34. 1993 WDOE oblique photo showing the Little Lilliwaup Creek delta (just right of center) entering Hood Canal under Highway 101. A smaller stream also enters the canal near the center of the image. The homes shown at left center of the image are built on fill below high water and bulkheaded.**

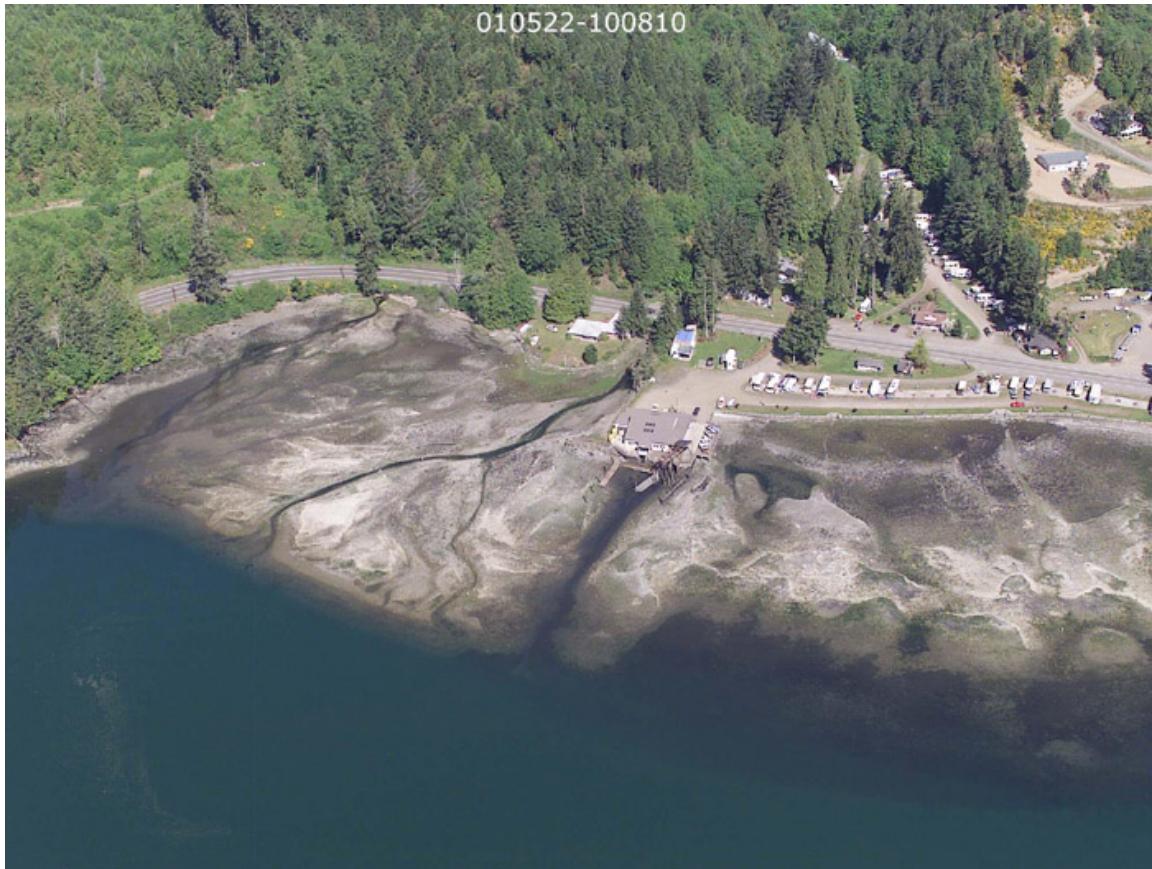
**Figure 36.** 2001 WDOE oblique photo of the Sund Creek habitat complex.

Today, Highway 101 crosses the mouth and causing substantial filling of former tide flat to the immediate south and north of the mouth, as is evident from the 1977 and more recent oblique photos (Figure 36). A trailer park and additional large structure has been constructed north of the delta on fill extending out past the high water mark. Land use adjacent to the complex, in addition to the highway and trailer park, includes a gravel pit just west of the highway. Despite historical modifications, we estimate that more salt marsh exists today than did in 1884 (Table 12), most of it occurring out in front of the trailer park, approximately where it was located historically, and an additional patch of marsh at the creek mouth, probably related to stream sediment accretion at the delta.

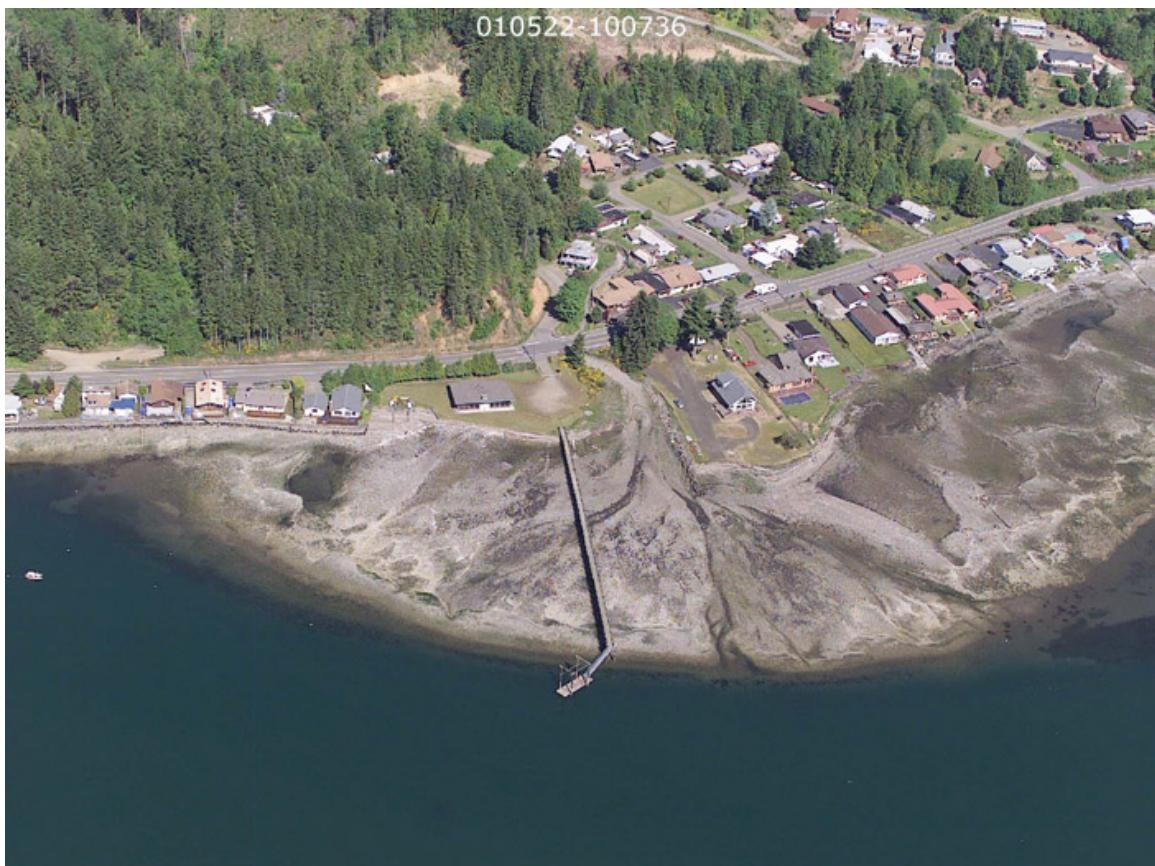
**Figure 38.** 2001 WDOE oblique photo of the Miller Creek habitat complex. The lower reach of the creek channel is often dry by mid-spring, as shown in this photo. Note how confined the channel becomes, particularly just upstream of the highway where it flows in very close proximity to houses. Note also the filling of upper intertidal beach for residential development to the left of the creek mouth in this image.

Based on the near complete loss of historical salt marsh and encroachment of residential and transportation infrastructure on the lower end of the creek, we consider the relative condition of the Miller Creek complex “Severely Impaired”.

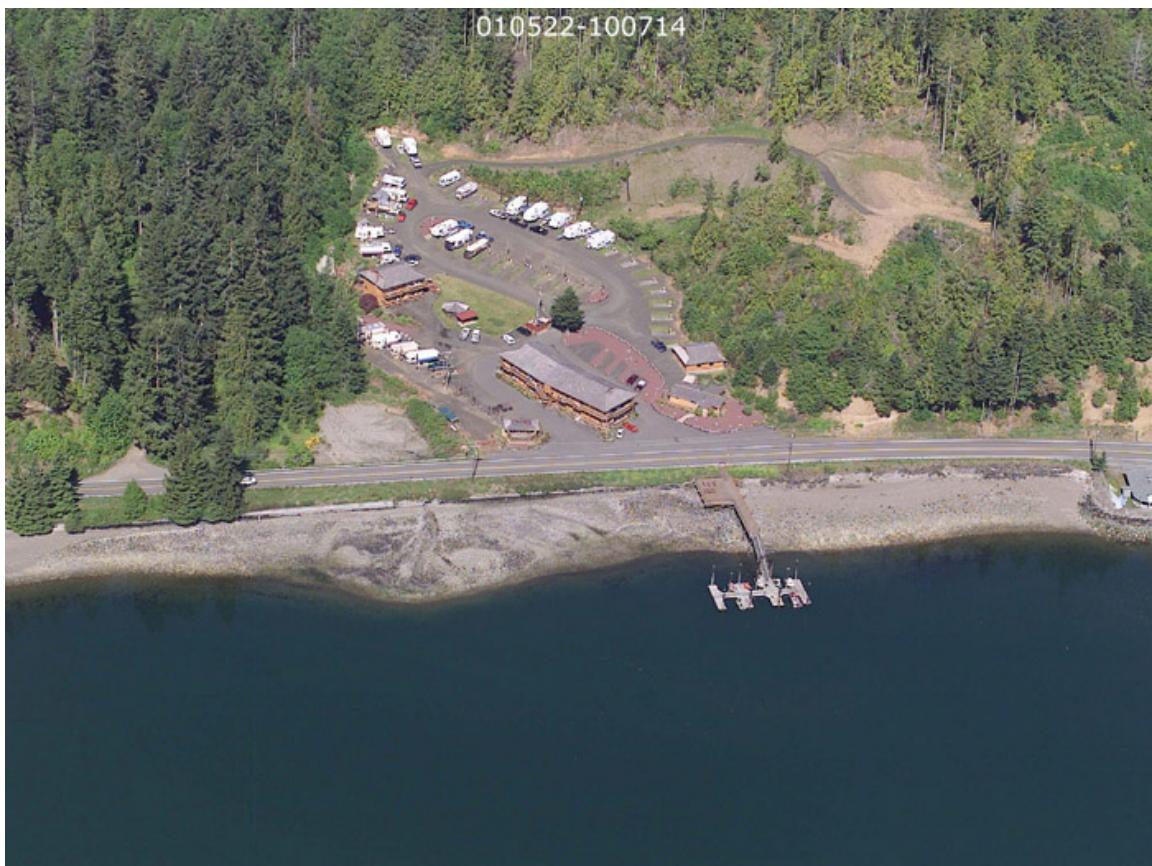
**Figure 40. May 22, 2001 WDOE oblique photo of the Clark Creek habitat complex. Highway 101 and the paved parking lot and trailer park immediately to the right of the creek are the primary impacts to the tiny stream delta.**

Because of the level of transportation and other development immediately adjacent to Clark Creek, we consider the relative condition “Severely Impaired”.

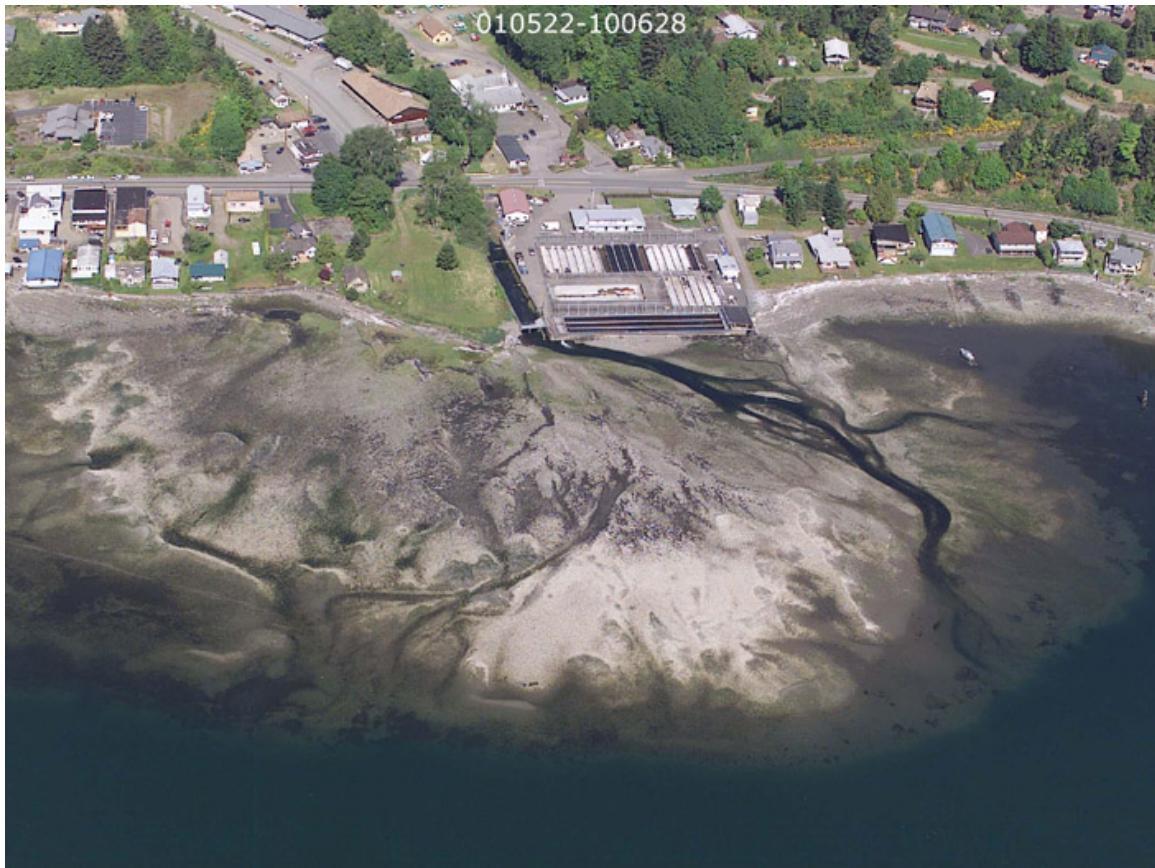
**Figure 42. 2001 WDOE oblique photo of the Finch Creek stream delta.**

Based on the severe channelization and filling along the lower left bank associated with the hatchery facility, we consider the relative condition of the Finch Creek complex “Severely Impaired”.

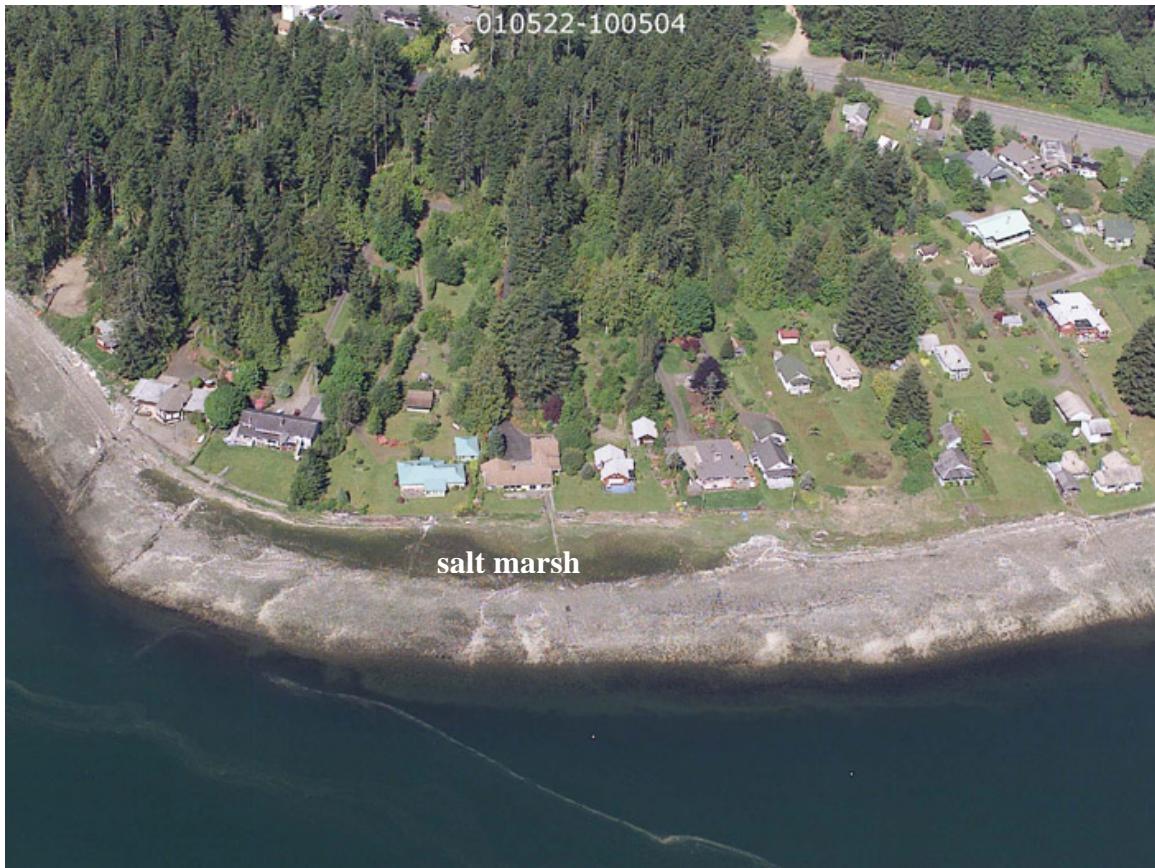
**Figure 44.** 2001 WDOE oblique photo showing the Neelim Marsh. Much of the historical salt marsh that was present at this site has been eliminated by the development of homes, but a “new” salt marsh is evident, particularly near the center and left in the image, growing seaward of bulkheads and more natural shorelines.

Though considerable development has occurred that has affected the historical marsh present at this site, it appears that a recent salt marsh has grown seaward of a partially bulkheaded shoreline. For this reason, we consider the relative condition “Moderately Impaired”.
