## **Appendix B – 11: South Hood Canal Sub-Region**

# **South Hood Canal Sub-Region**

## **Sub-Region Summary**

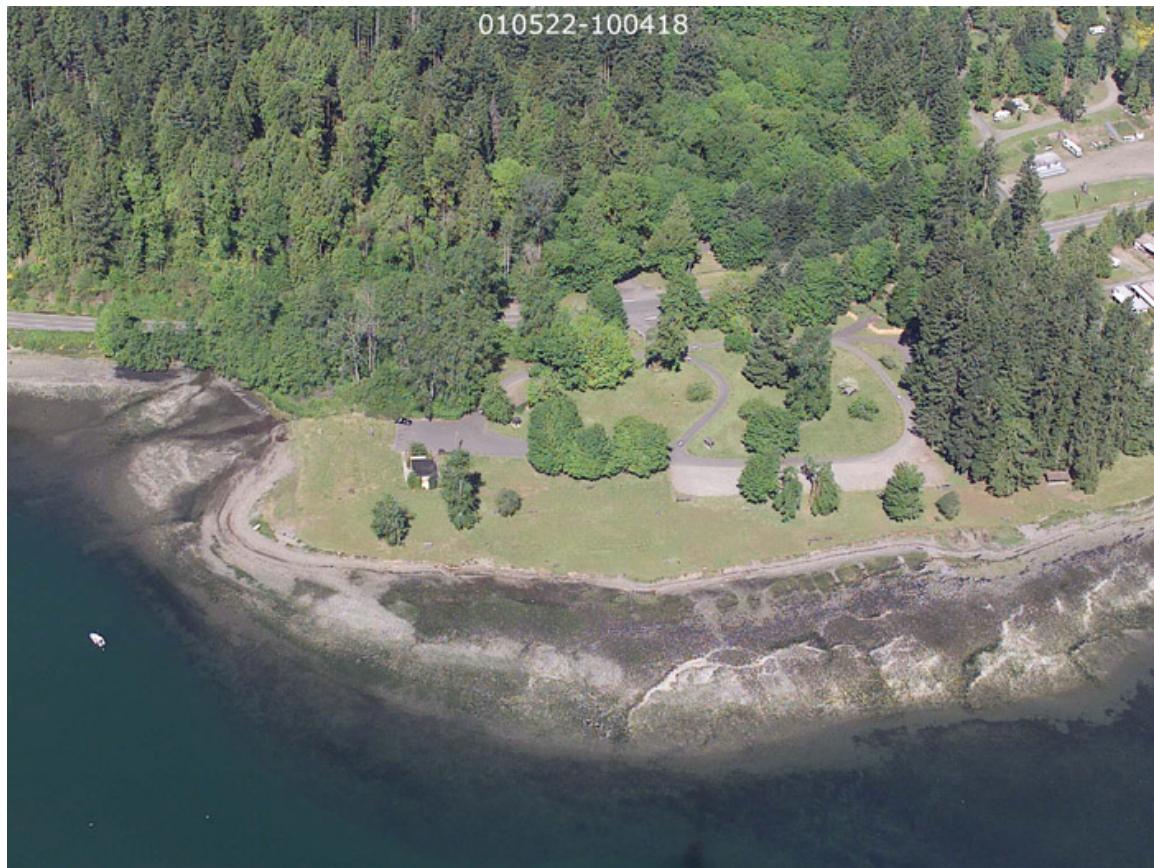
**Figure 46. 2001 WDOE oblique photo showing the site of the historical Potlatch Marsh habitat complex, now the site of Potlatch State Park with lawns, parking lots, and roads.**

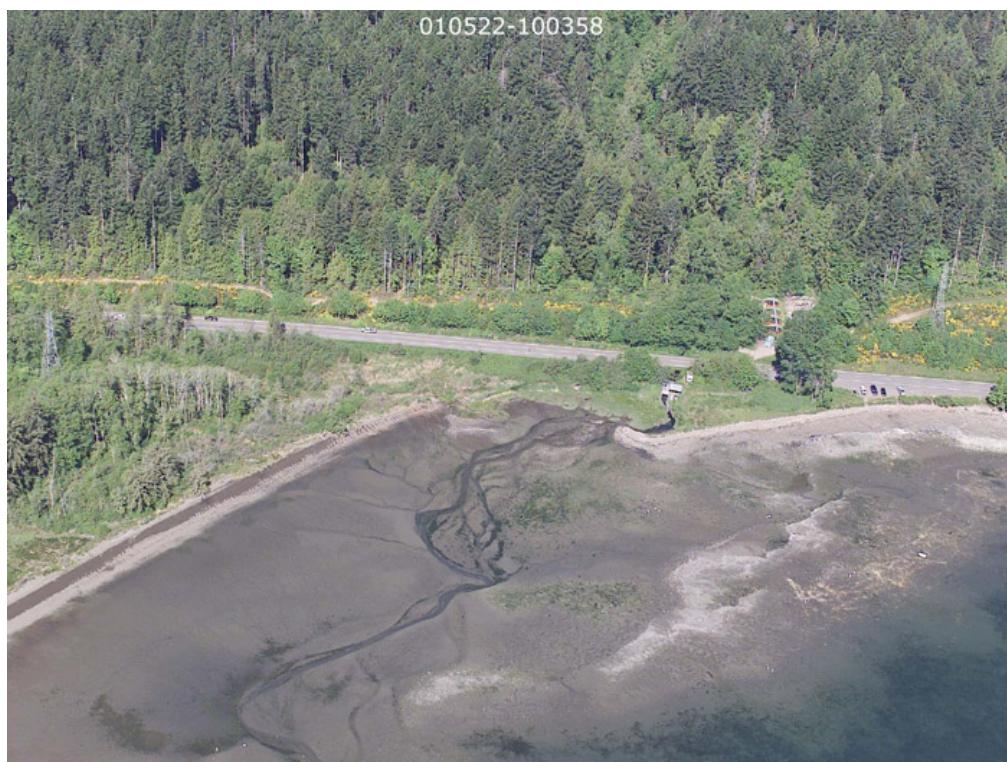
**Figure 47.** 2001 WDOE oblique photo showing the tiny Enati Creek complex, located just north (to the right in the image) of the Skokomish River estuary, the largest habitat complex in the study area.

Although salt marsh appears today at this site where it apparently was absent in 1884, because of encroachment from the highway, an old road near the mouth, and the small hatchery facilities, we consider the relative condition “Moderately Impaired”.

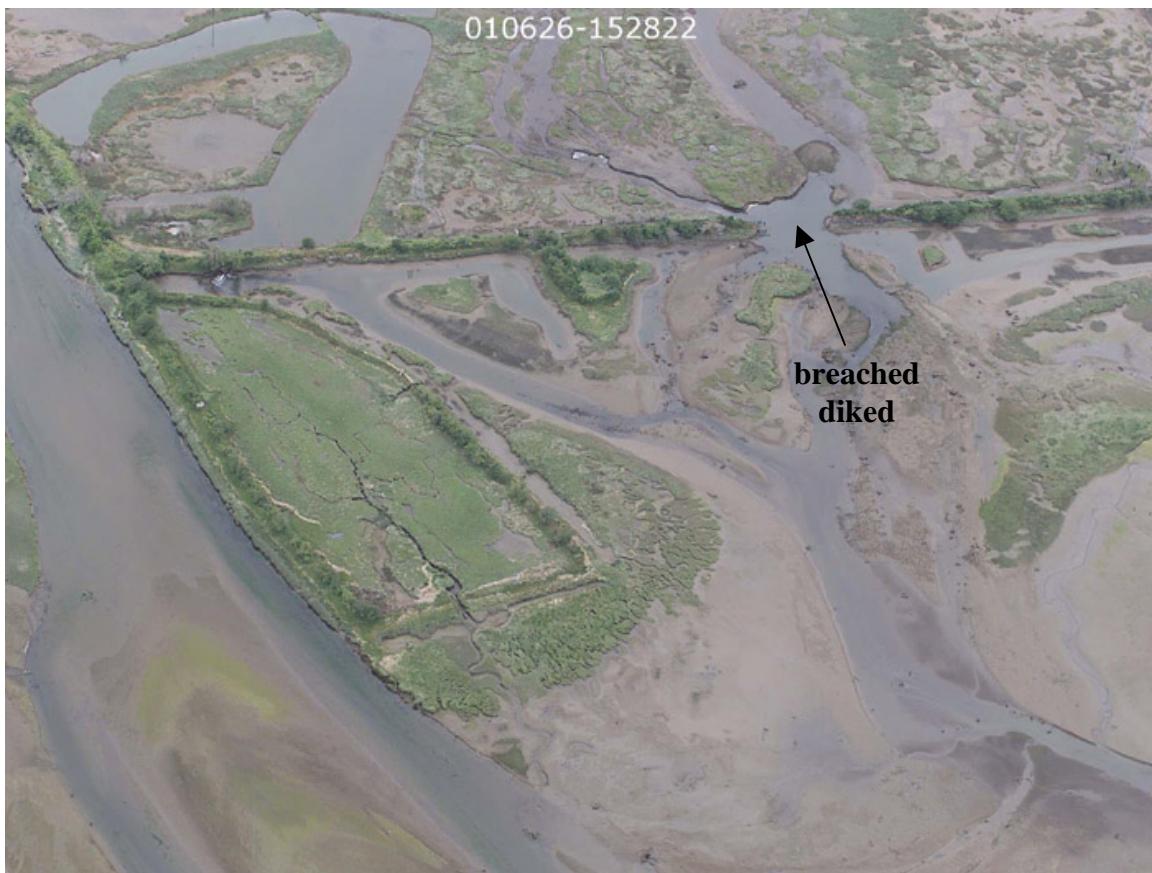
**Figure 54. 2001 WDOE oblique photo showing one of several dike sections in the Nalley Island portion of the Skokomish estuary that has been breaching since the mid-1990s.**

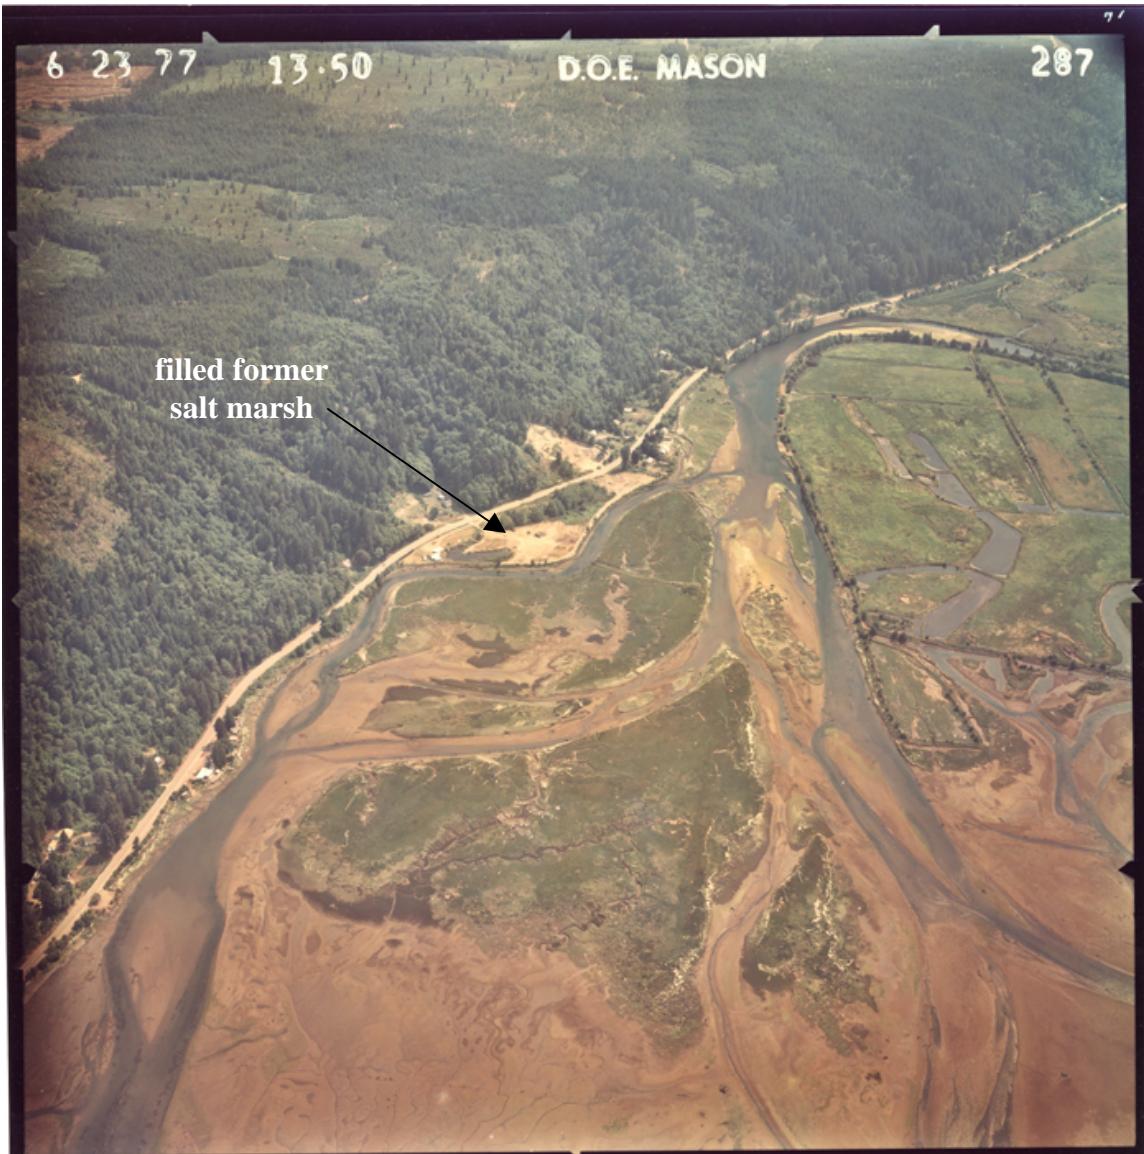
**Figure 55. 1977 WDOE oblique photo showing a section of the Nalley/East Marsh of the Skokomish Estuary where filling of former salt marsh had apparently recently taken place or was occurring at the time. Notice the extensive diking and dredged (“borrow pits”) on the right side of the image.**

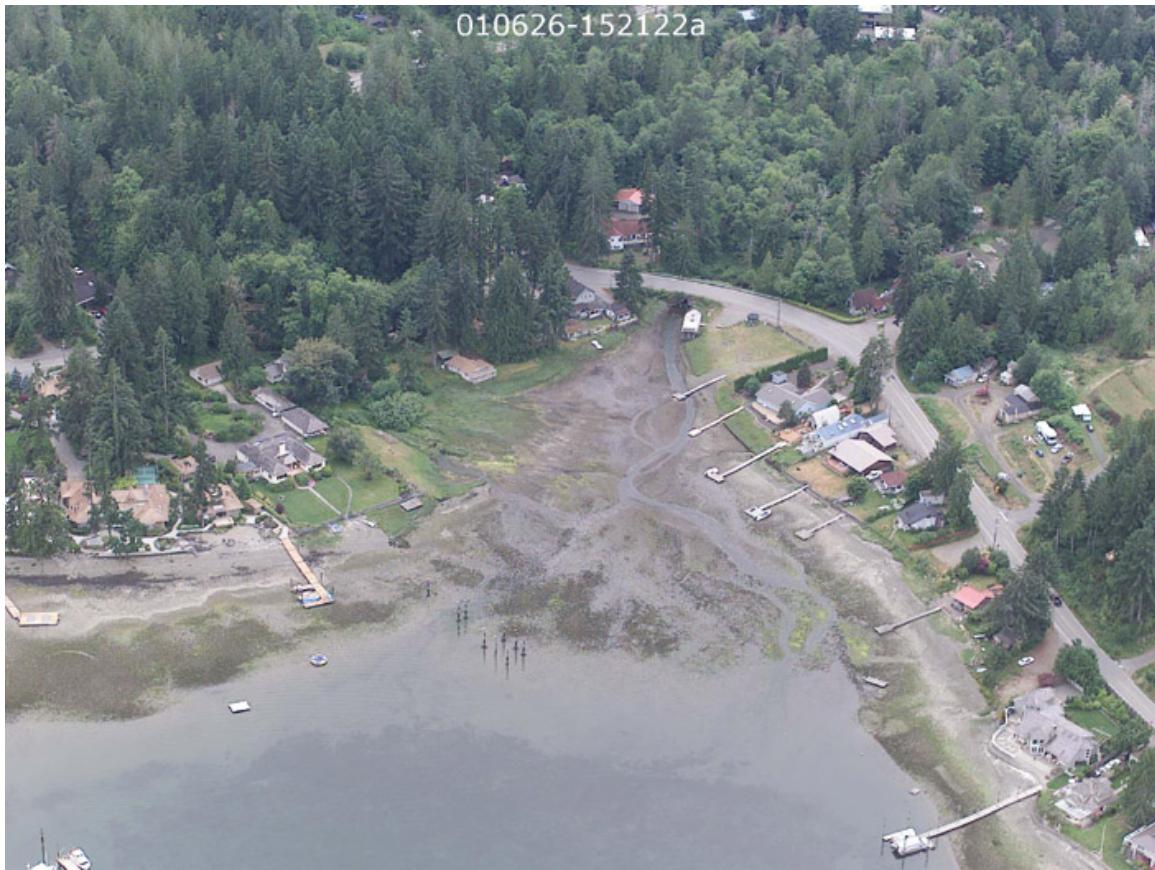
**Figure 57. 2001 WDOE oblique photo of the tiny Dalby Creek habitat complex located east of the Skokomish estuary. Notice the number of docks in the image, one even appears in the main channel of the creek at a low tide.**
