Appendix B – 12: Hood Canal Hook Sub-Region

Hood Canal Hook Sub-region

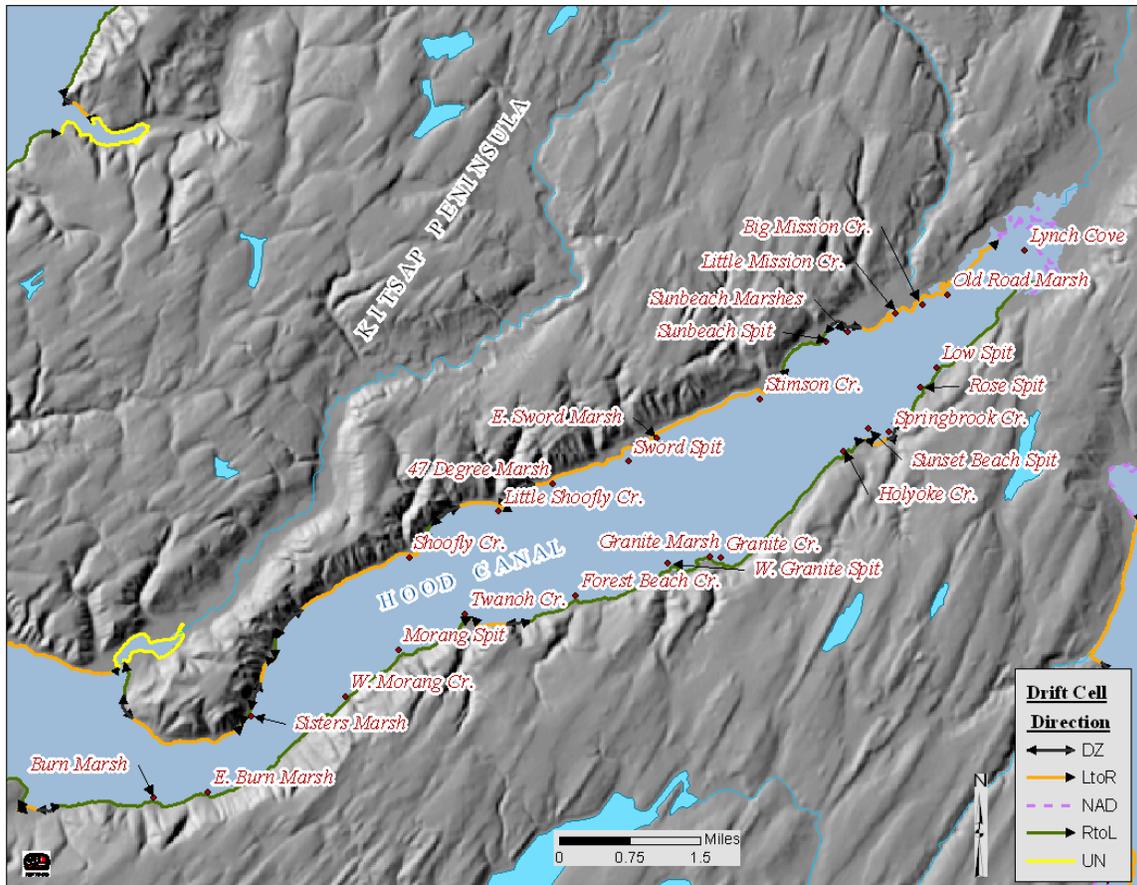
Figure 1. Hood Canal Hook sub-region, including habitat complexes and net sediment drift (WDOE 2002, based on Blankenship 1983). Net shore drift in the Hook on both the north and south shorelines is predominantly in a west-to-east direction. Legend items DZ = “divergence zone”, NAD = “no appreciable drift”, UN = “unknown”, LtoR = “left-to-right”, and RtoL = “right-to-left” (from the perspective of someone in a boat and facing the shoreline).

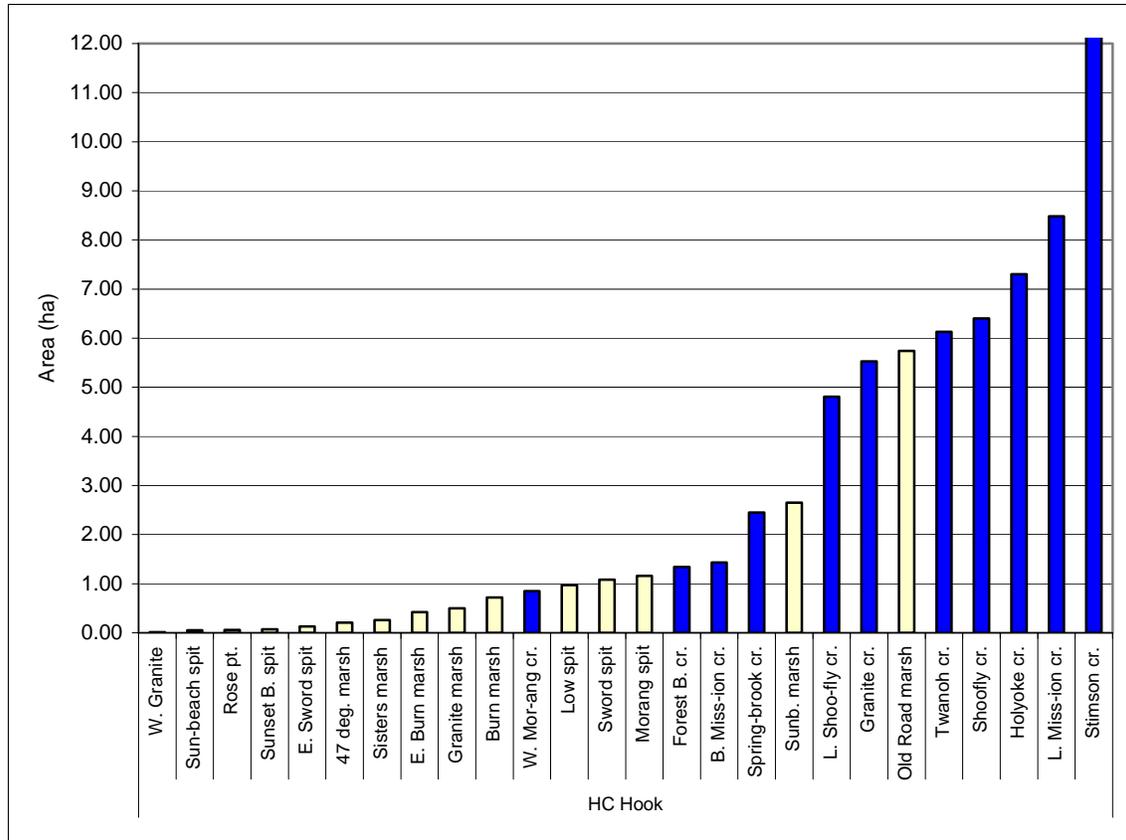
Figure 2. Scale, in ascending order, of habitat complexes in the Hood Canal Hook sub-region. Blue columns represent stream-delta complexes. The largest complex, by far, at 387 hectares, is Lynch Cove (including the Union River), is not shown in this graphic because it dwarfs the other complexes. Scale was determined by summing the area of tidal flat, spit, tidal marsh, channel, and lagoon habitat features associated with each complex, based on the early T sheet delineations (1884).

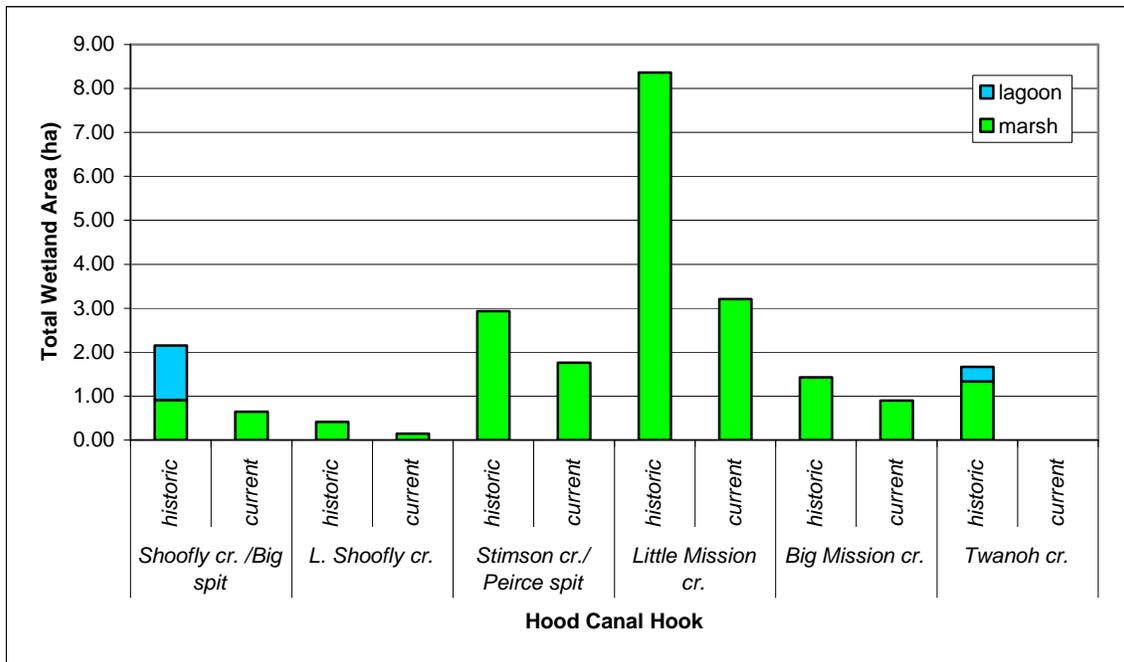
Figure 3. Historical changes in area of tidal marsh and lagoon habitat associated with stream-delta complexes in the Hood Canal Hook sub-region. The Lynch Cove/Union River complex is not shown in this graphic because the amount of salt marsh associated with the complex would dwarf all other complexes. The Springbrook, Holyoke, Granite, Forest Beach, and West Morang Creek stream-delta complexes are not shown in this graphic because they historically and currently lack tidal marsh and lagoon habitat.

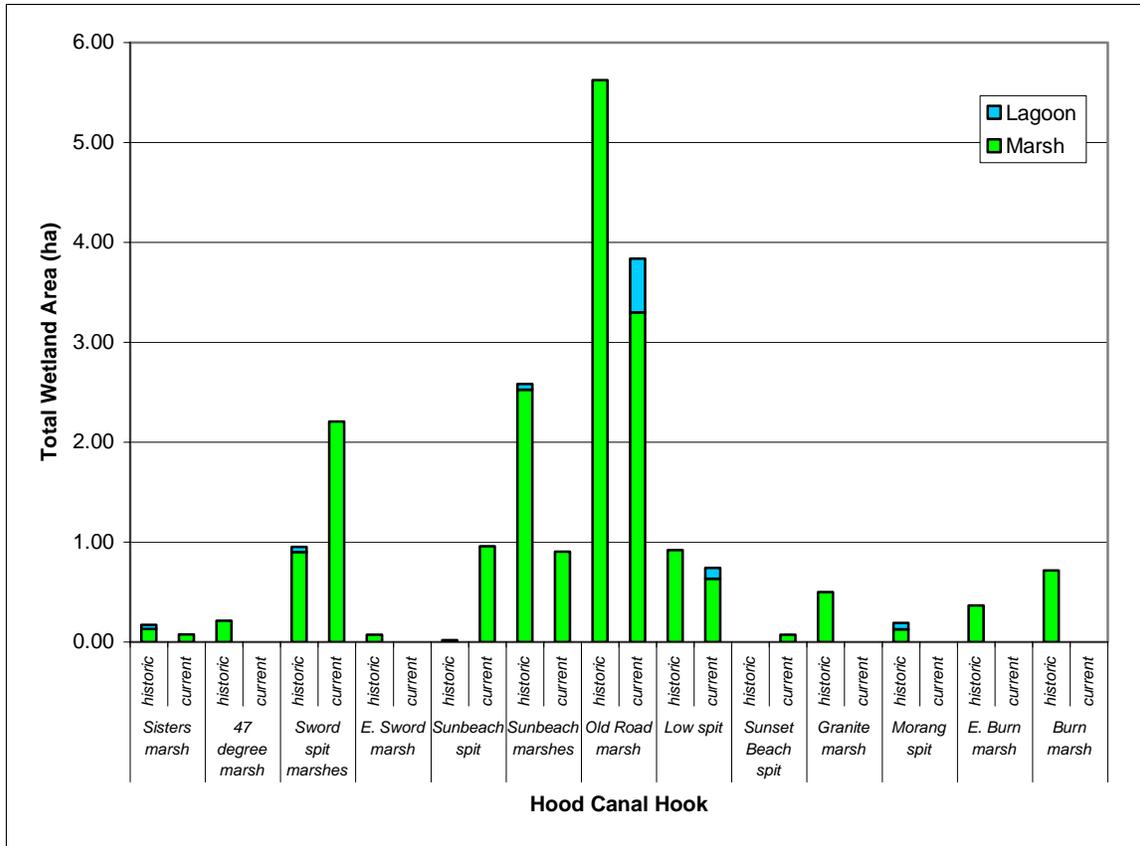
Figure 4. Historical changes in surface area of tidal marsh and lagoon habitat associated with spit/marsh complexes in the Hood Canal Hook sub-region. The Sunbeach Spit, Rose Spit, and West Granite Spit habitat complexes are not included because they historically and currently lack tidal marsh and lagoon habitat.

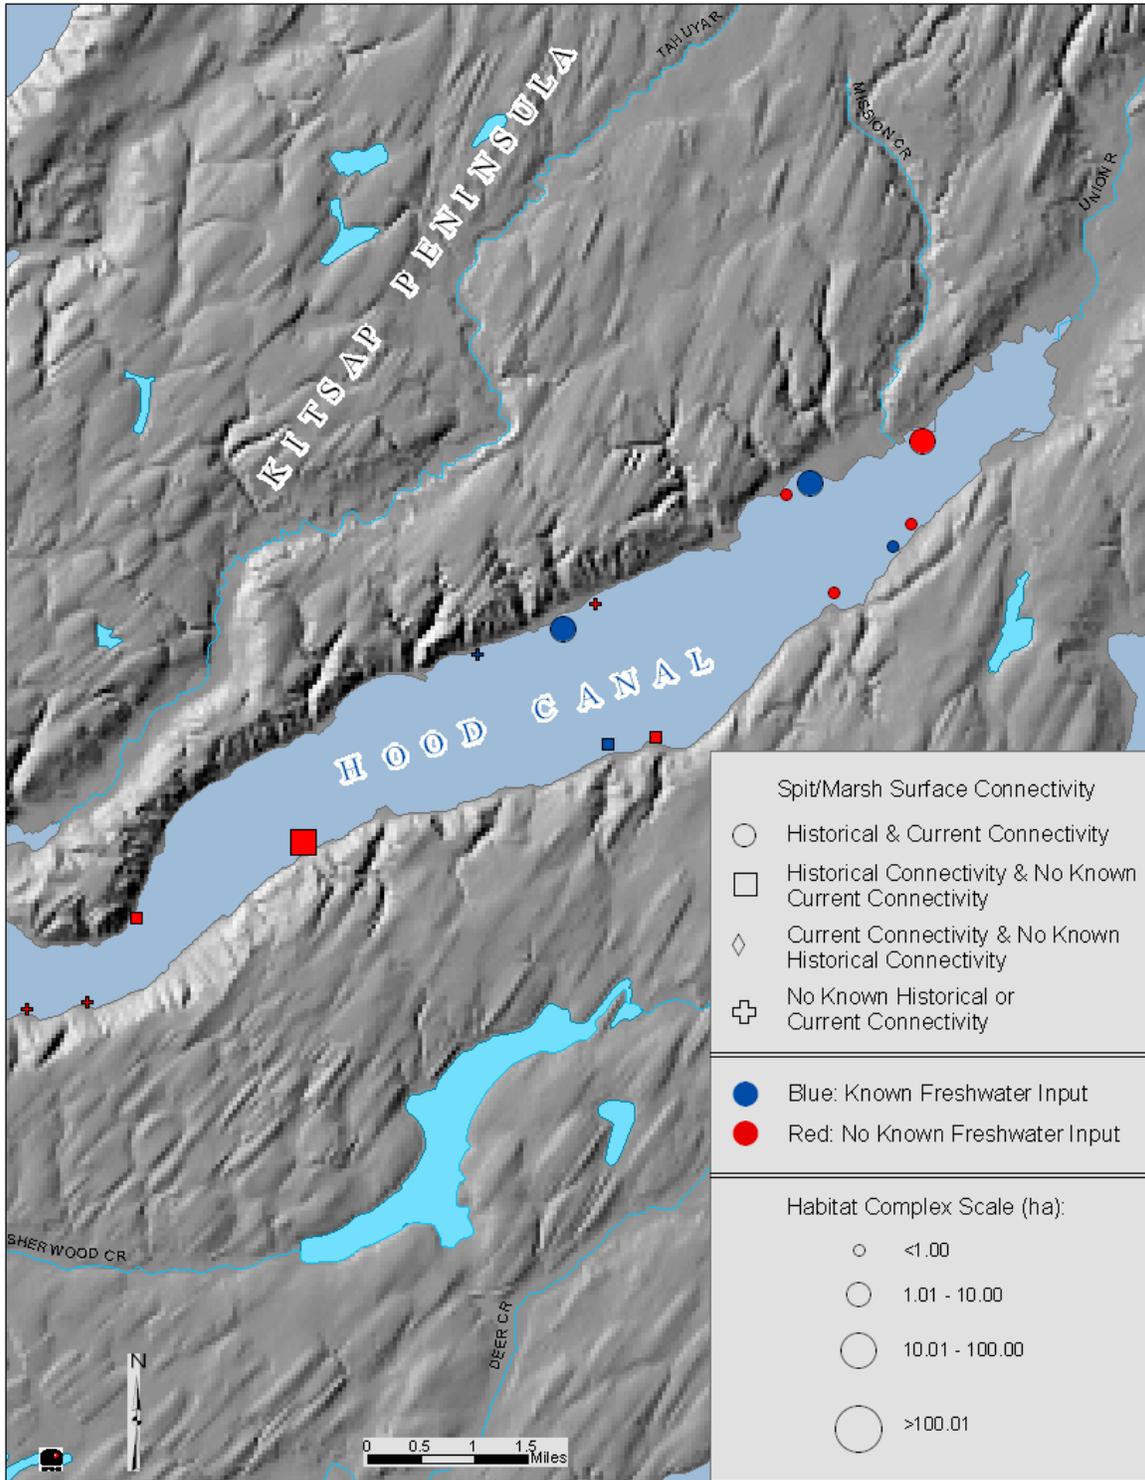
Figure 5. Spit/marsh habitat complexes of the Hood Canal Hook sub-region, including historical scale, the historical and current status of surface water connectivity with adjacent open waters, and freshwater inputs.

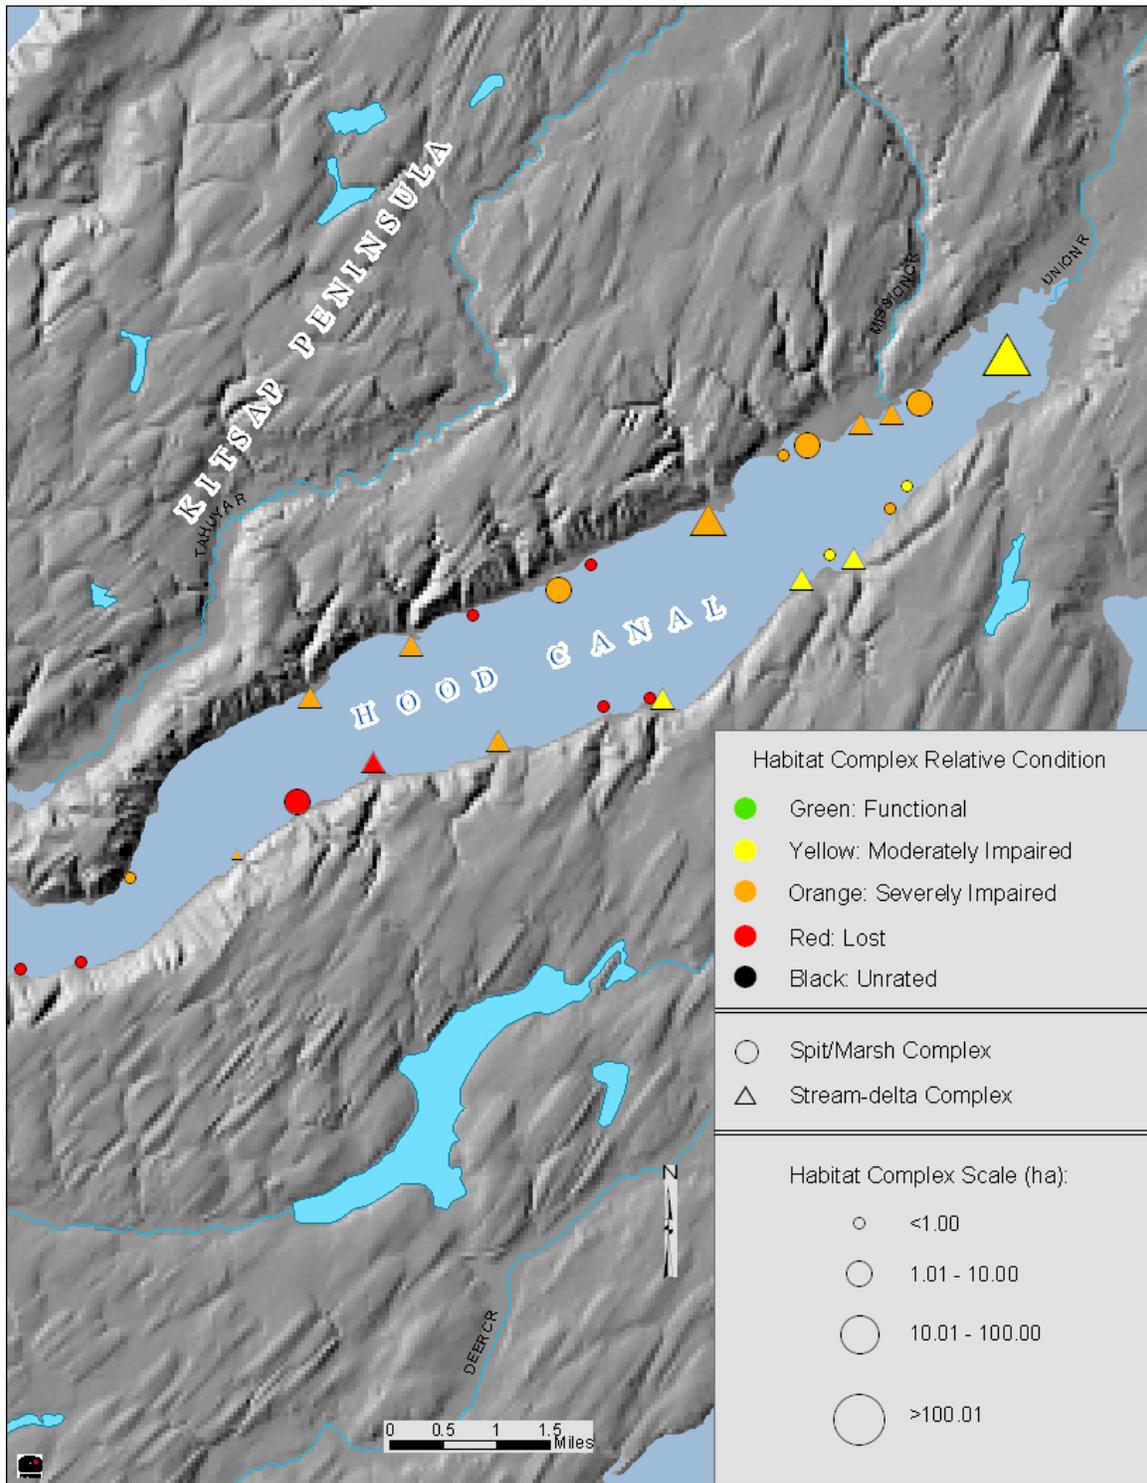
Figure 6. Relative condition of habitat complexes in the Hood Canal Hook sub-region.

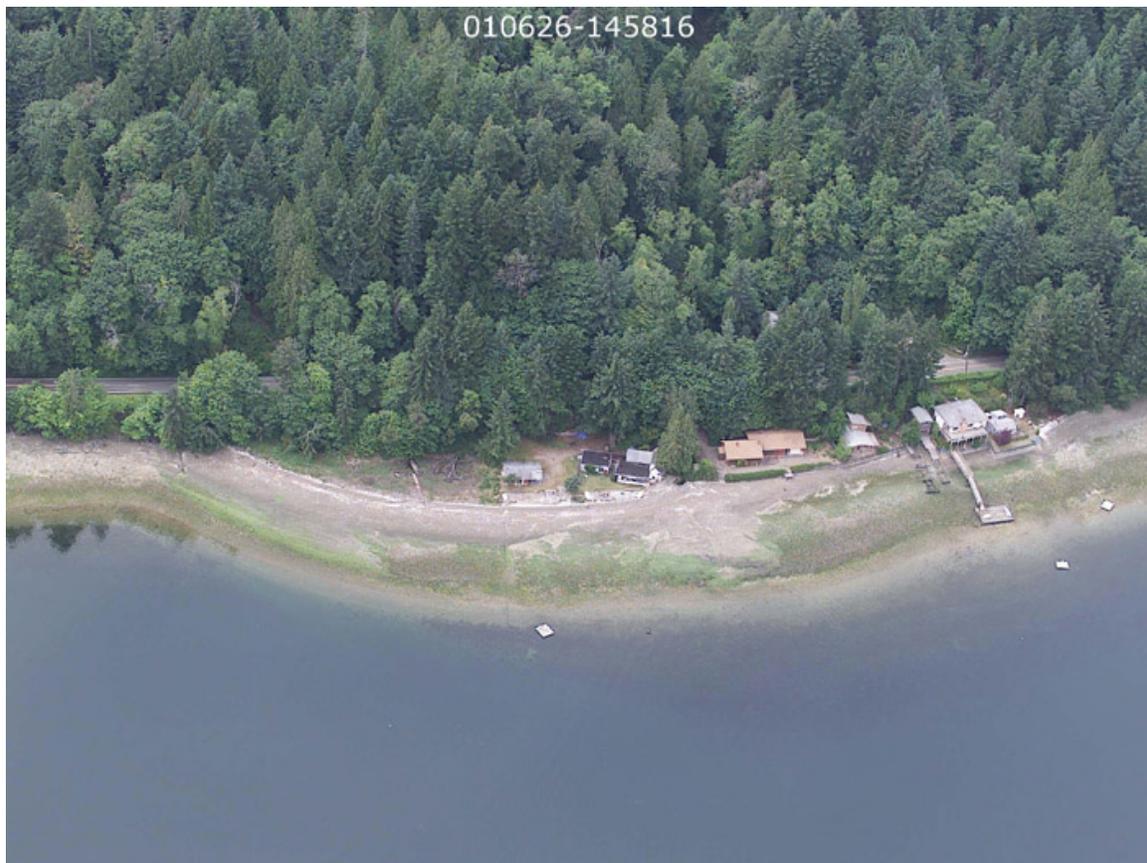
Because of the reduction of salt marsh and lagoon habitat, development along much of the spit, and the loss of historical surface water connection, we consider the relative condition of this complex “severely impaired”.

Figure 7. 2001 WDOE oblique photo showing the remnant Sisters Marsh (left side of photo). The right side (north side) has been filled over for homes.

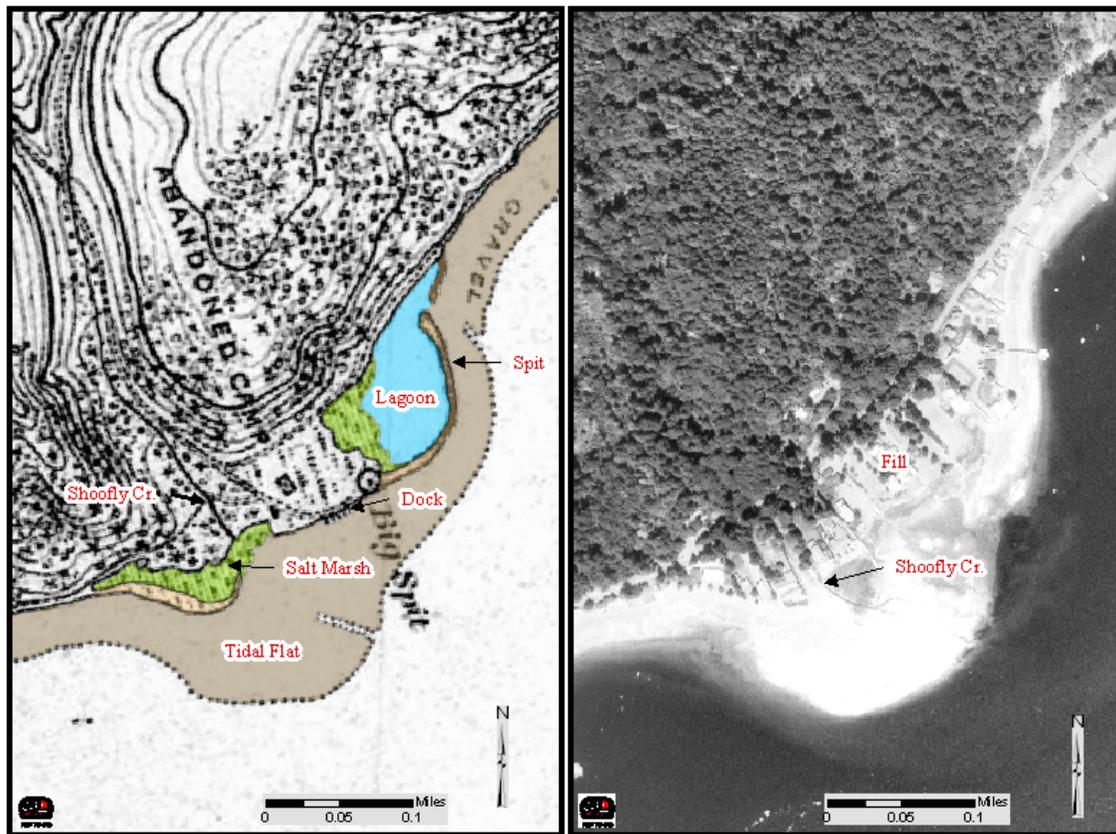
Figure 8. 1884 T sheet (at left) and 2000 WDNR orthophoto (at right) showing the Shoofly Creek/Big Spit habitat complex.

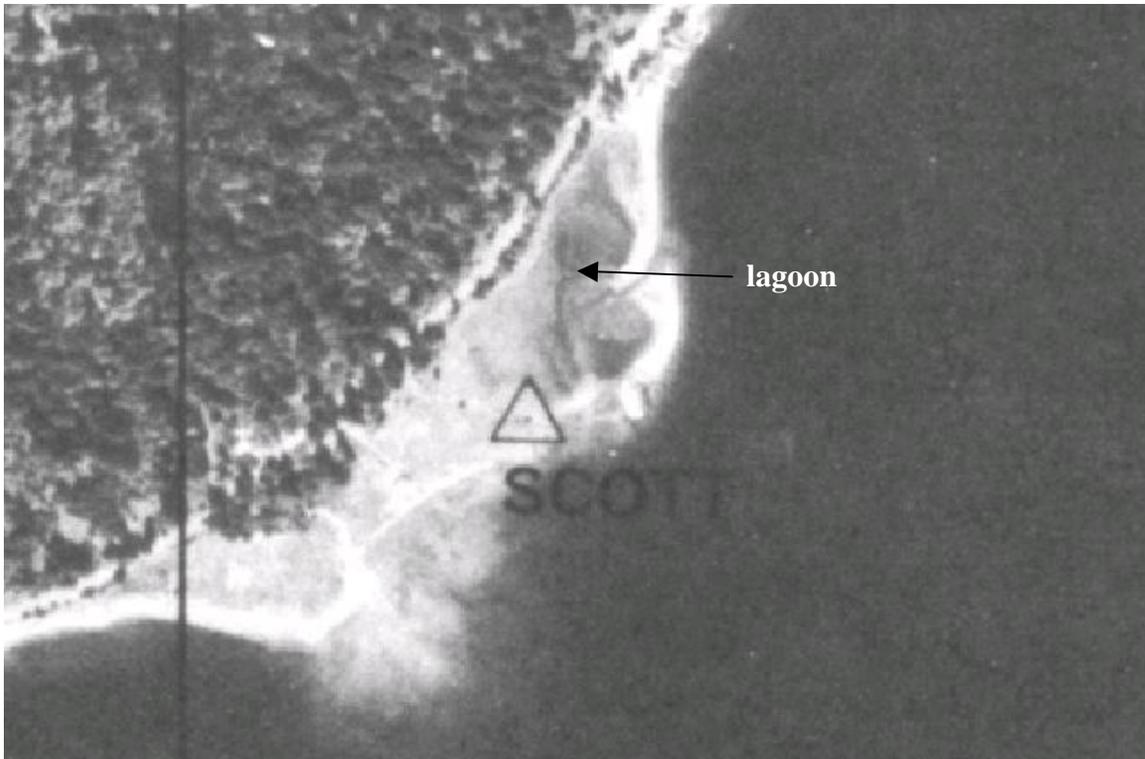
Figure 9. 1942 air photo showing the Shoofly Creek/Big Spit habitat complex.

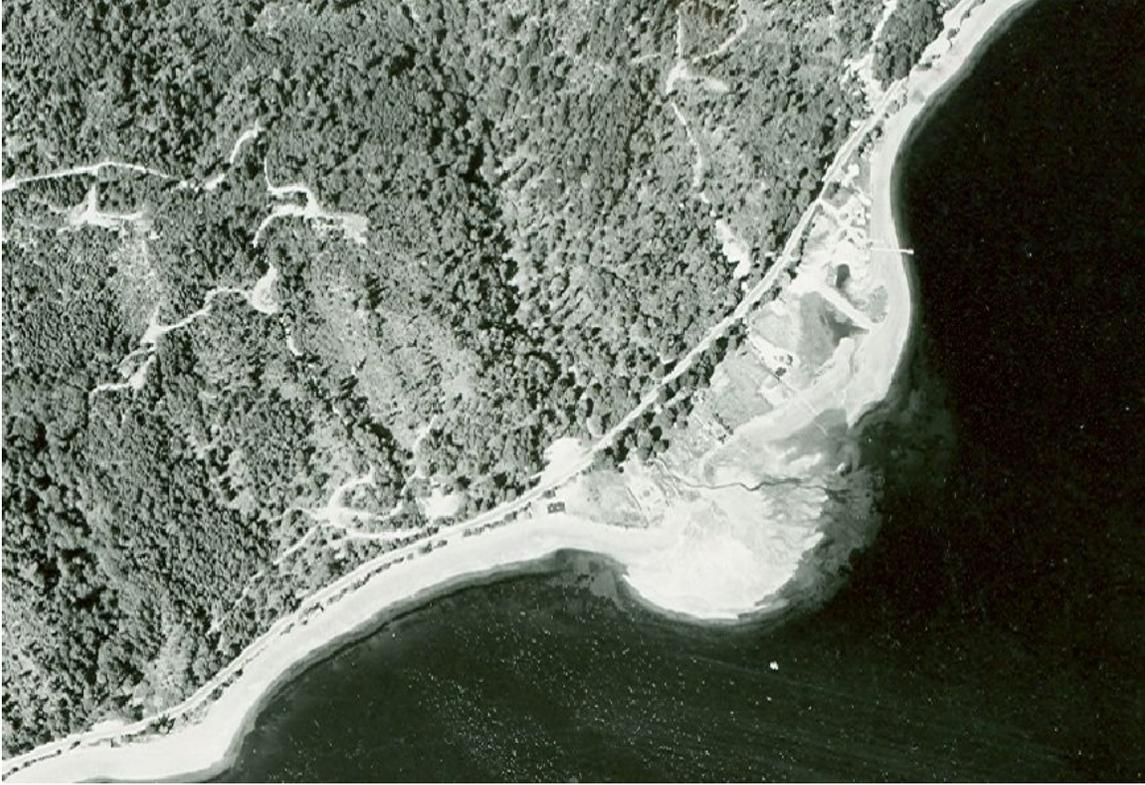
Figure 10. 1957 air photo showing the Shoofly Creek/Big Spit habitat complex. Notice the filling and road or pier across the lagoon at Big Spit. Compare with the 1942 air photo above.

Based on the complete loss of the spits and tidal lagoon habitat associated with Big Spit, and substantial loss of salt marsh at this complex, we consider the relative condition “Severely Impaired”.

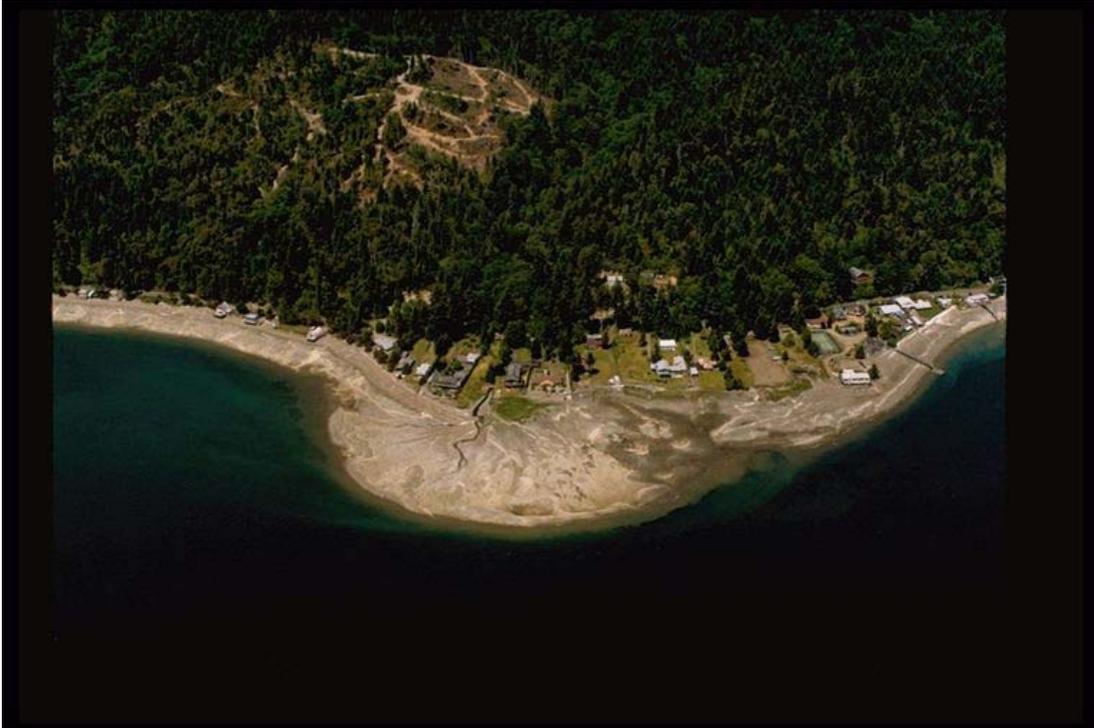
Figure 11. 1993 WDOE oblique photo showing Shoofly Creek (delta) and site of Big Spit, the latter by this time appearing to be completely filled over.

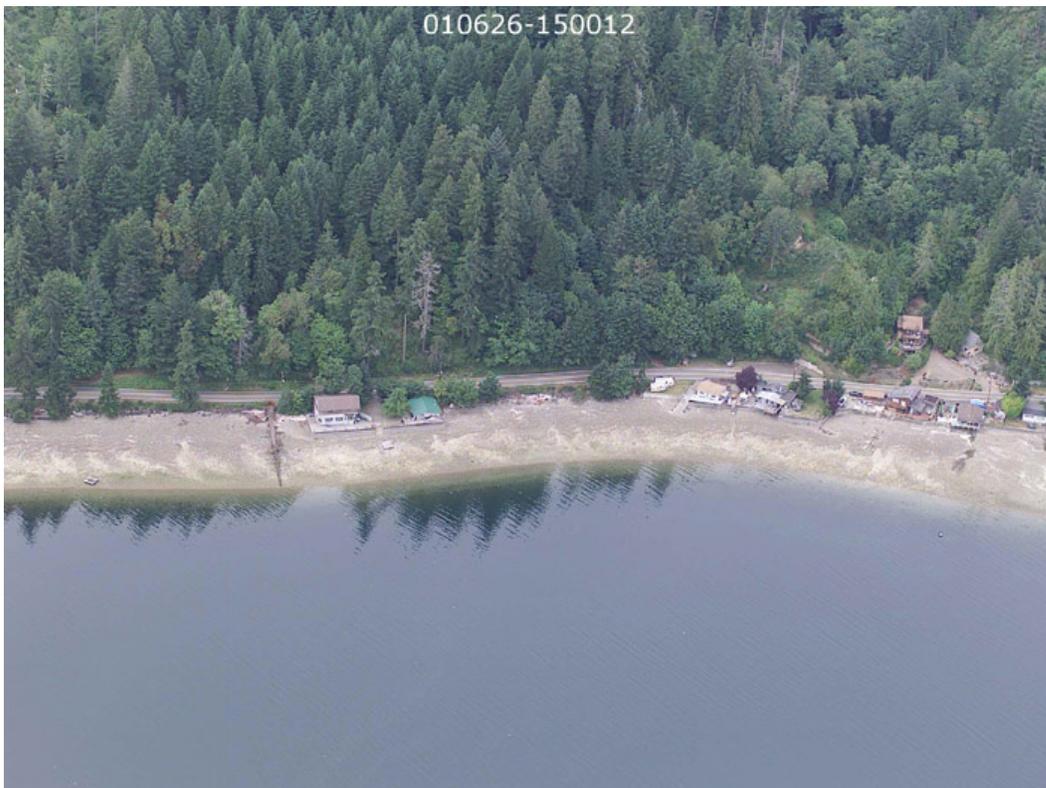
Figure 12. 2001 WDOE oblique photo showing the sediment divergence zone just east of Shoofly Creek/Big Spit and west of Little Shoofly Creek.

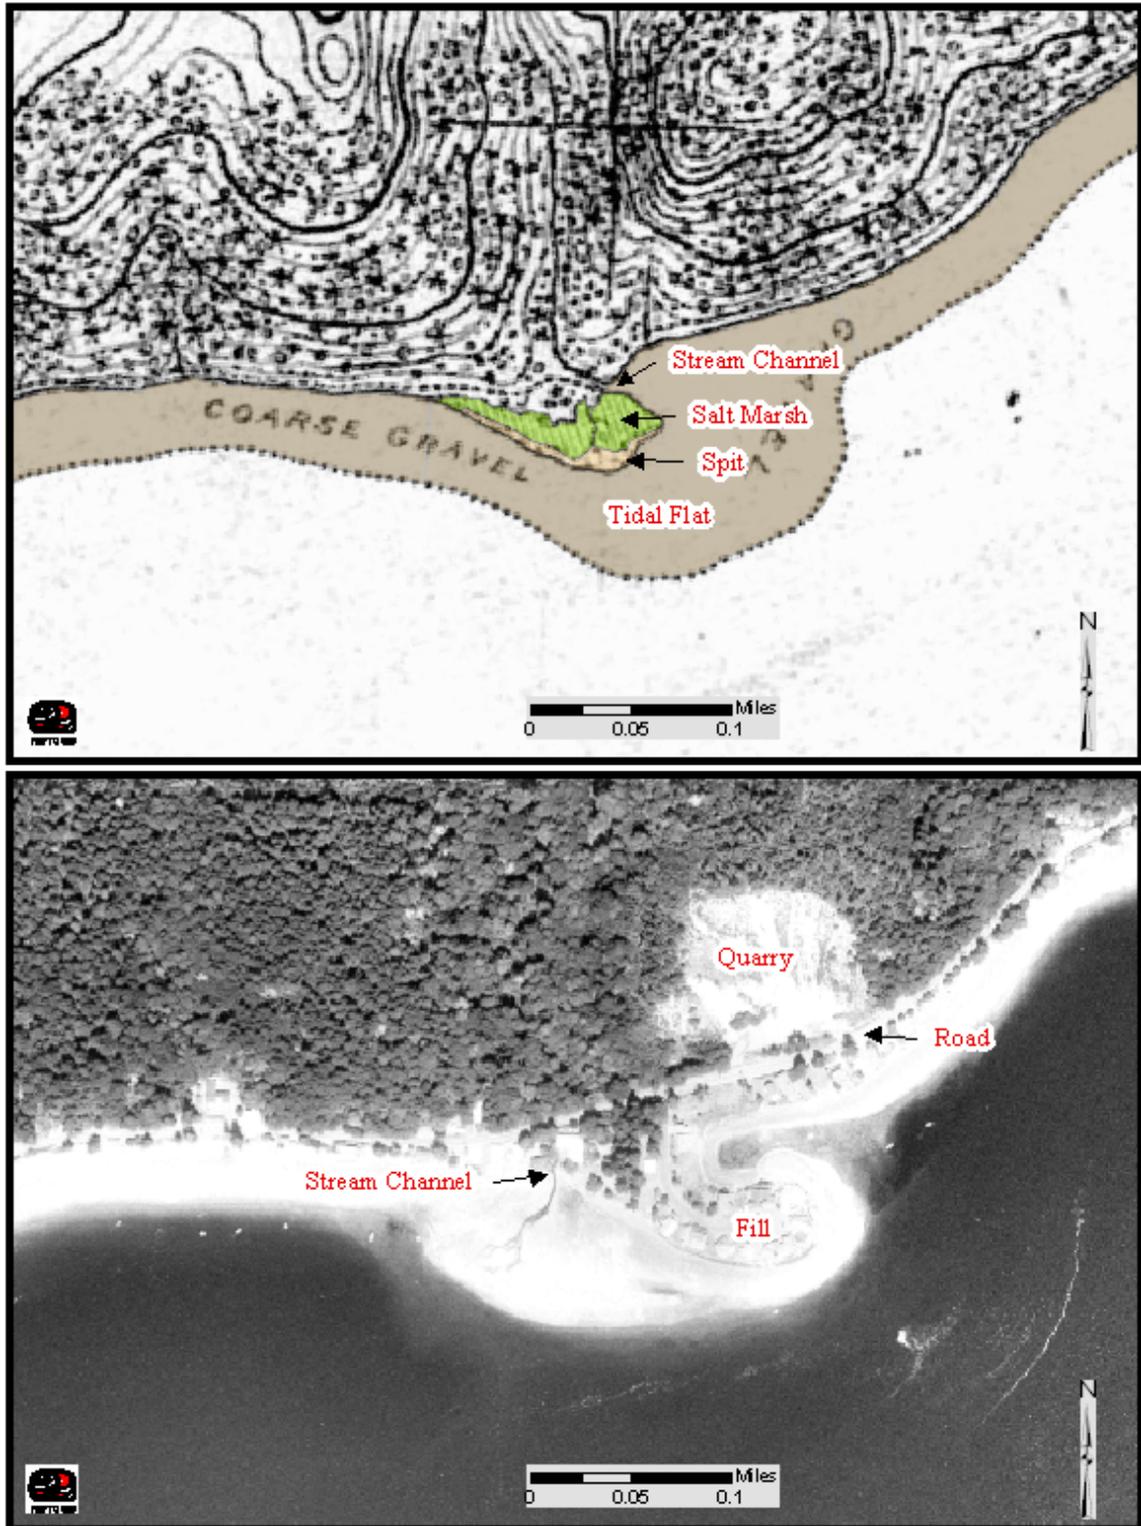
Figure 13. 1884 T sheet (top) and 2000 orthophoto (bottom) showing changes to the Little Shoofly Creek habitat complex.

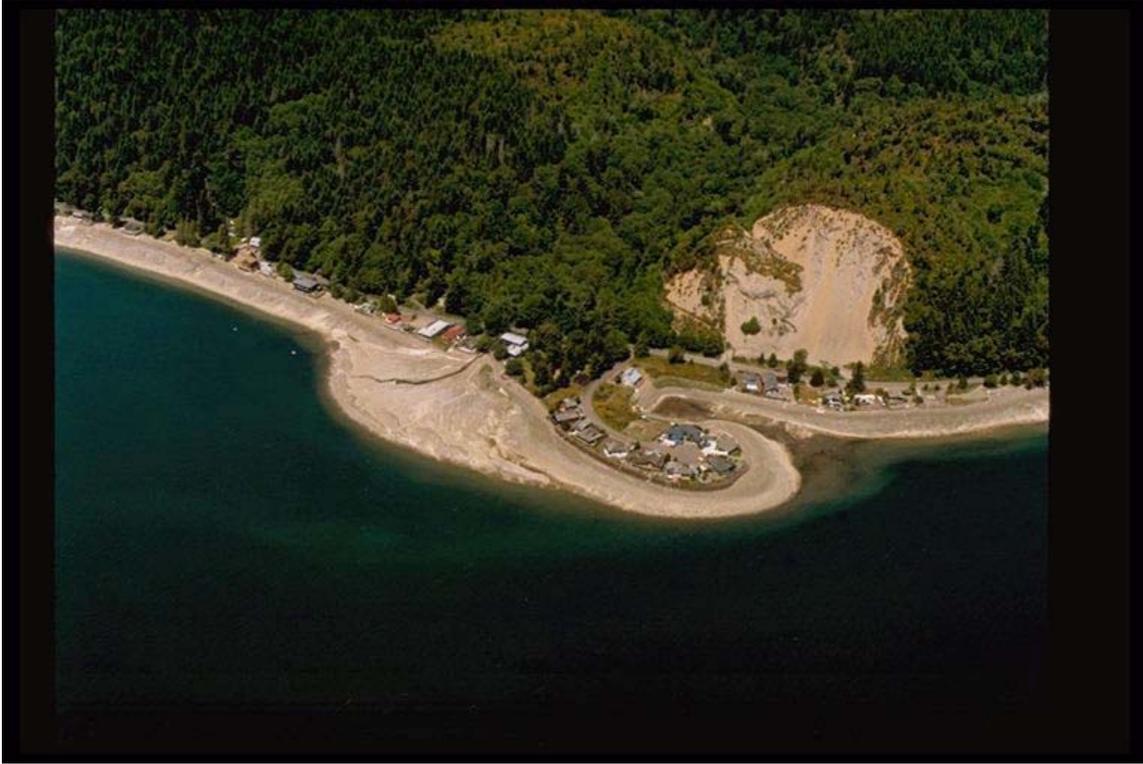
Figure 14. 1993 WDOE oblique photo of the Little Shoofly Creek habitat complex. Notice how the creek now enters west of a historically present spit. The spit has now been developed over and an artificial “cove” dredged out. A gravel or sand quarry is seen just above North Shore Road.

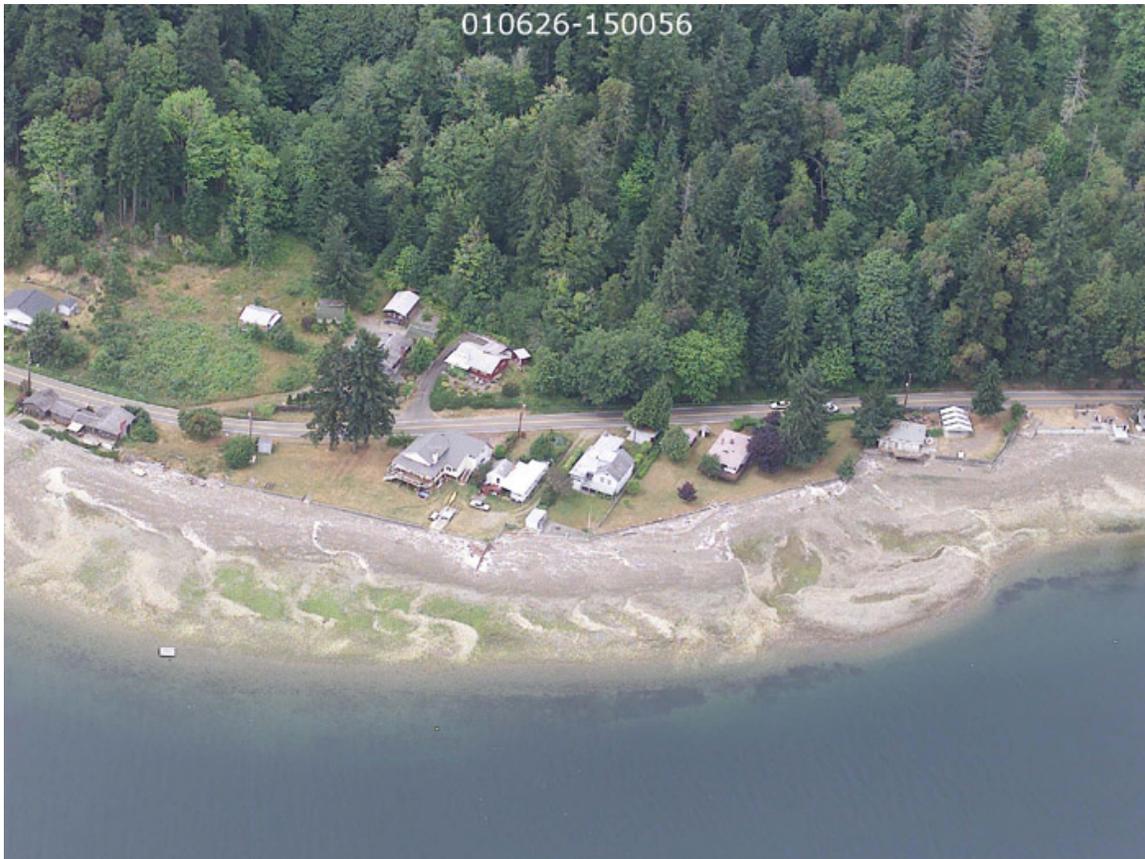
Figure 15. 2001 WDOE oblique photo of the site of the historical 47 Degree Marsh. None of the small historical marsh exists today due to residential development.

Because historical salt marsh has been completely eliminated from this site, we consider the relative condition “Lost”.

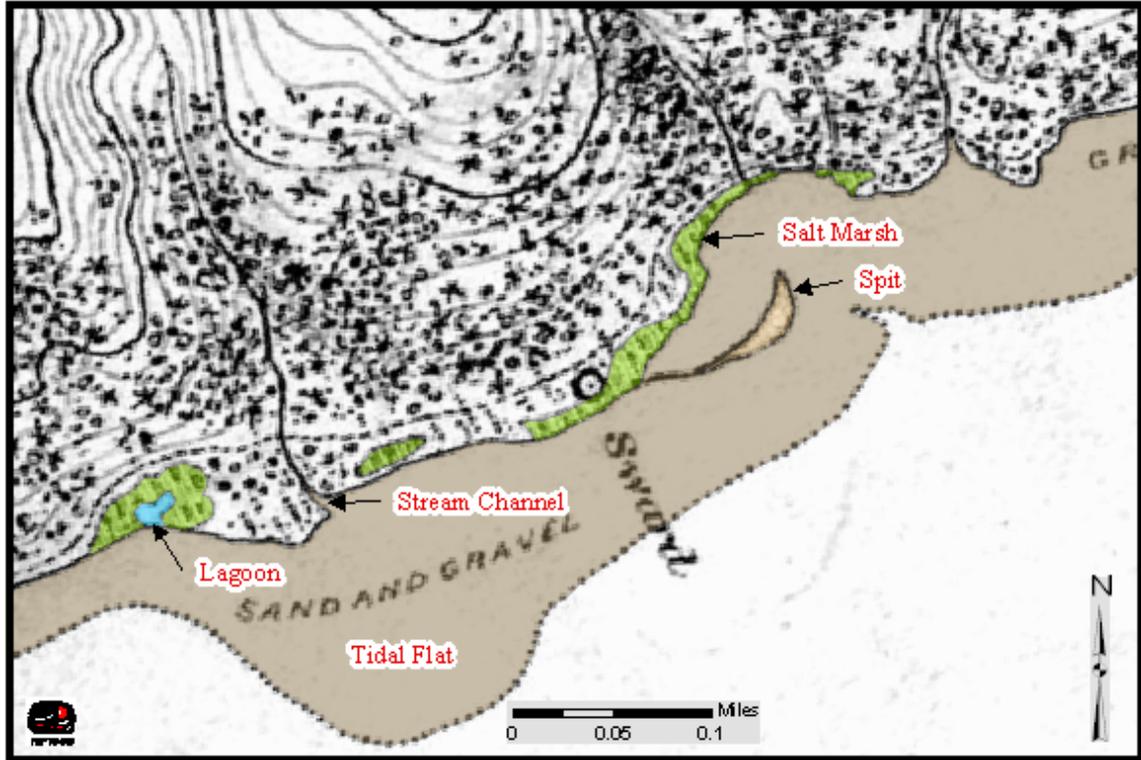
Figure 16. 1884 T sheet showing the Sword Spit habitat complex and associated marshes to the west.

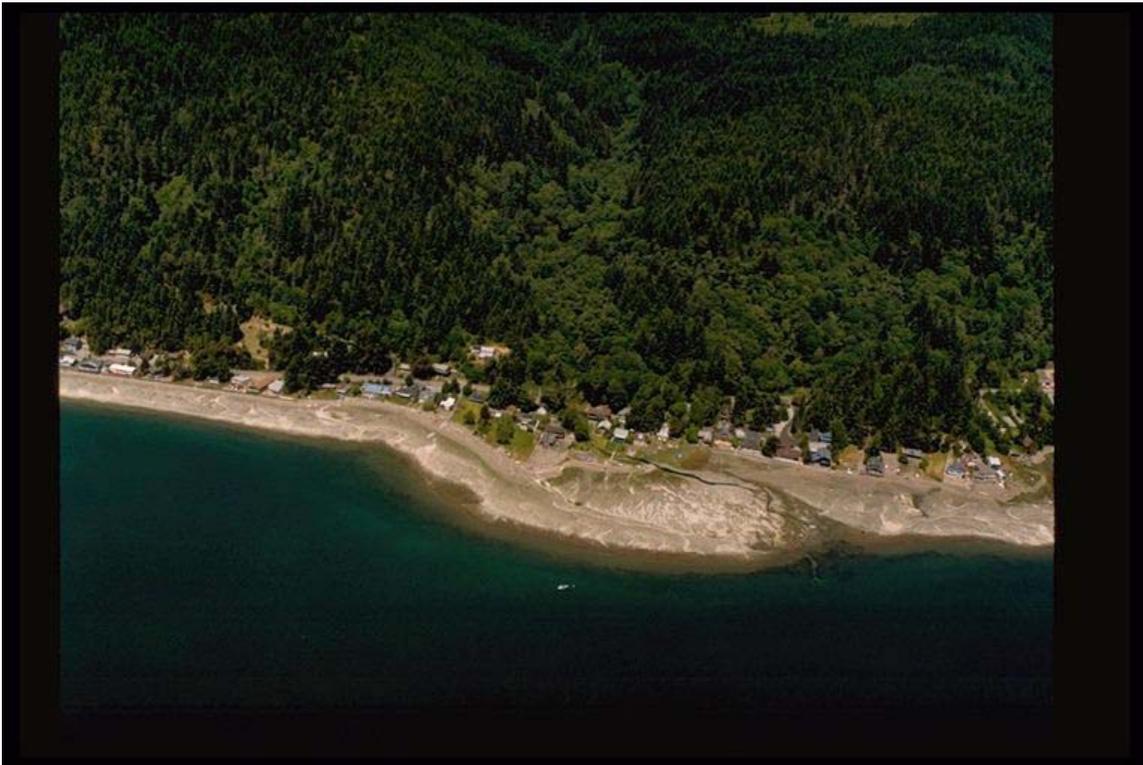
Figure 17. 1993 WDOE oblique photo showing the west portion of the Sword Spit habitat complex. The Sword Spit itself is actually at the far right of this image where only the base of the spit is evident west of the stream outlet. Small patches of salt marsh historically occurred at the base of the spit. The immediately following figure shows all of Sword Spit.

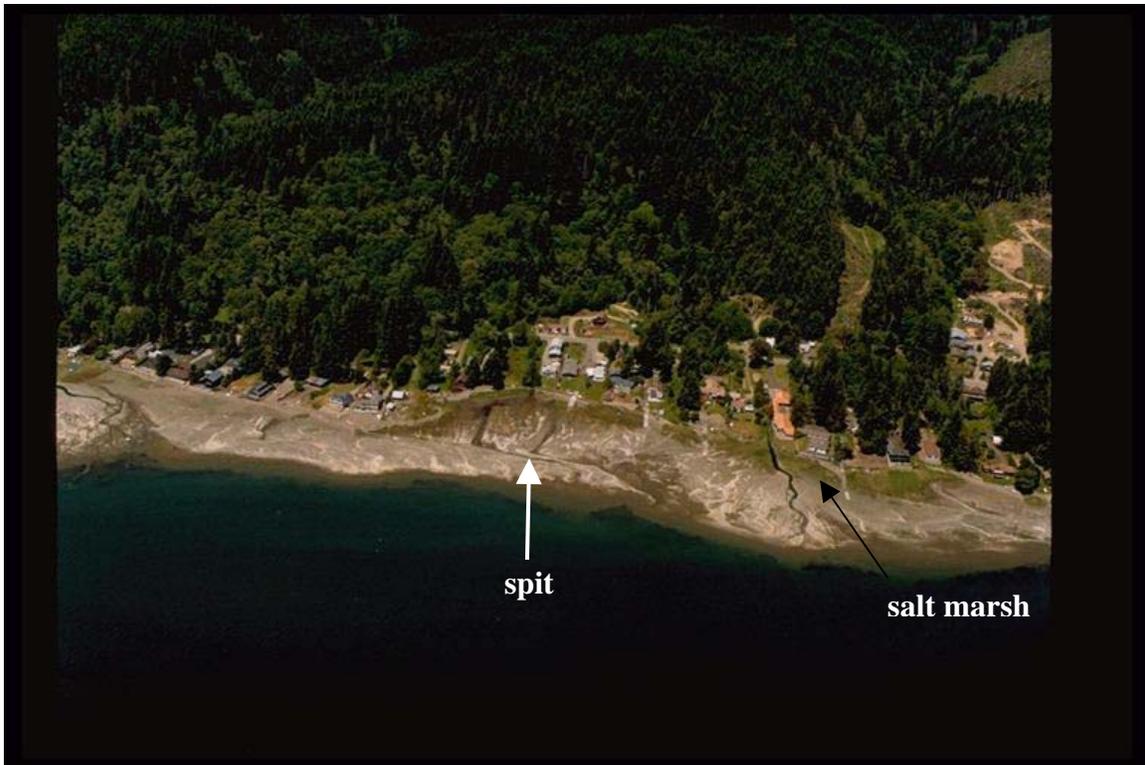
Figure 18. 1993 WDOE oblique photo showing the Sword Spit habitat complex. The spit is the low elevation bar running parallel with the shoreline near the center of the image. Patches of salt marsh occur behind the spit, often growing seaward of bulkheads.

Though our estimates show the surface area of salt marsh has roughly doubled at this complex, the new salt marsh has come at the expense of tidal flat, and homes have probably filled over tide flat as well. In addition, tidal wetland habitat is fragmented, and drift cell processes affecting the spit have likely been highly disrupted. For these reasons, we consider the relative condition “Severely Impaired”.

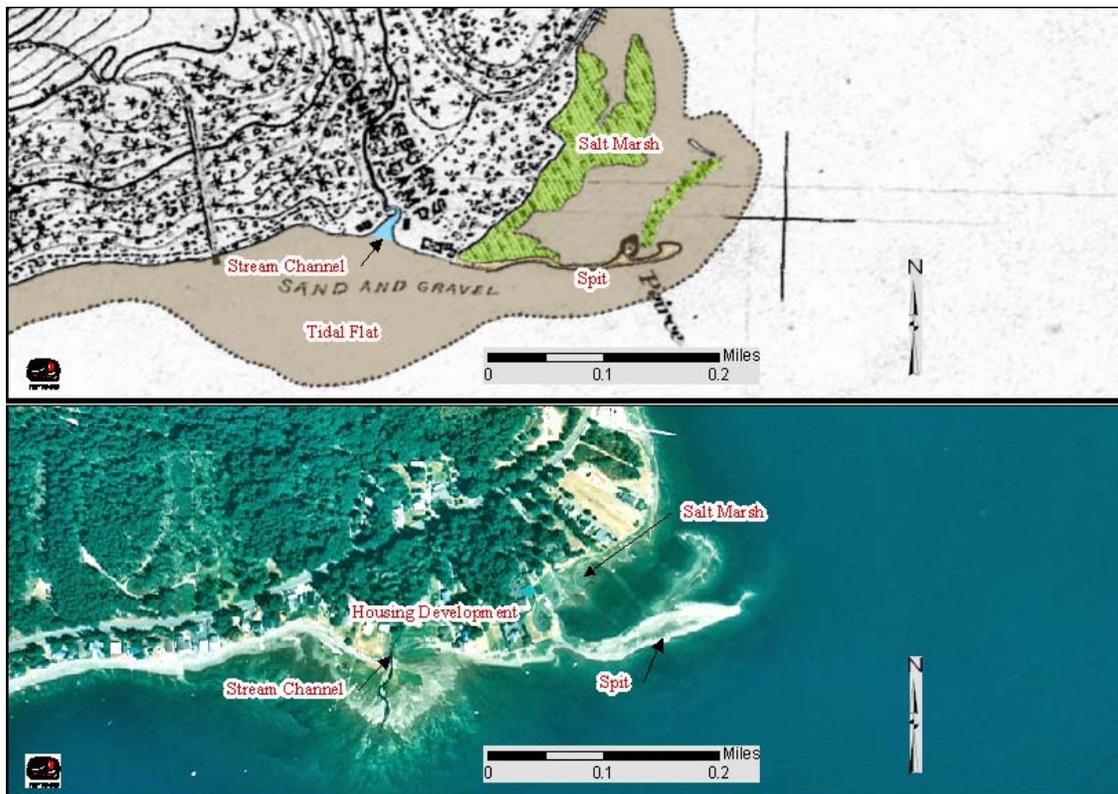
Figure 19. 1884 T sheet (top) and 2003 WDNR air photo (bottom) showing the Stimson Creek/Peirce Spit habitat complex. Notice the presence of a log chute just west of the mouth of Stimson Creek in 1884, and the logging camp centered around the creek mouth itself. The creek mouth and salt marsh associated with Big Spit have been filled over for a housing development and roads.

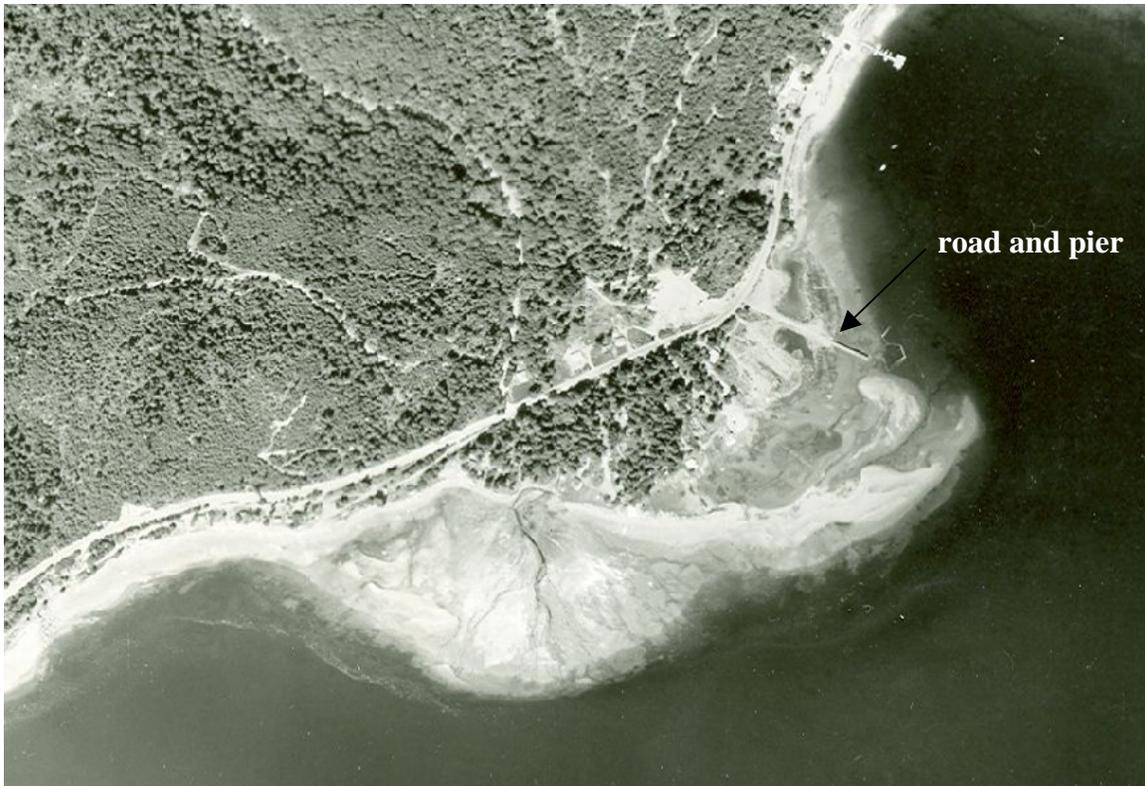
Figure 20. 1956 air photo showing the Stimson Creek/Peirce Spit habitat complex. A road and pier extended out into the tidal lagoon at the east end of the complex at this time.

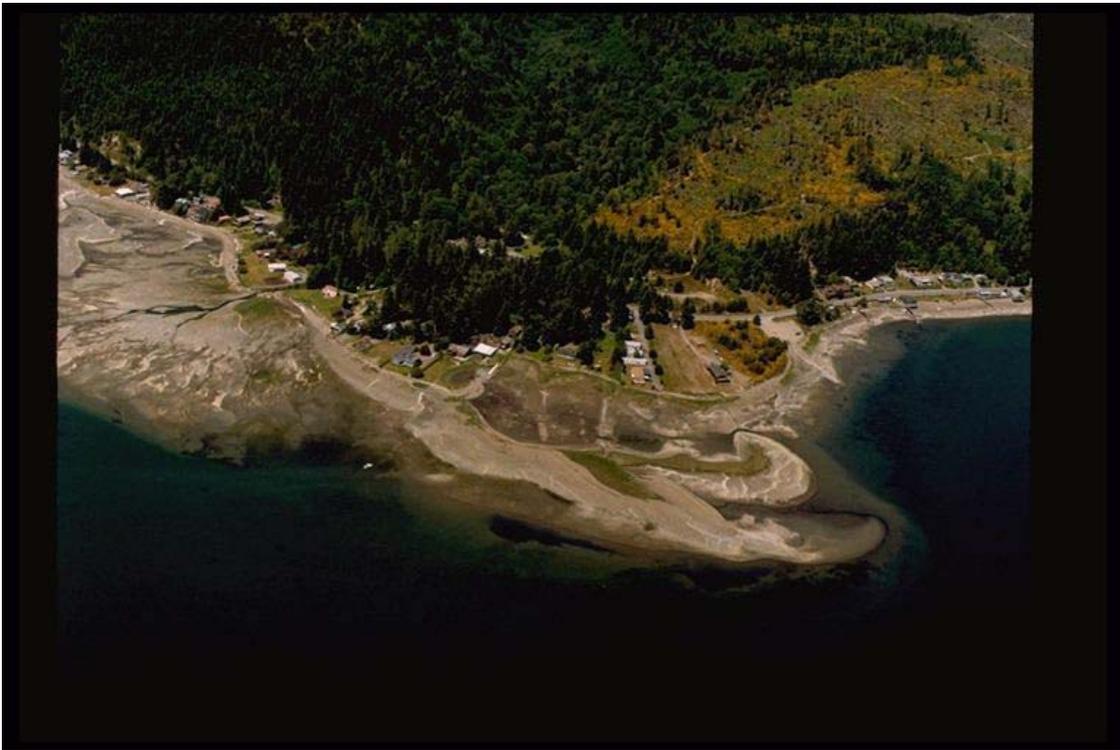
Figure 21. 1993 WDOE oblique photo of the Stimson Creek/Peirce Spit habitat complex. Stimson Creek is shown on the left side of the image.

Because of the substantial loss of historical salt marsh and the filling around the mouth of Stimson Creek we consider the relative condition of this complex “Severely Impaired”.
