Appendix B – 12: Hood Canal Hook Sub-Region

Hood Canal Hook Sub-region

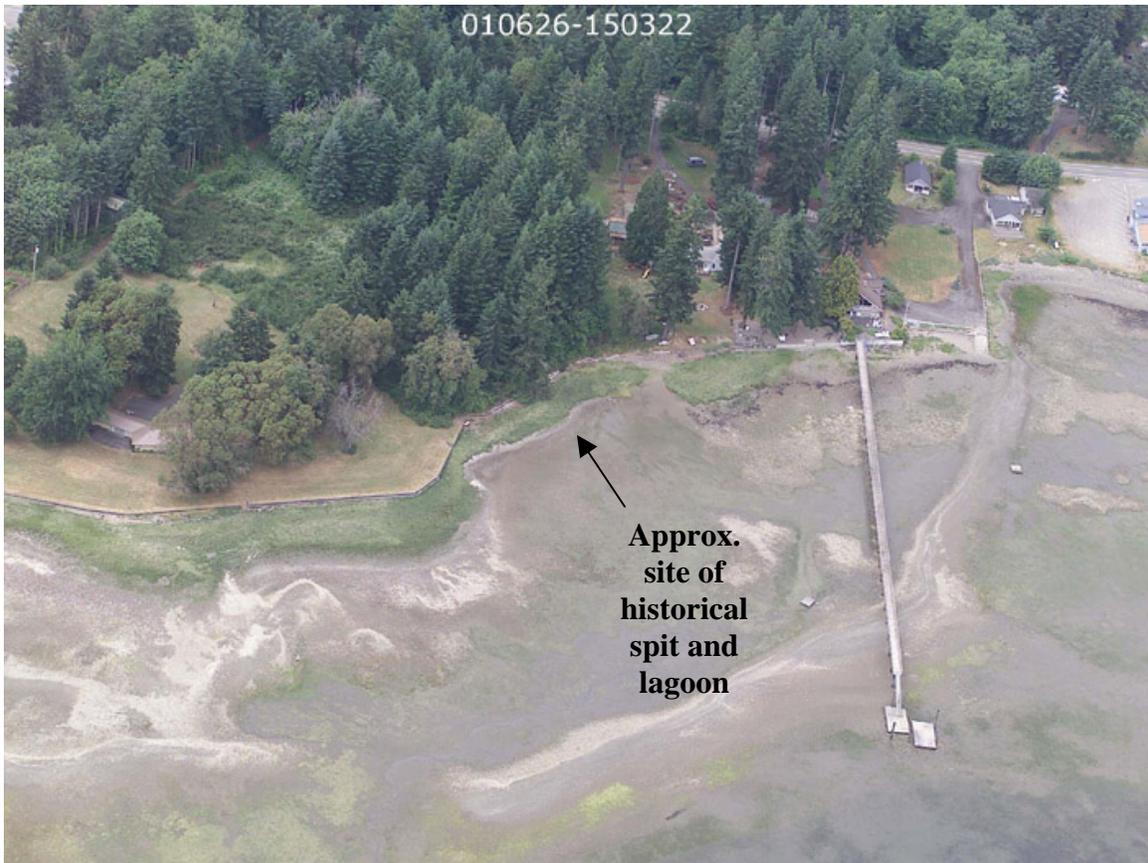
Figure 22. 2001 WDOE oblique photo showing the site of the tiny historical Sunbeach Spit complex. Note the salt marsh growing in front of bulkheads along this stretch of beach, and one of two piers that occurs just east of the former habitat complex.

Though the tiny historical spit and lagoon is no longer present at this site, a considerable fringing salt marsh has grown in front of bulkheads at this site. Assuming some compensatory benefit from the new salt marsh, even though the historical habitat has been lost, we consider the relative condition of the Sunbeach Spit complex “Severely Impaired”.

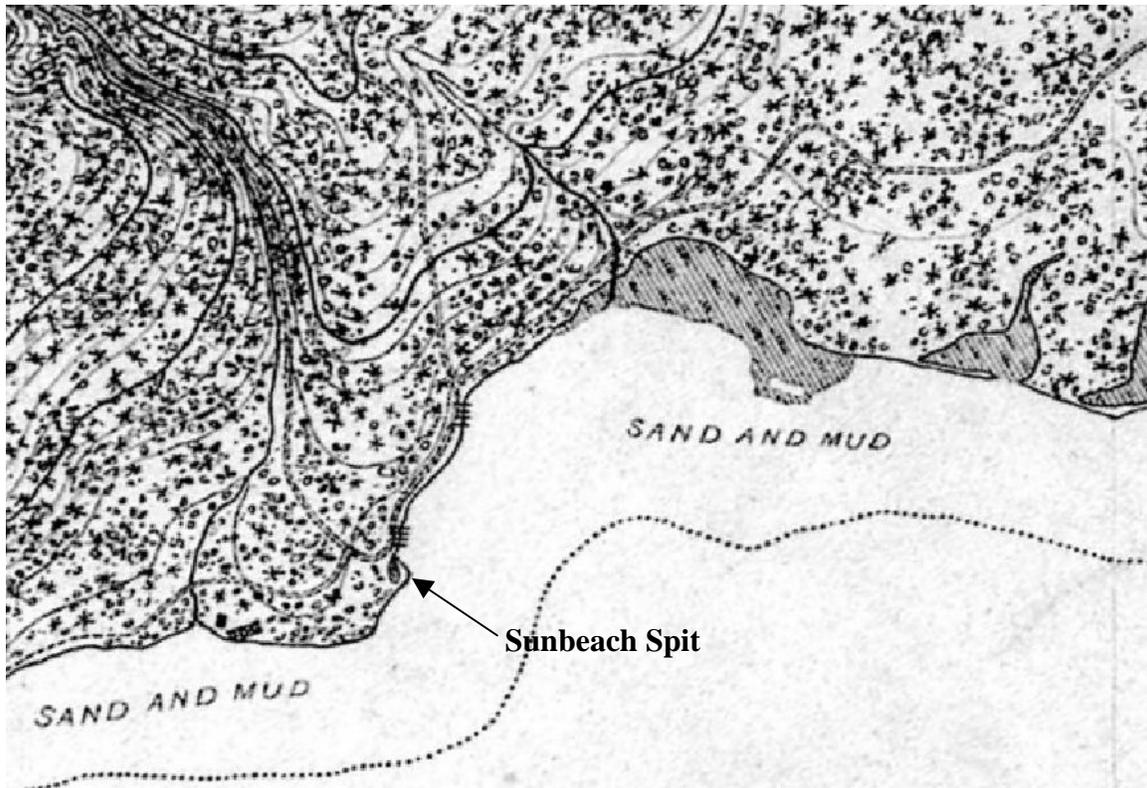
Figure 23. 1884 T sheet showing the Sunbeach Marshes habitat complex (at the center and right part of the image). The tiny Sunbeach Spit complex occurs just left of the center where the shoreline begins to run north and south. At the far right is a partial section of salt marsh associated with the adjacent Little Mission Creek complex. Notice the presence of roads, buildings and docks along the shoreline.

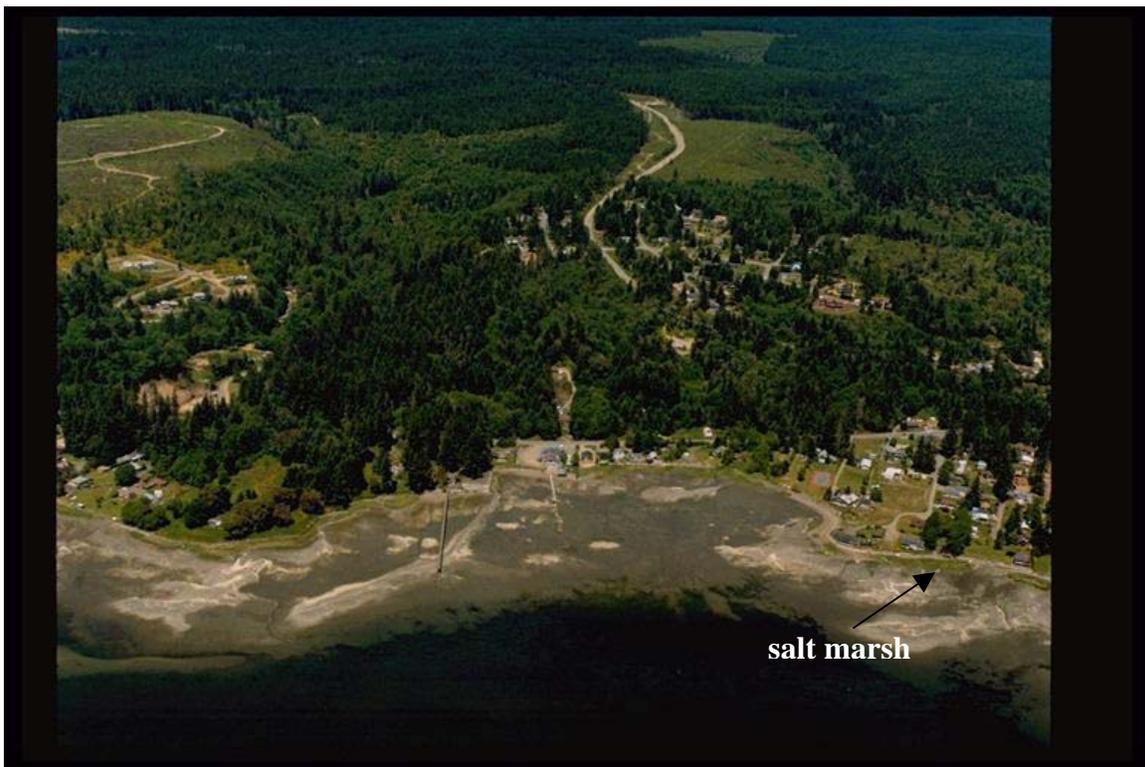
Figure 24. 1993 WDOE oblique photo showing the shoreline of the historical Sunbeach Spit (see narrative above) and Sunbeach Marshes habitat complexes. Sunbeach Spit was located just left of the longer pier, left of the center of the image. The Sunbeach Marshes were located near the center of the image and extending to the extreme right of the image, an area that has been developed over. Salt marsh is growing along parts of this shoreline today, much of it appears to be newly emerged and growing in front of bulkheads.

Although much of the historical marsh was eliminated by fill, a remnant or what appears to be new marsh is apparently developing seaward of the shoreline. For this reason, we consider the relative condition “Severely Impaired”.

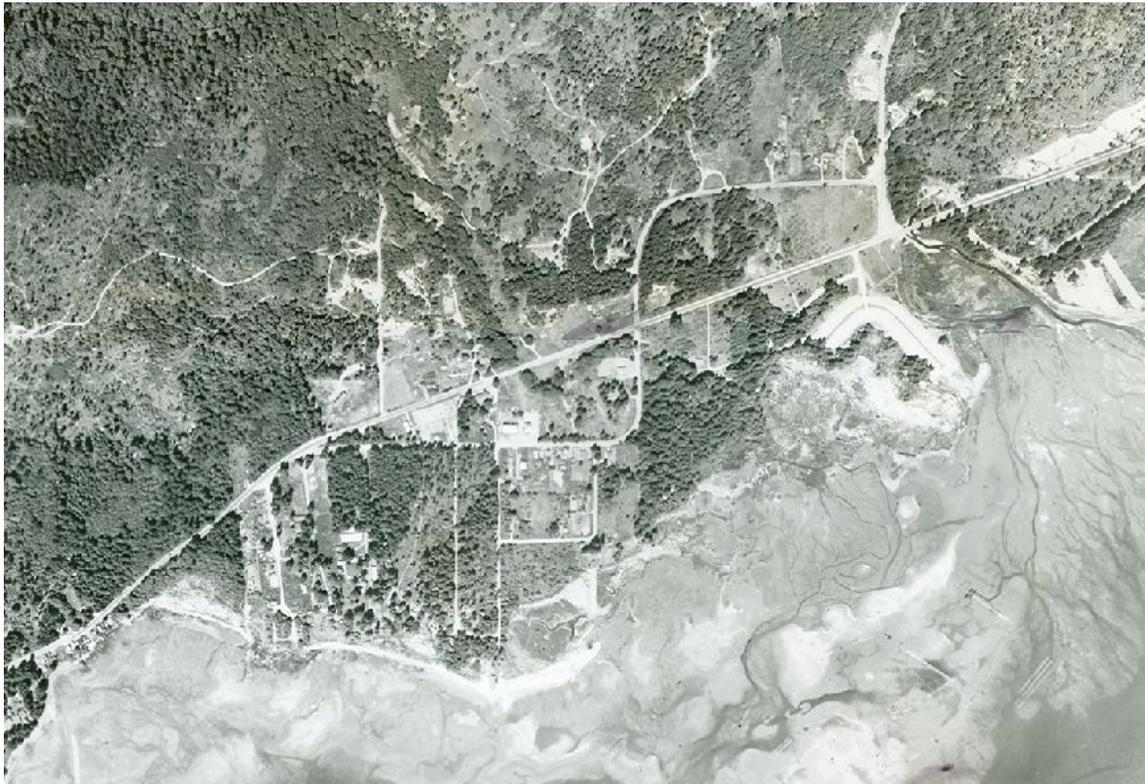
Figure 26. 1957 air photo of the Little and Big Mission Creek habitat complexes.

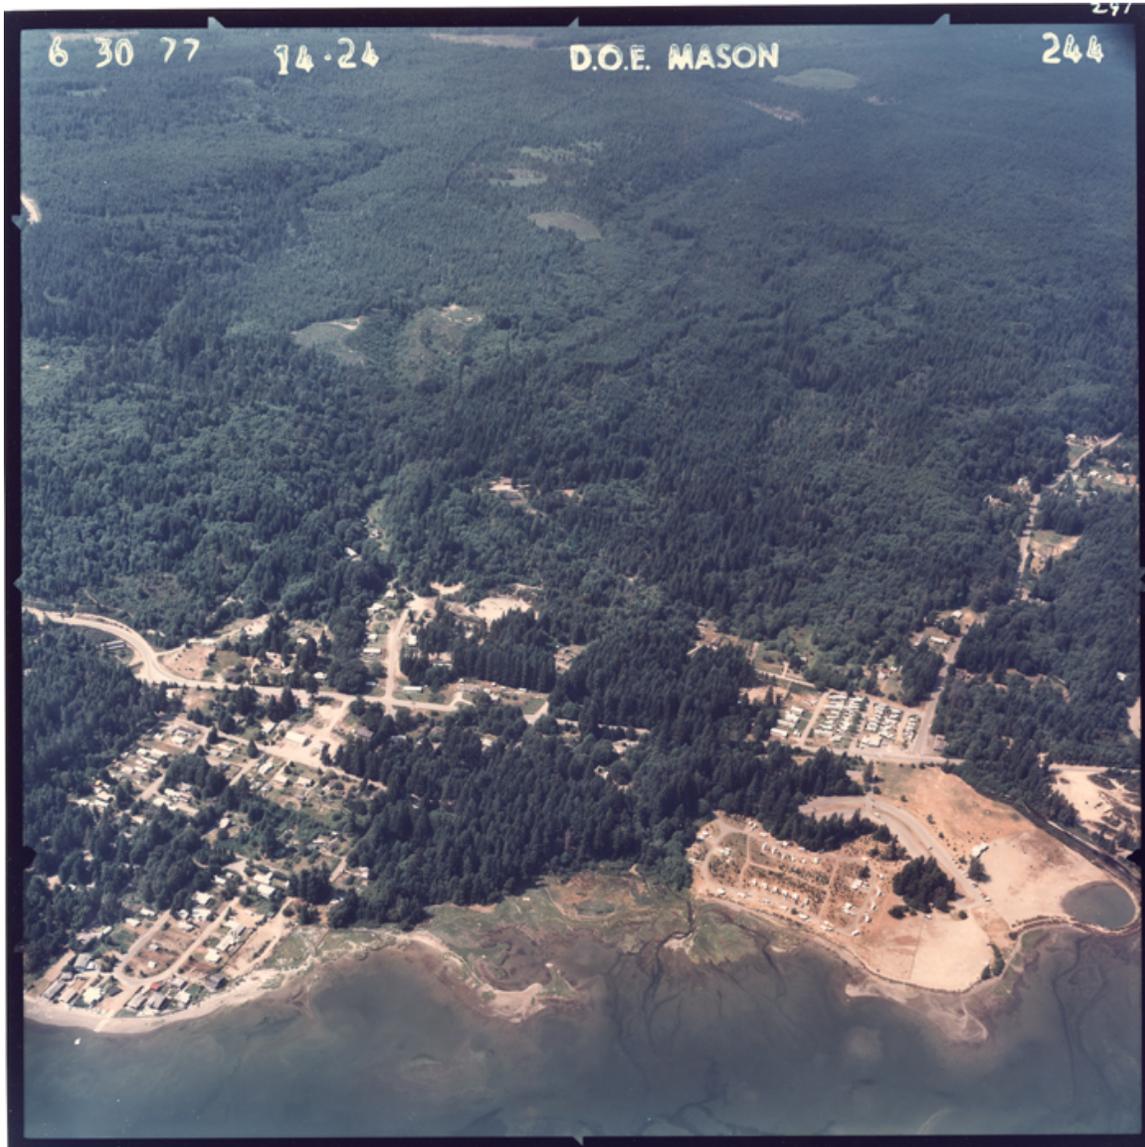
Figure 27. 1977 WDOE oblique photo showing the Little and Big Mission Creek habitat complexes.

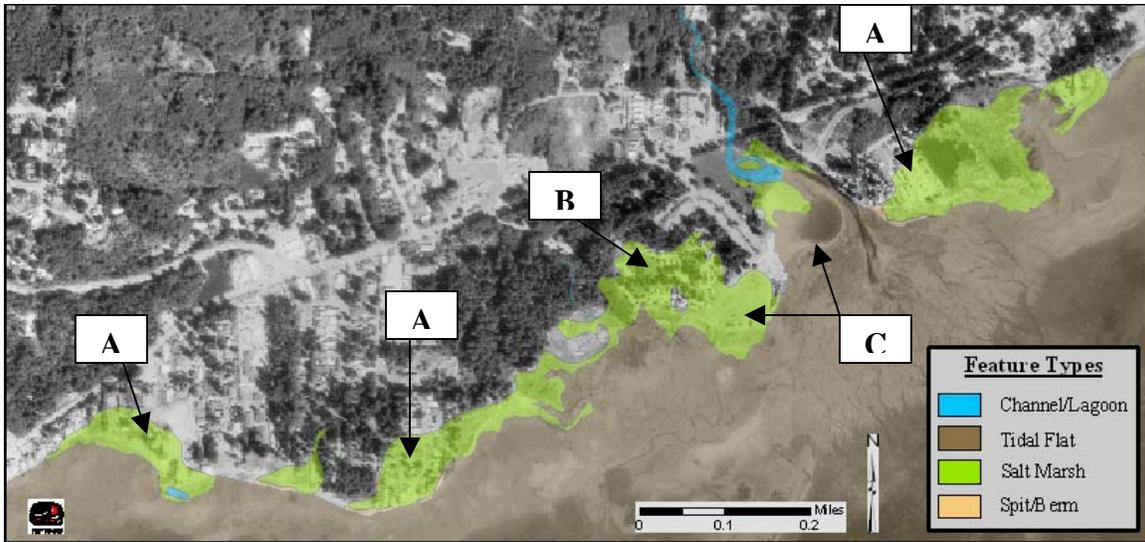
Figure 28. 2000 WDNR ortho-photo of the Mission Creeks estuary complex overlaid with habitat features (color-coded) from the 1884 T sheet. Letter A indicate the locations of housing developments, B is an area of developed campsites at Belfair State Park, and C are diked and filled portions of former marsh and tidal flat. The large patch of salt marsh at the far right of the image is the Old Road Marsh habitat complex (see narrative below).

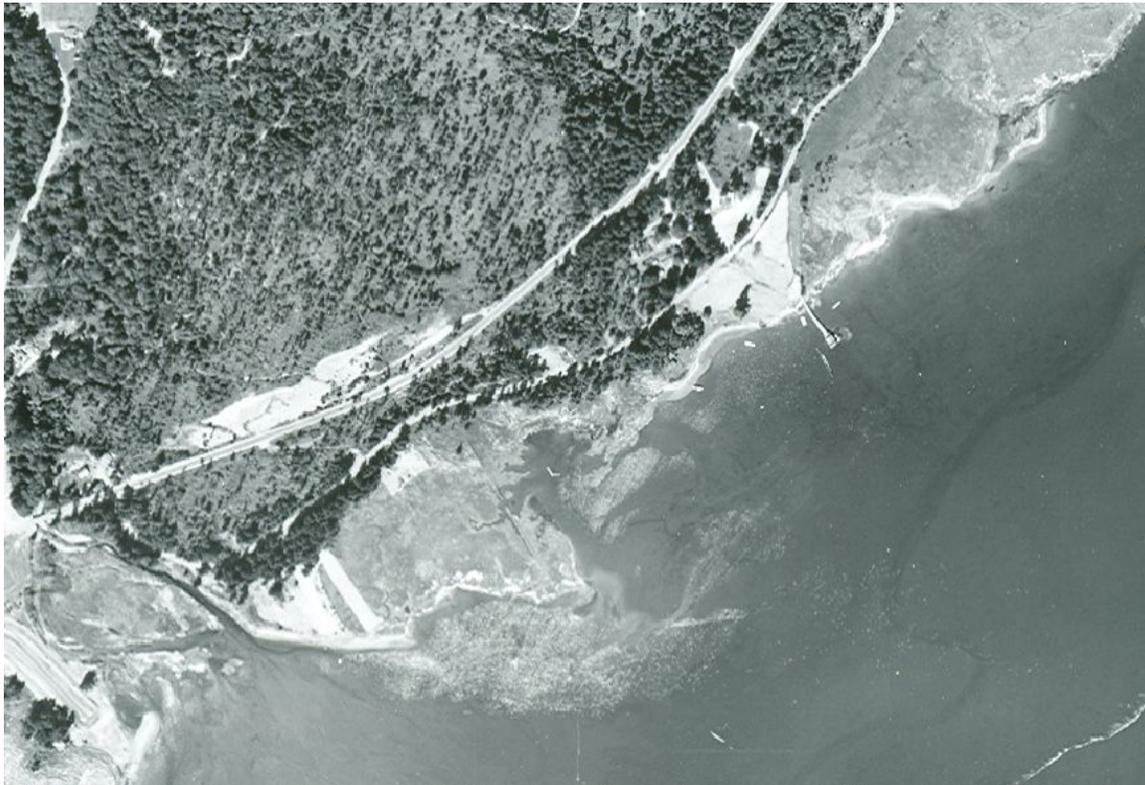
Figure 29. 1957 air photo of the Old Road Marsh complex. Note the filling near the west part of the marsh and spit located just east of Big Mission Creek in the left part of the image.

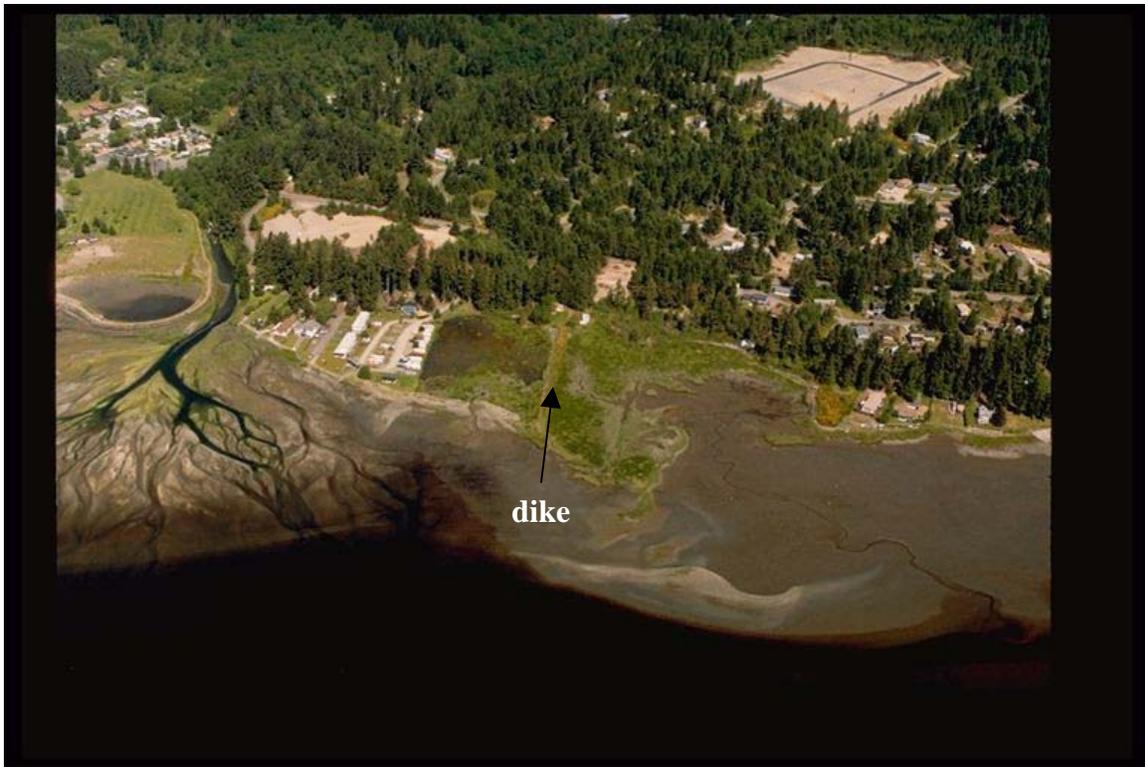
Figure 30. 1993 WDOE oblique photo showing the Old Road Marsh just east of Big Mission Creek, shown in the left part of the image. Notice the dike across the Old Road Marsh and development at the west end of the marsh.

Based on the loss of tidal marsh habitat, and impaired habitat connectivity, we consider the relative condition of this complex “Severely Impaired”.

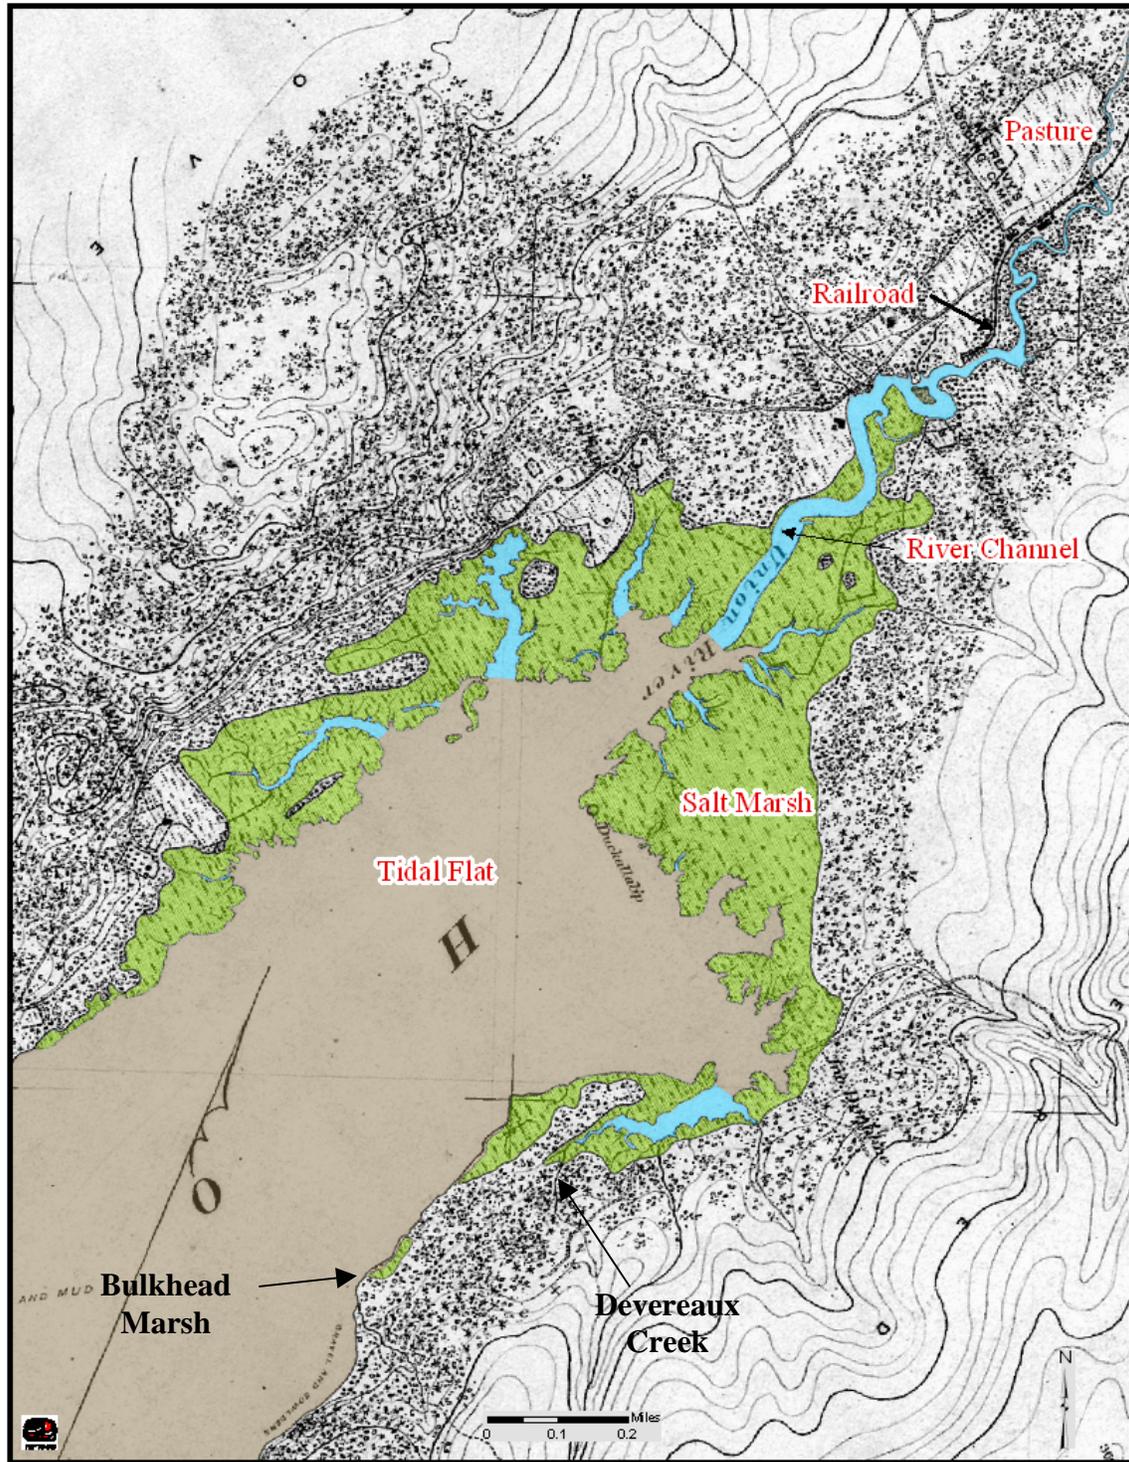
Figure 31. 1884 T sheet showing the Lynch Cove/Union River estuary complex, including the Devereaux and Bulkhead marsh portions of the complex.

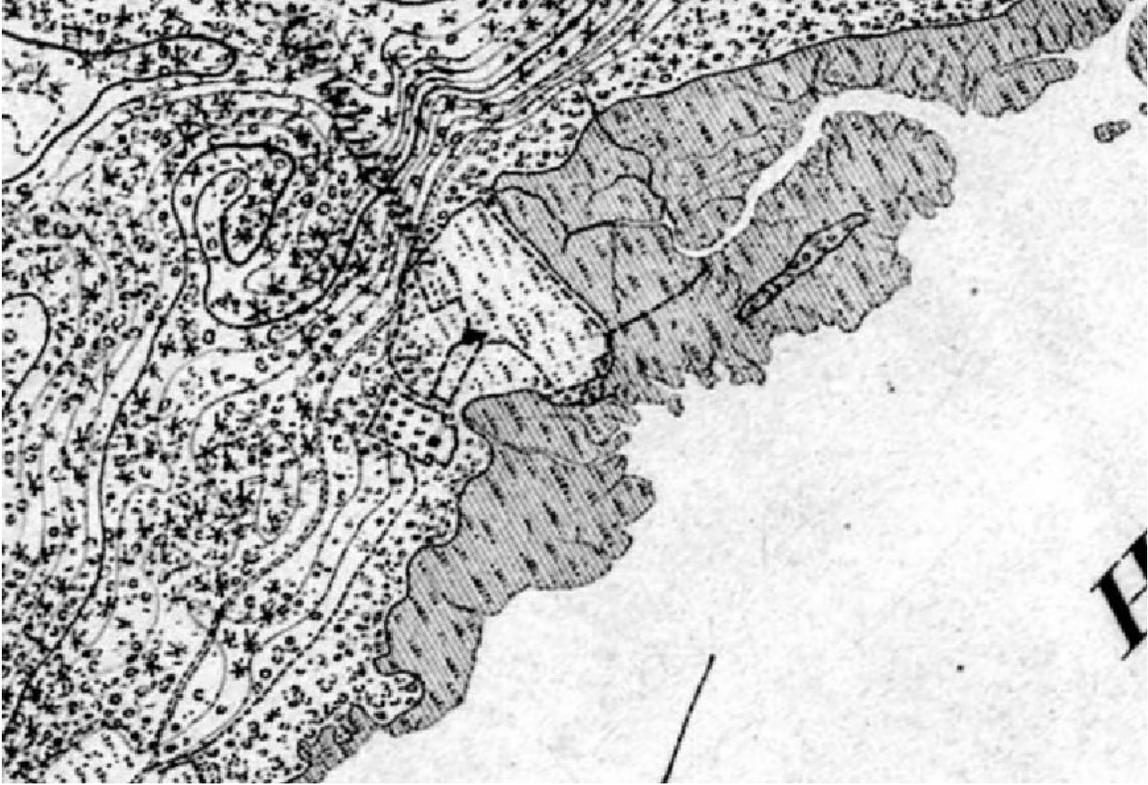
Figure 32. 1884 T sheet of the west end of the Lynch Cove/Union River complex on the north shore, showing a possibly diked portion of tidal marsh near the center of the image.

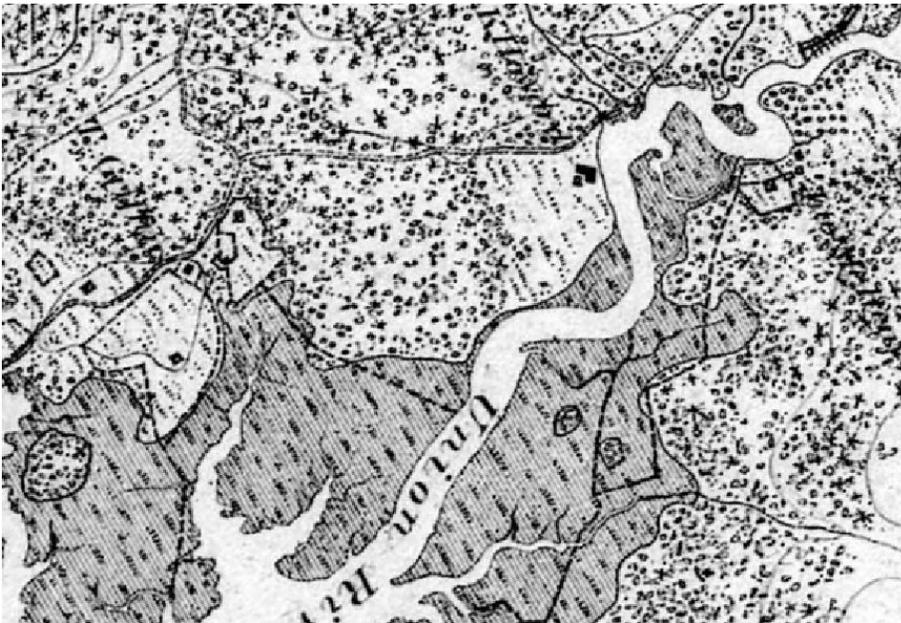
Figure 33. 1884 T sheet showing possible signs of diked tidal marsh at the time where fencing occurs across portions of the marsh. The dock in the upper right corner of this image is the terminus of a logging railroad that ran up the Union River valley.

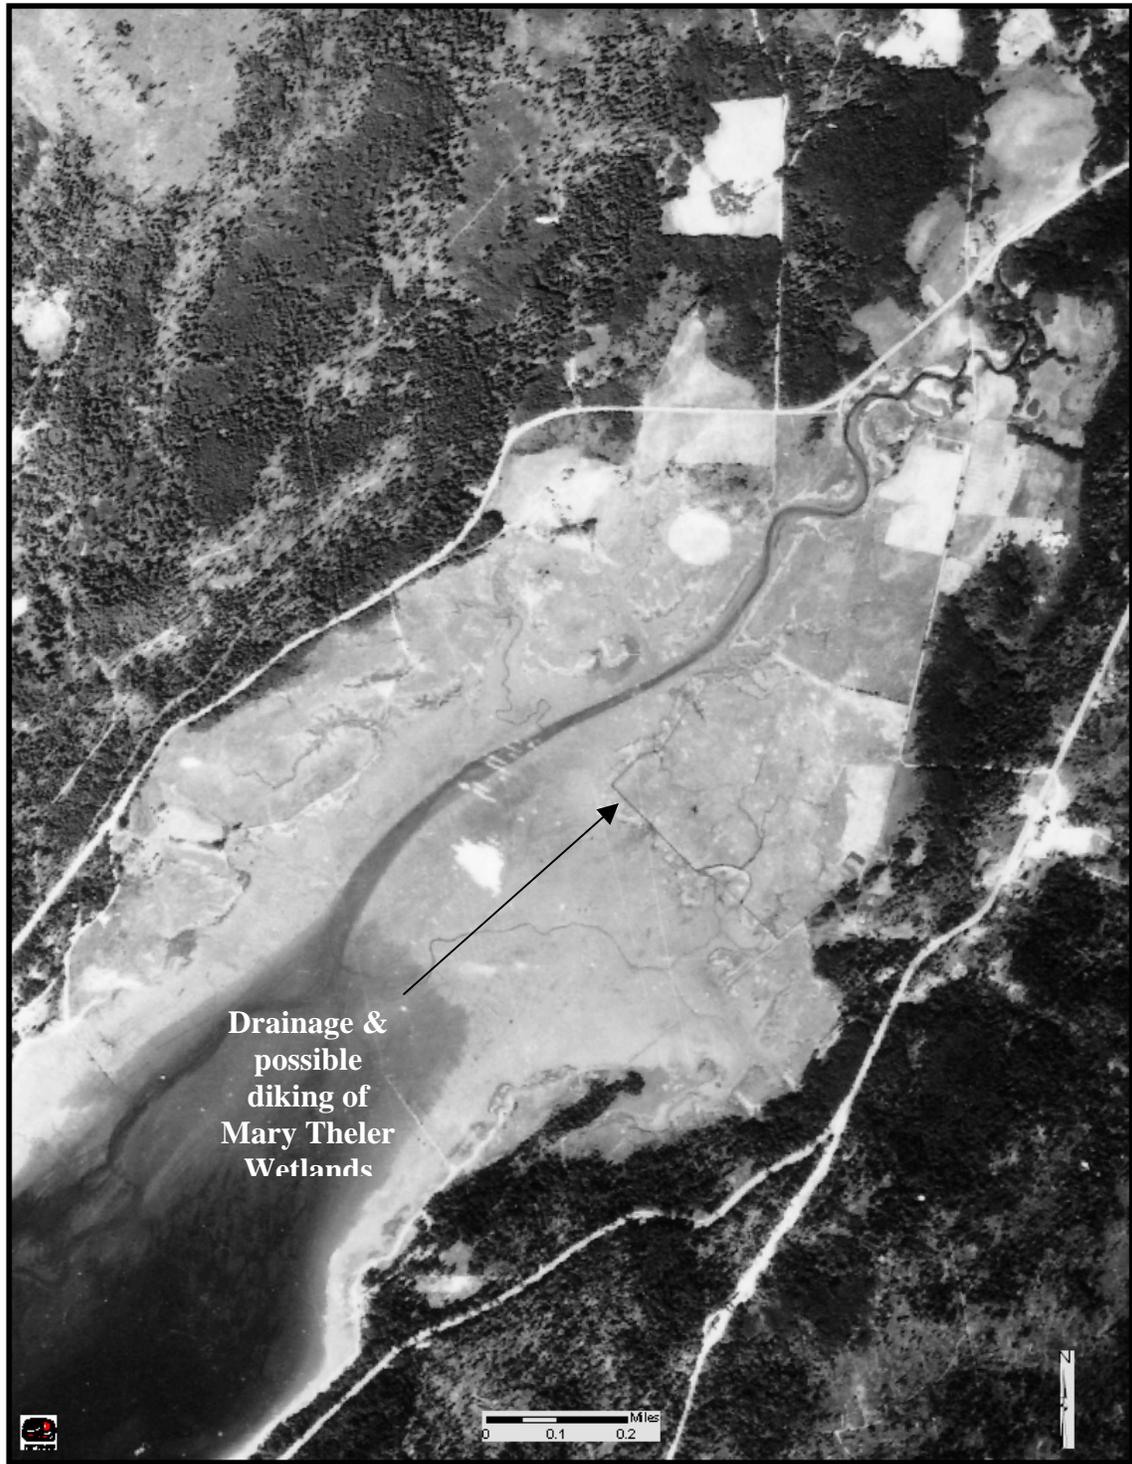
Figure 34. 1939 air photo (USGS) of the Lynch Cove/Union River estuary complex.

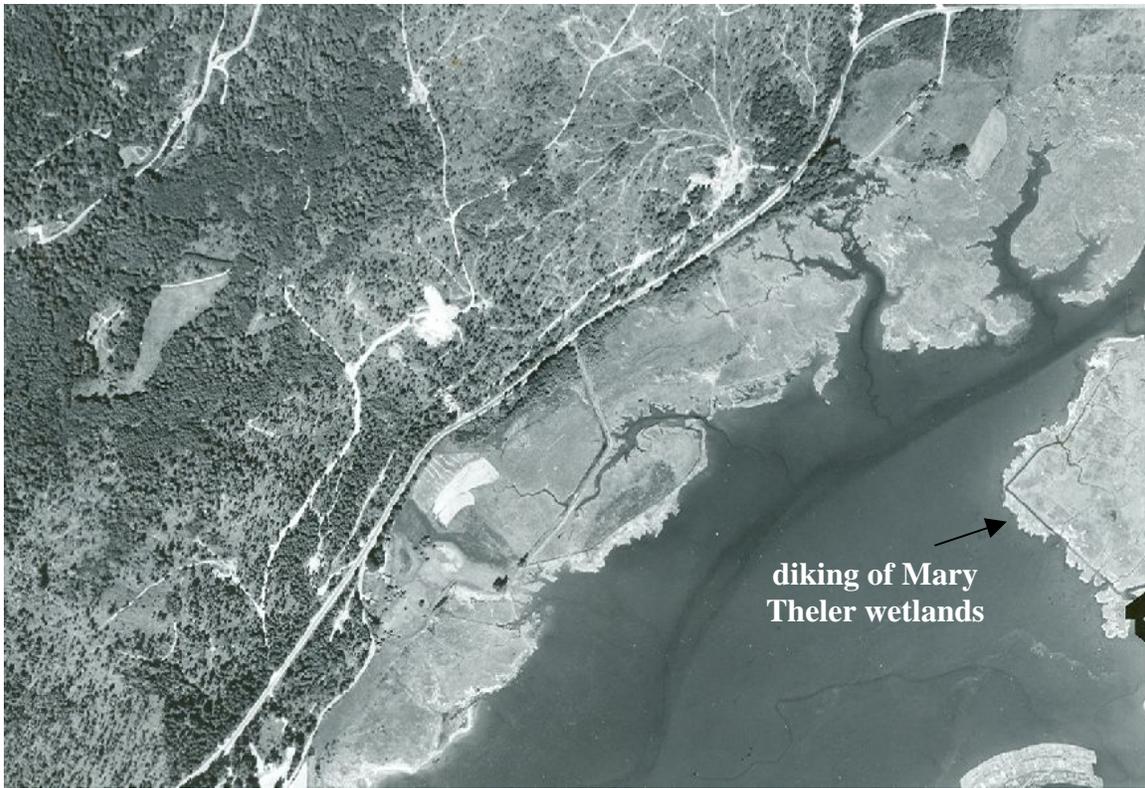
Figure 35. 1957 air photo of the western part of the Lynch Cove/Union River estuary complex. Note the extensive diking of sections of tidal marsh, and log rafting (lower right corner) near the mouth of Devereaux Creek.

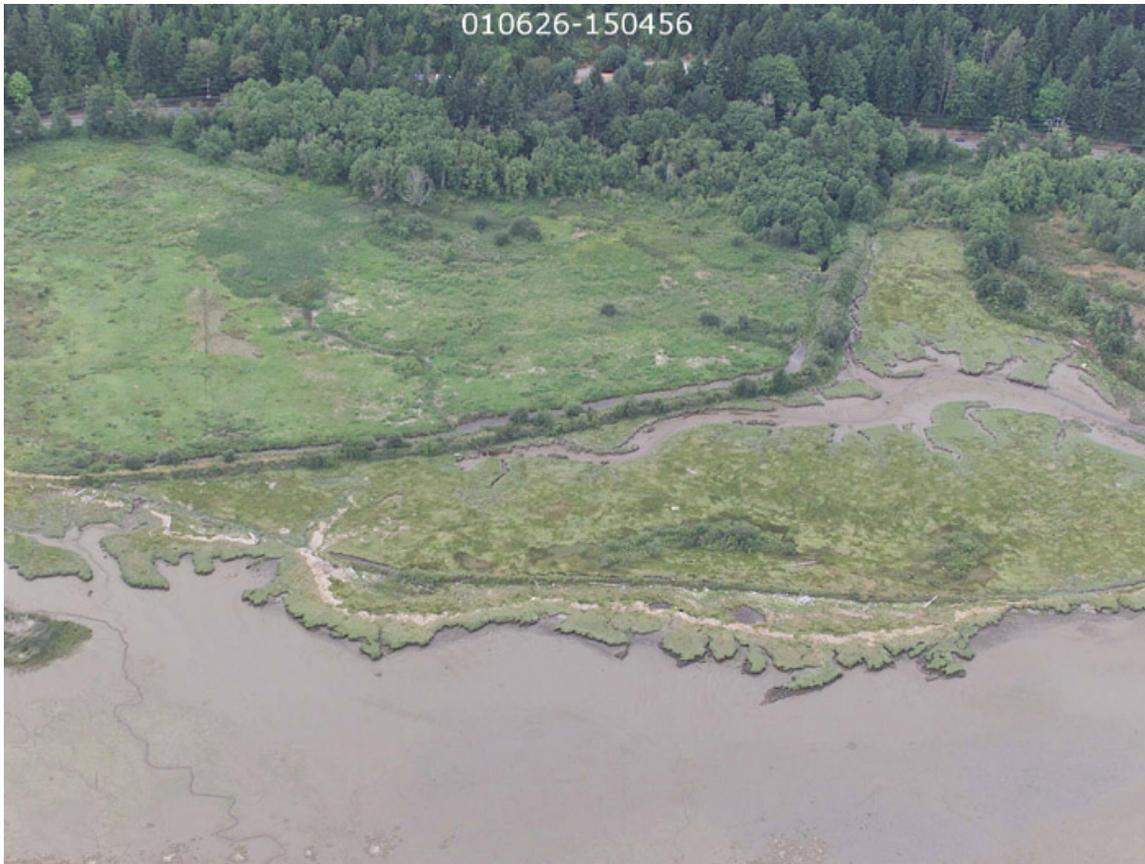
Figure 36. 2001 WDOE oblique photo showing an area (~ 4.5 ha) of tidal marsh in the northwest part of Lynch Cove that may have received early attempts at diking. By the time of the 1957 air photo, it had been convincingly diked.

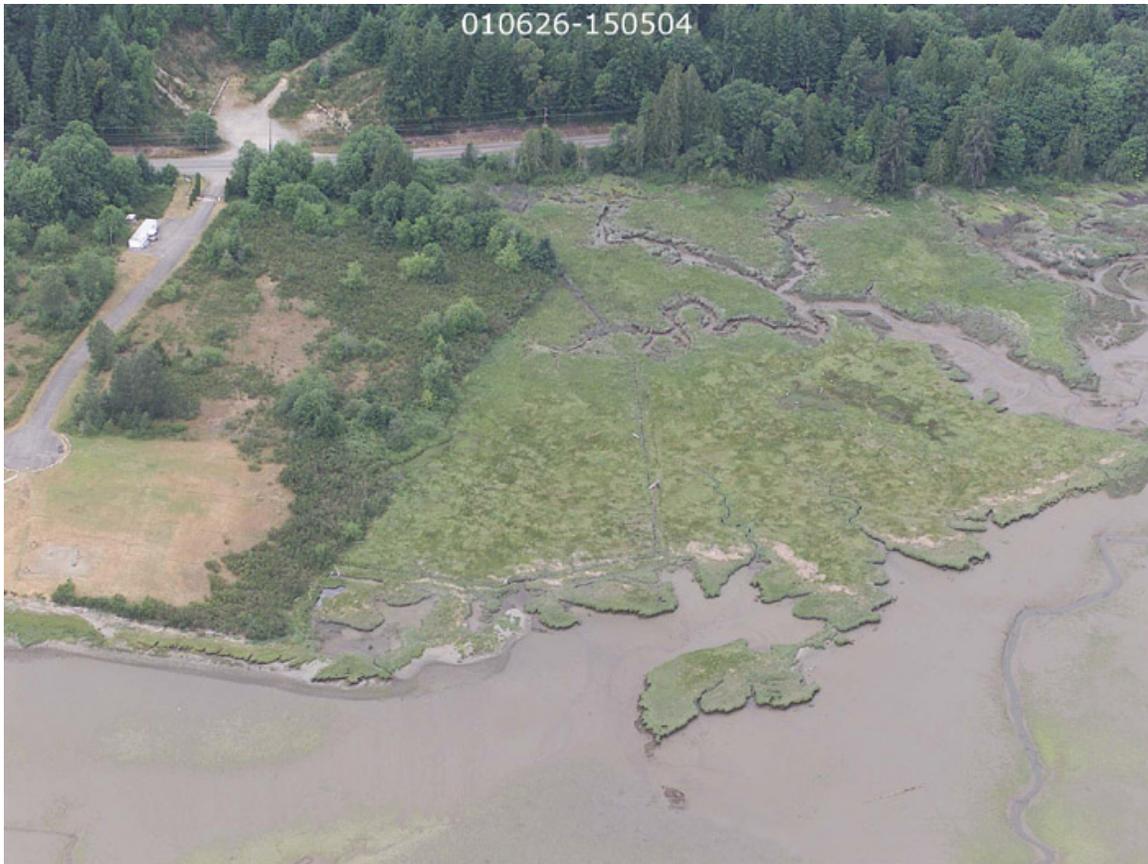
Figure 37. 2001 WDOE oblique photo showing an area (~ 3.2 ha) of historical tidal marsh along the north shore of Lynch Cove that has been filled over by a road that leads to a swimming pool (left side of image).

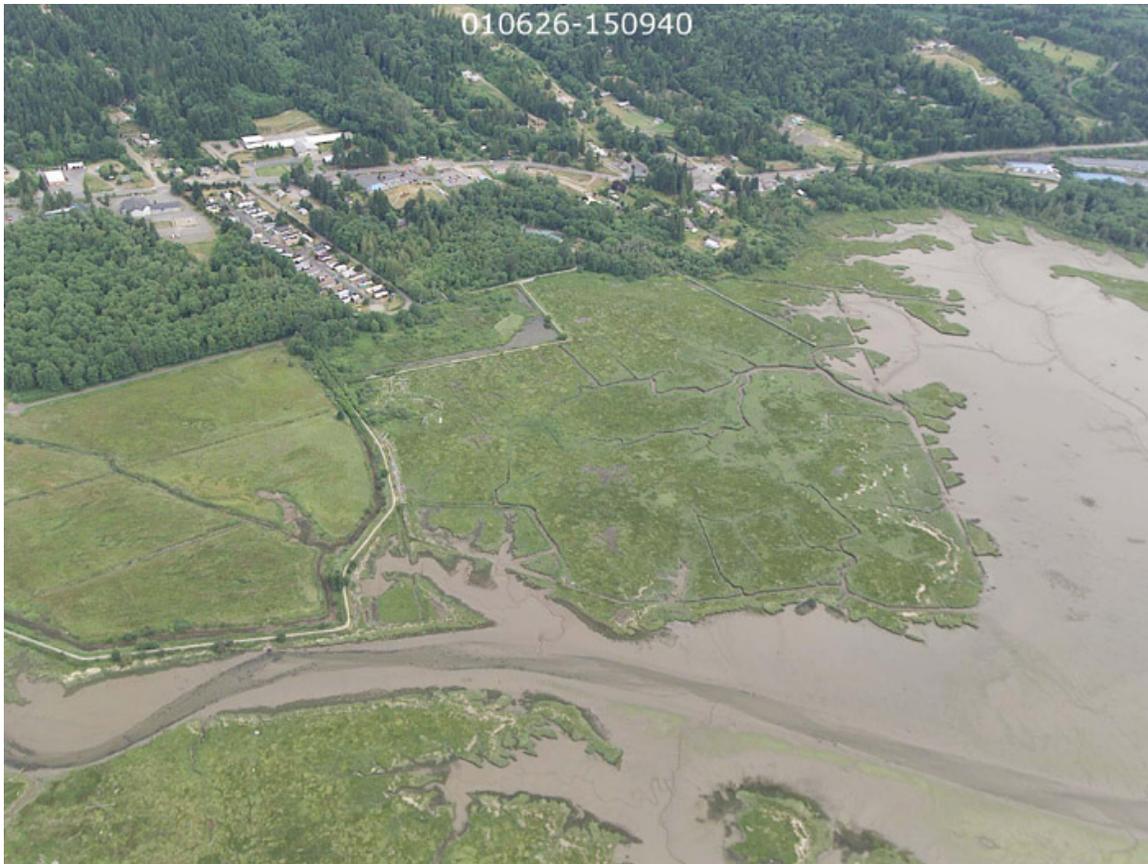
Figure 38. 2001 WDOE oblique photo showing the large diked area of tidal marsh (~ 7.8 ha) in the left part of the image. Notice evidence of old diking and modifications of drainage patterns in the tidal marsh at the center and right side of the image. The upper part of this tidal marsh near the center of the image was shown as a lowland forest in the 1884 T sheet.

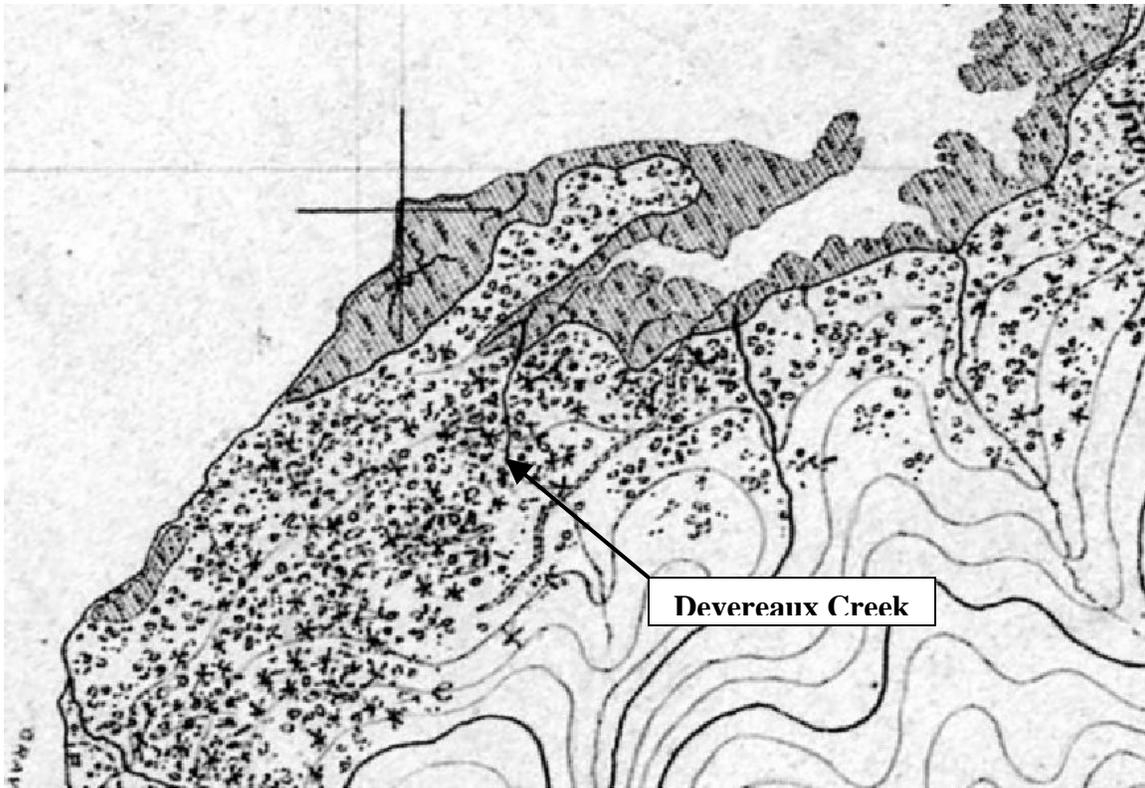
The salt marsh associated with Devereaux Creek that enters a small cove along the south shore of Lynch Cove has been modified though it retains many of the same characteristics it had in 1884 (Figure 39). The 1957 air photo shows a road/dike cutting across the marsh leading to the shore where several log rafts occur in the tide flat (Figure 40). This dike is still evident today (Figure 41). This part of the Union River/Lynch Cove habitat complex has been recommended as a candidate estuarine “sanctuary” by the Washington State Department of Natural Resources Natural Heritage Program. A vegetation description of this site is provided by Kunze (1984).

Figure 39. 1884 T sheet showing the southwest portion of the Lynch Cove/Union River estuary complex, including the tiny Bulkhead Marsh near the lower left corner of the image. The larger salt marsh shown is that associated with Devereaux Creek. The tiny Bulkhead Marsh has been filled over and bulkheads occur along the shoreline, though “new” salt marsh is now developing in front of the bulkheading (see Figure 42 below).

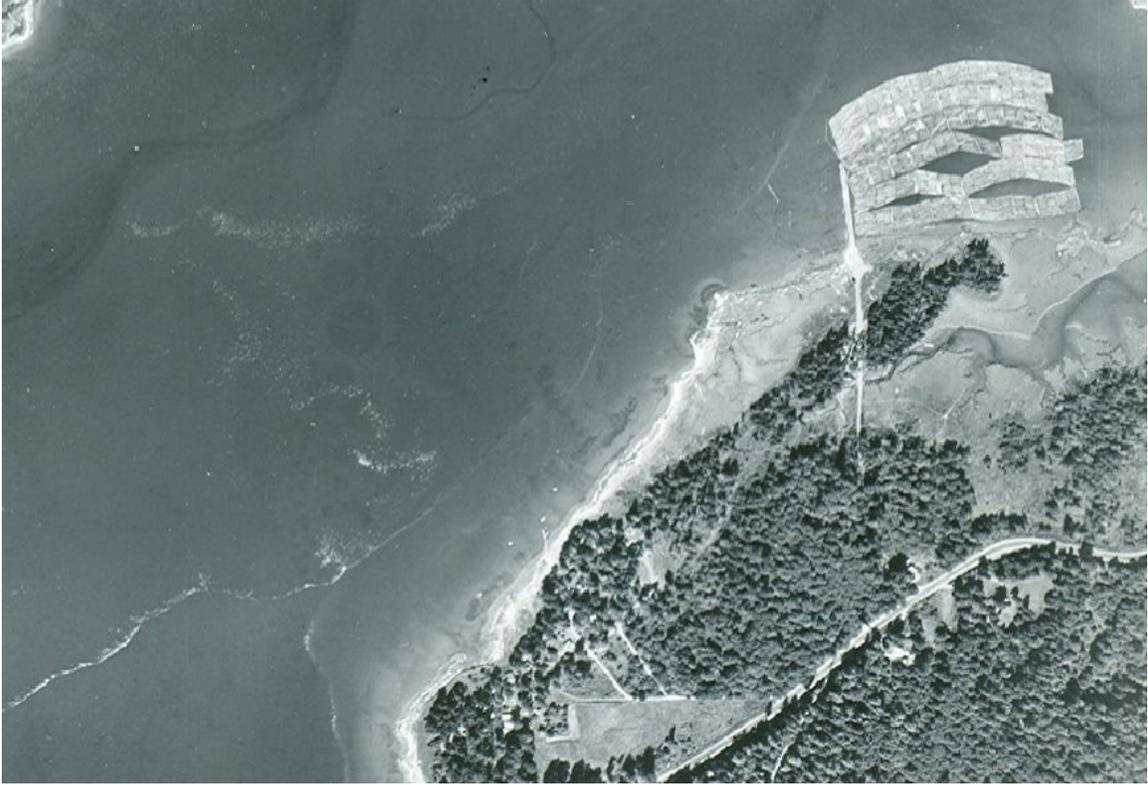
Figure 40. 1957 air photo showing the Devereaux Creek portion of the Lynch Cove/Union River estuary complex. Notice the road/dike crossing the tidal marsh to access a log dump and log rafting.

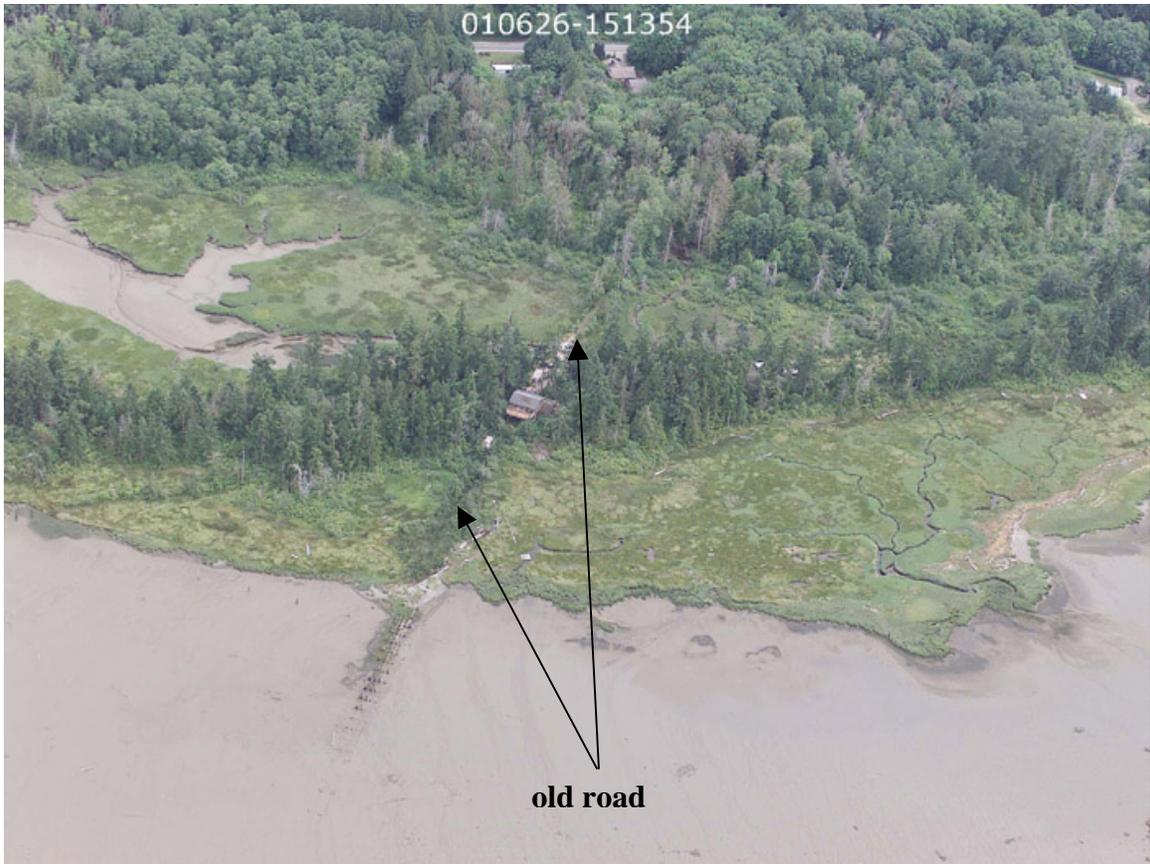
Figure 41. 2001 WDOE oblique photo showing the south portion of the Lynch Cove/Union River estuary (Devereaux Creek area). Notice the old road through the marsh present in the 1957 air photo (see Figure 40 above).

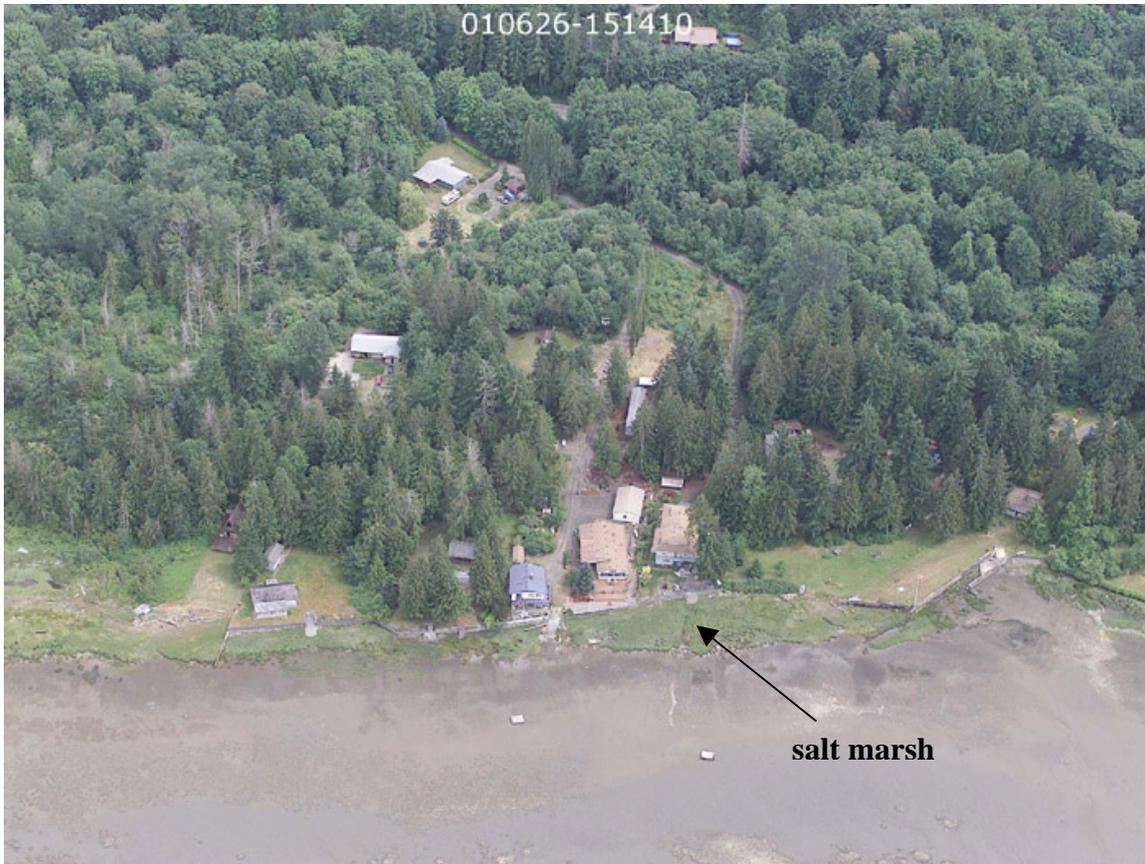
Figure 42. 2001 WDOE oblique photo showing salt marsh growing seaward of bulkheads in the vicinity of the historical “Bulkhead Marsh”, that was filled for the building of houses.
