Appendix B – 12: Hood Canal Hook Sub-Region

Hood Canal Hook Sub-region

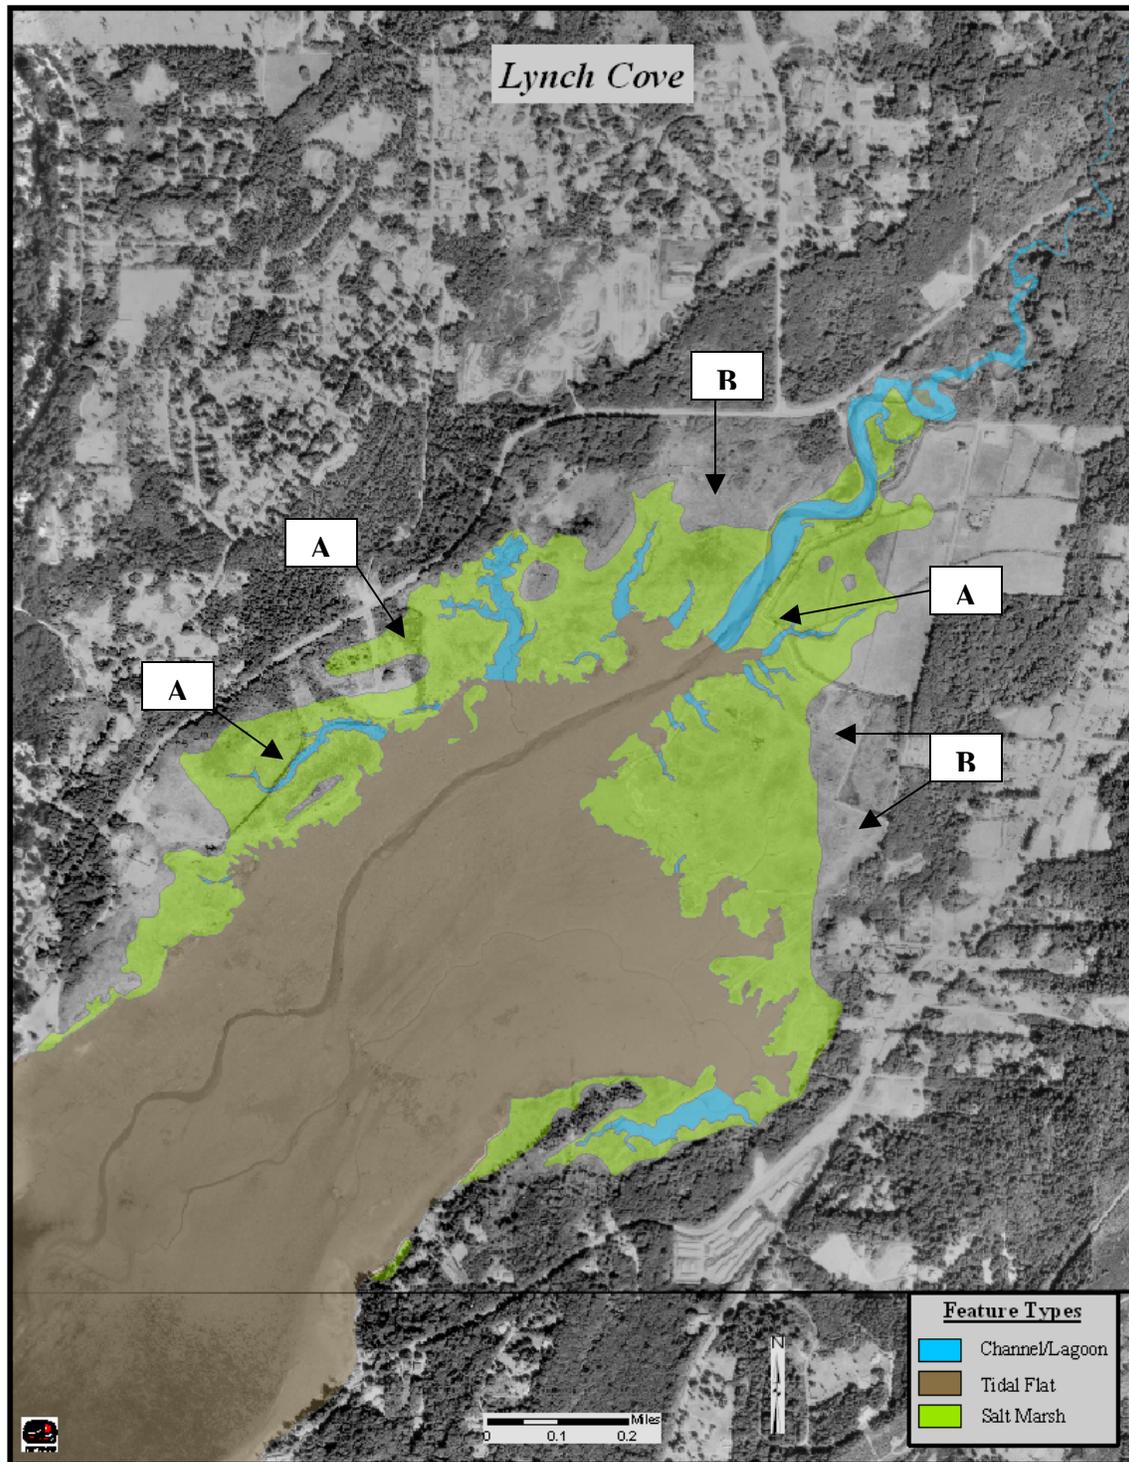
Figure 43. 2000 WDNR ortho-photo of the Lynch Cove/Union River estuary, overlaid with color-coded habitat features from the 1884 T sheet indicating major salt marsh areas that have been diked or filled, denoted with the letter A. Areas denoted by the letter B are currently salt marsh that were indicated as forest in the 1884 T sheet.

Although overall changes in the extent of tidal marsh are minimal according to our assessment, the habitat connectivity is impaired in substantial parts of the estuary, primarily from diking of tidal marsh. For this reason, we consider the relative condition of the estuary “Moderately Impaired”.

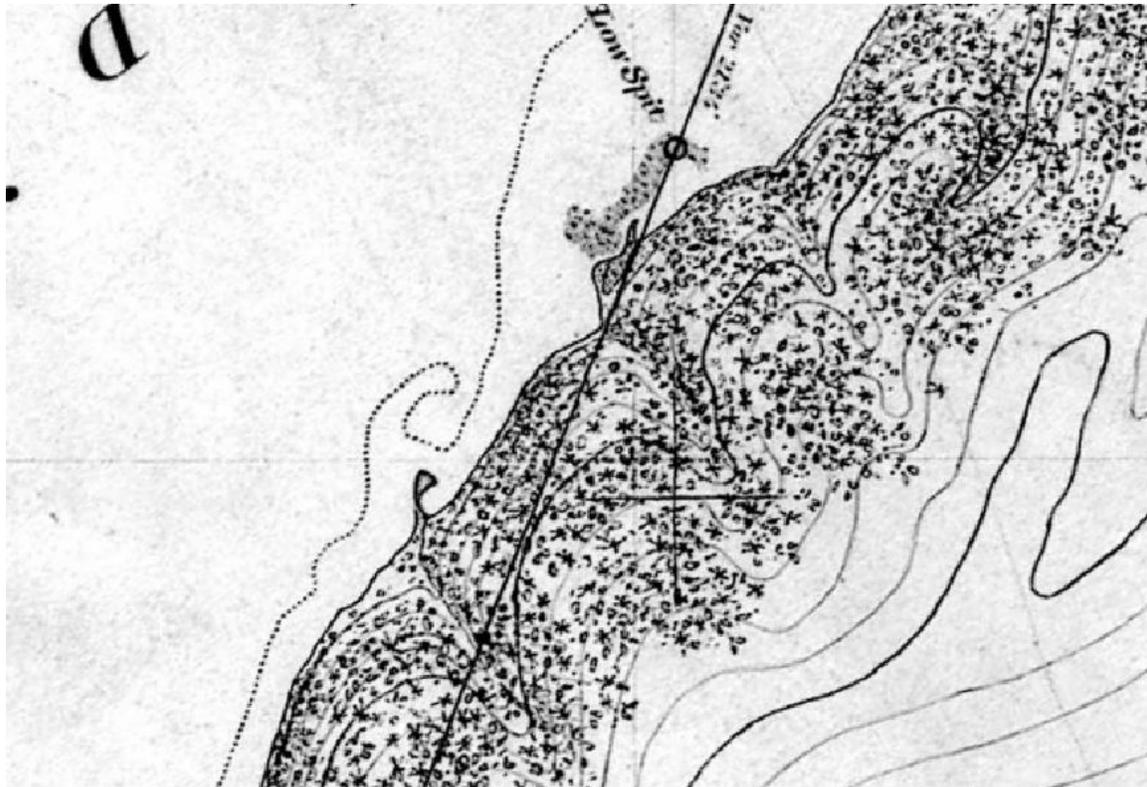
Figure 44. 1884 T sheet showing the tiny Low Spit habitat complex, and to the south, the Rose Spit complex (the small narrow protrusion from the coastline).

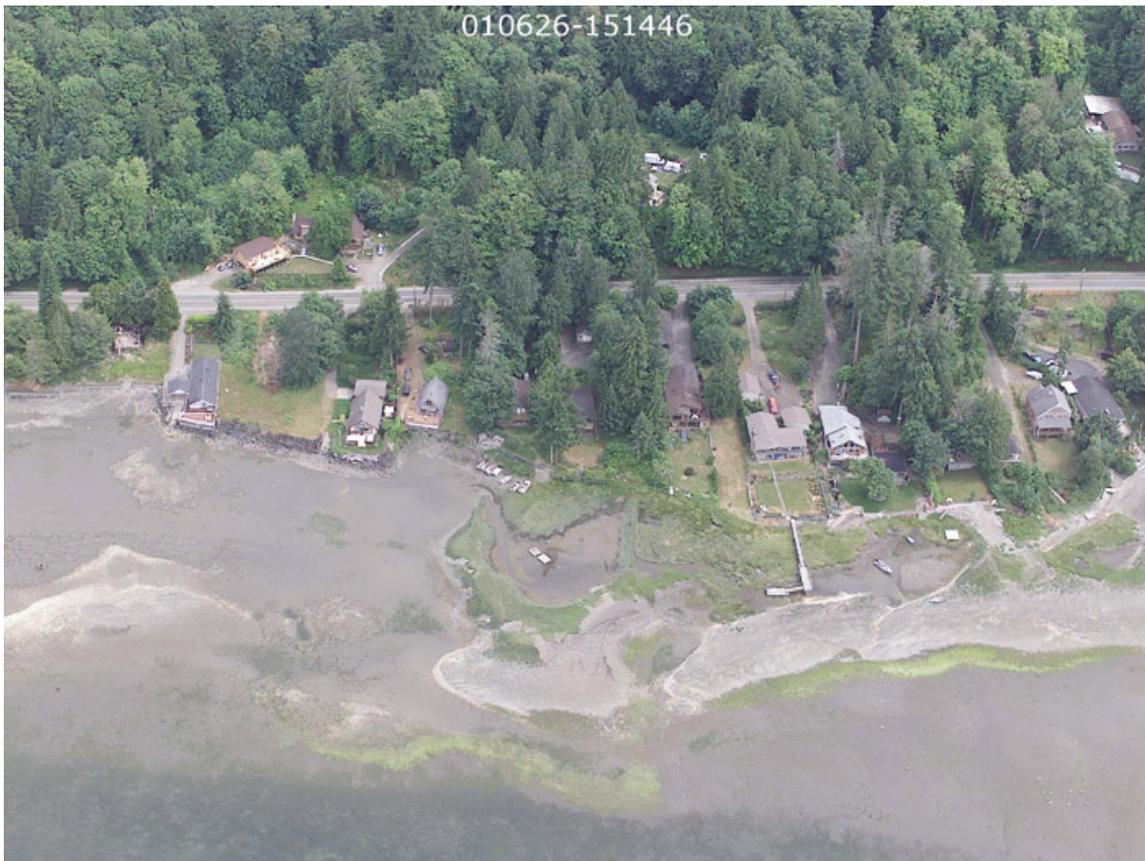
Figure 45. 2001 WDOE oblique photo of the Low Spit habitat complex.

Based on some loss of historical salt marsh and impairment to overall habitat connectivity, we consider the relative condition “Moderately Impaired”.

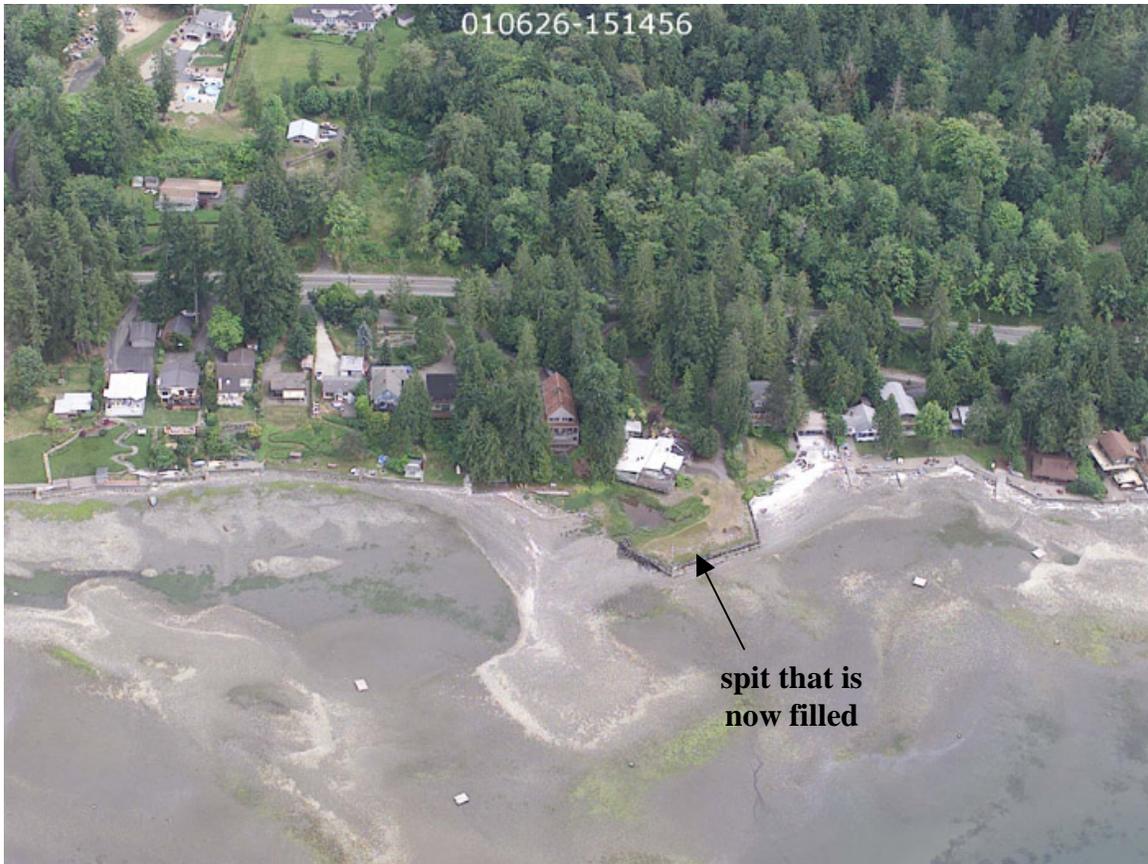
Figure 46. 2001 WDOE oblique photo showing the tiny Rose Spit complex, now bulkheaded and filled with a small pond or lagoon.

Based on the considerable modifications to this spit and dredging evident behind the spit, the relative condition is "Severely Impaired".

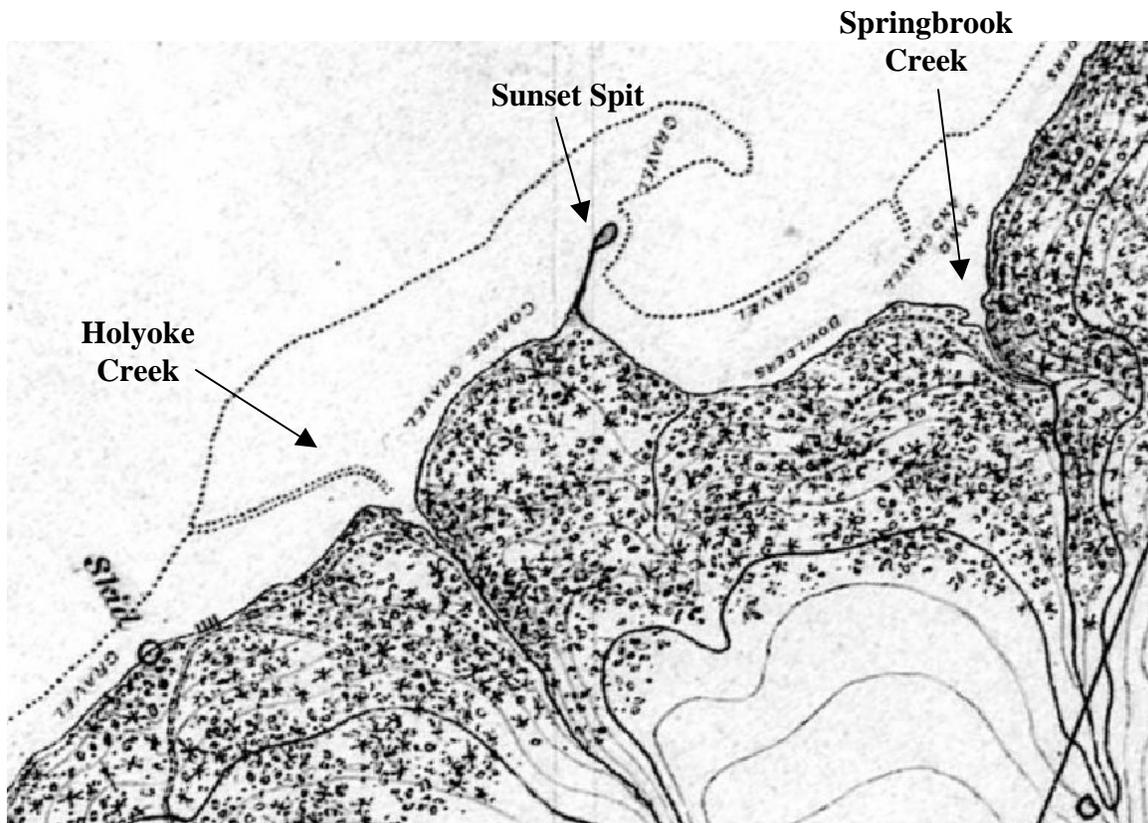
Figure 47. 1884 T sheet showing three habitat complexes, from east to west (right to left), Springbrook Creek, Sunset Spit, and Holyoke Creek.

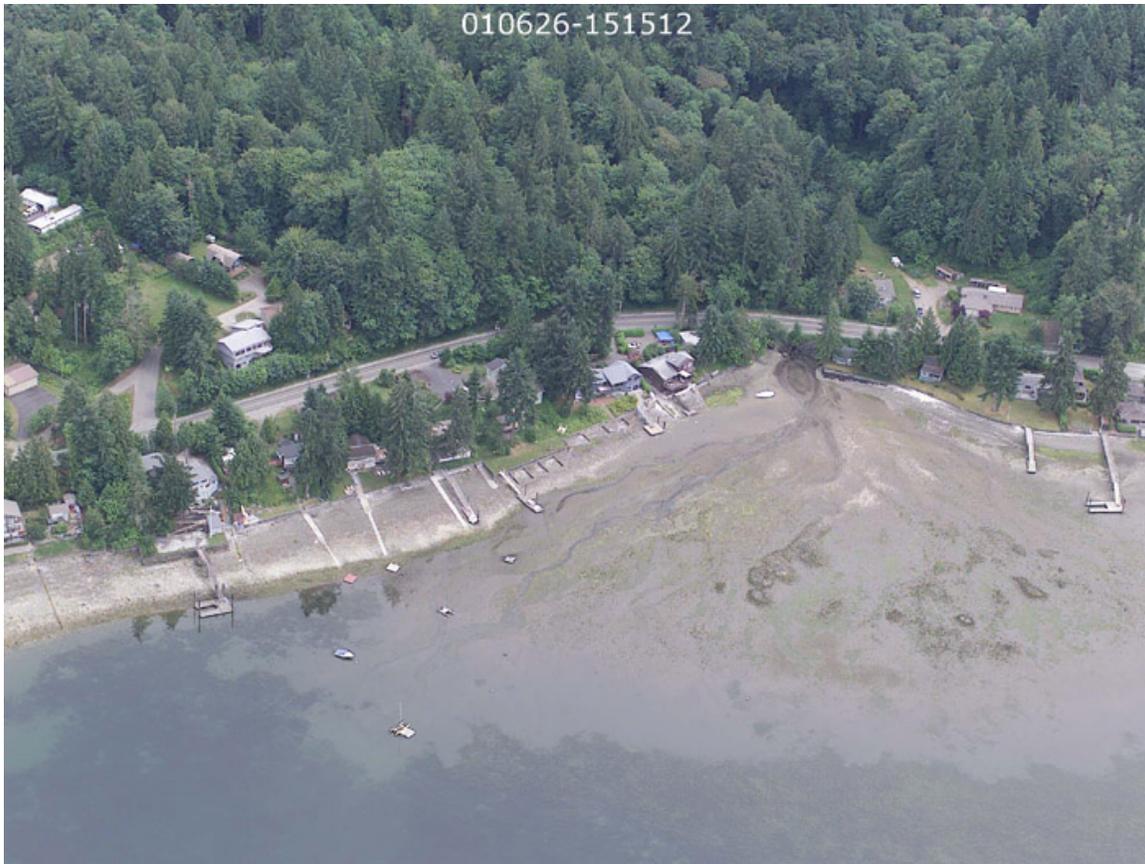
Figure 48. 2001 WDOE oblique photo showing the mouth of Springbrook Creek, partially filled over by Highway 106.

Because the tidal inlet of the creek has been partially filled by Highway 106, we consider the relative condition of this complex “Moderately Impaired”.

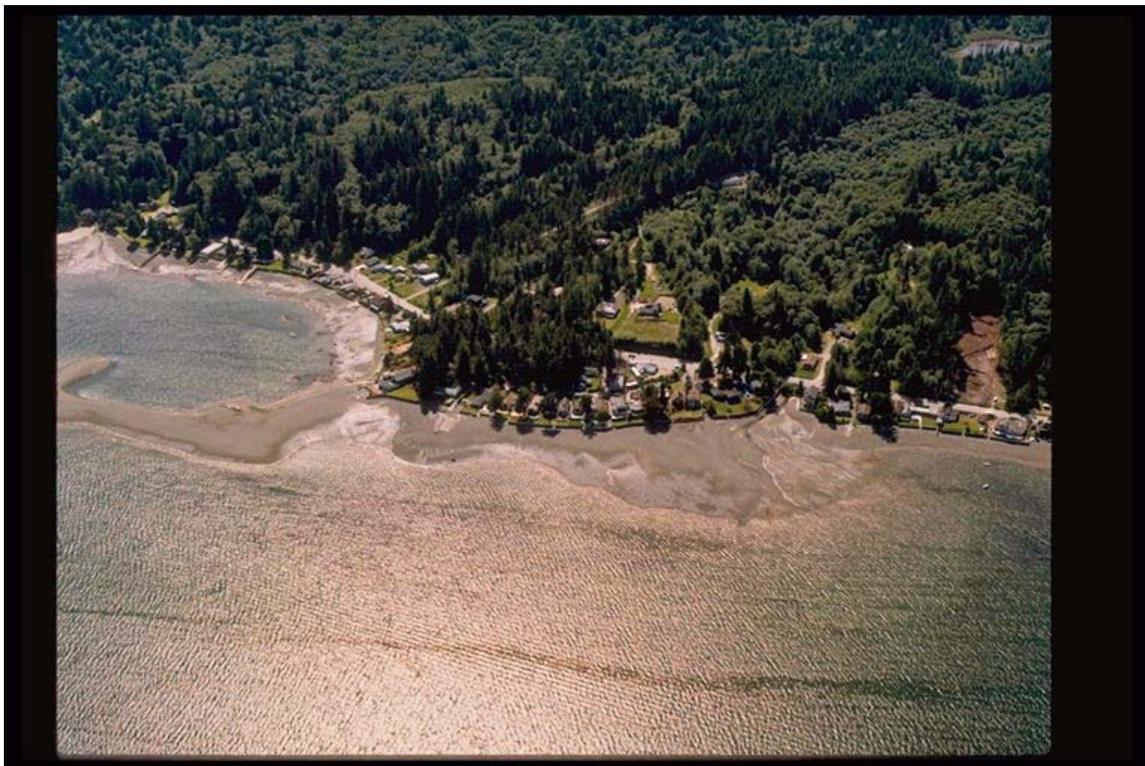
Figure 49. 1993 WDOE oblique photo showing the Sunset Spit complex (left side of image). Springbrook Creek is shown in the far left part of the image, and Holyoke Creek is shown in the right side of the image. This photo illustrates the extent of bulkheading and residential development along this shoreline.

Based primarily on the development at the base of the spit, we consider the relative condition “Moderately Impaired”.

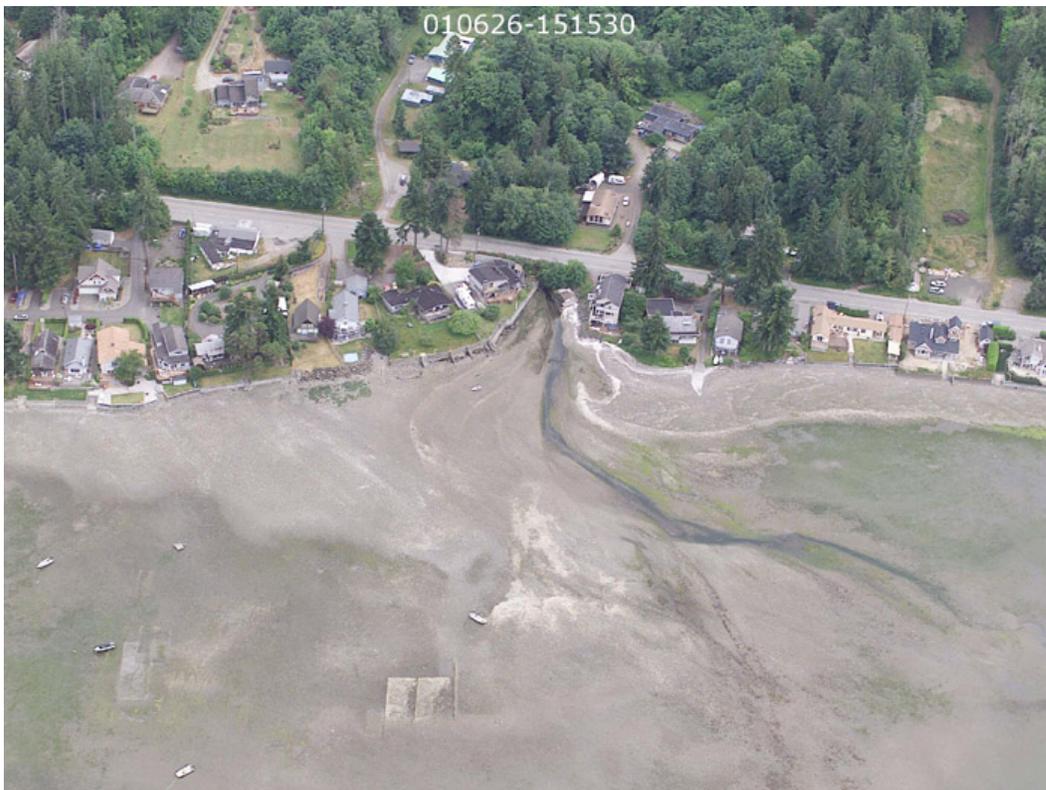
Figure 50. 2001 WDOE oblique photo of the Holyoke Creek mouth, partially filled over by Highway 106.

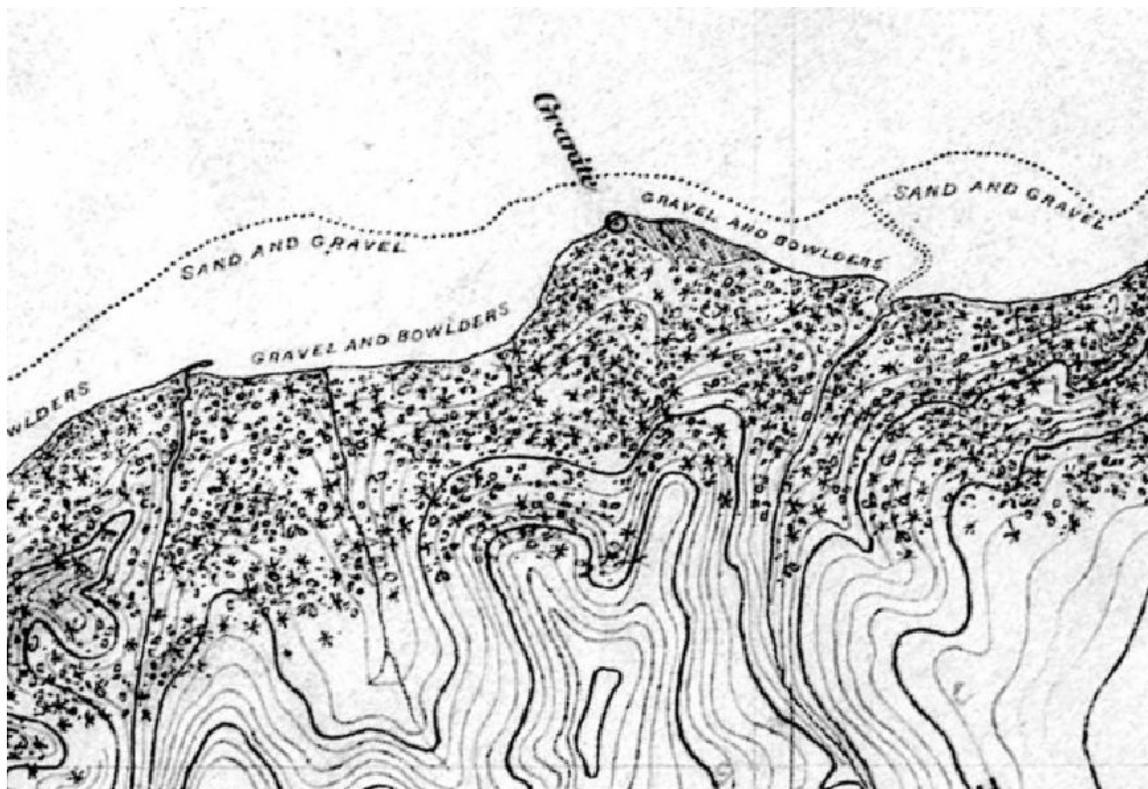
Figure 51. 1884 T sheet showing, from east to west, Granite Creek, Granite Marsh (near the benchmark “Granite”), and the tiny West Granite Spit habitat complexes.

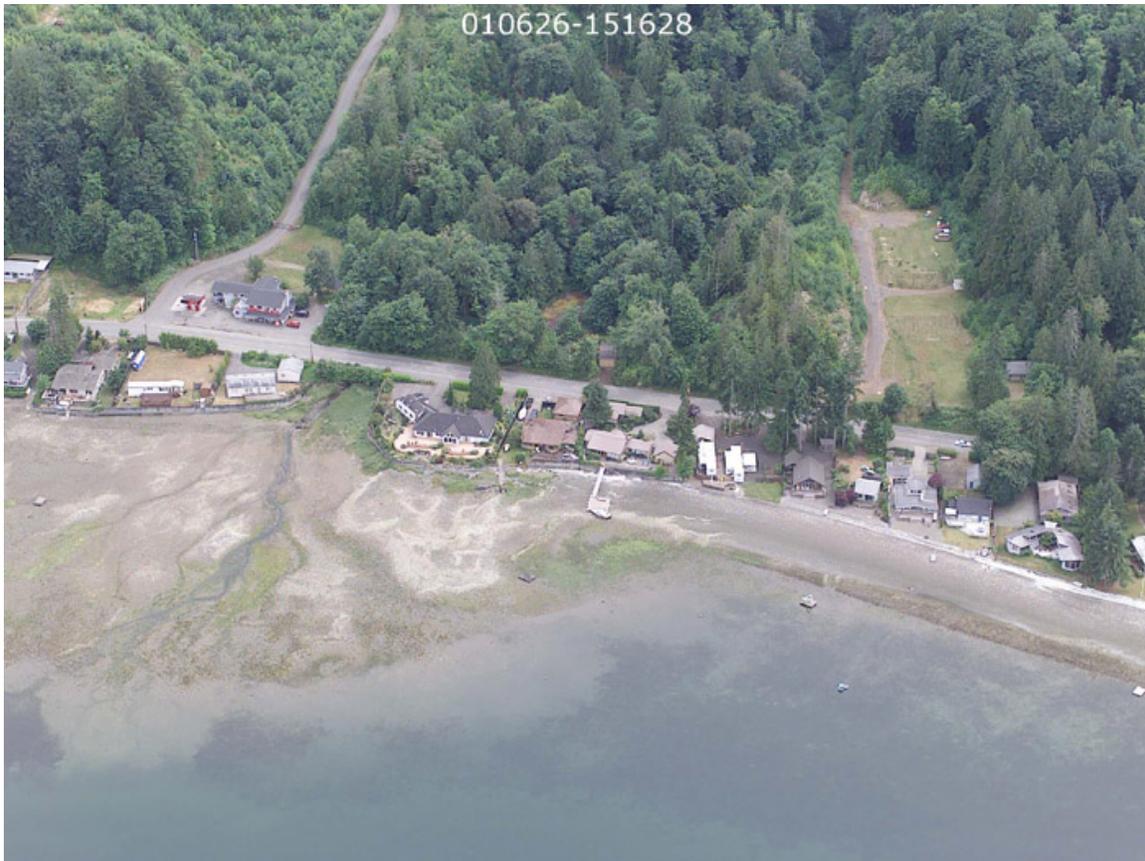
Figure 52. 2001 WDOE oblique photo of the Granite Creek habitat complex, indicating salt marsh at the mouth where it was not indicated in the 1884 T sheet.

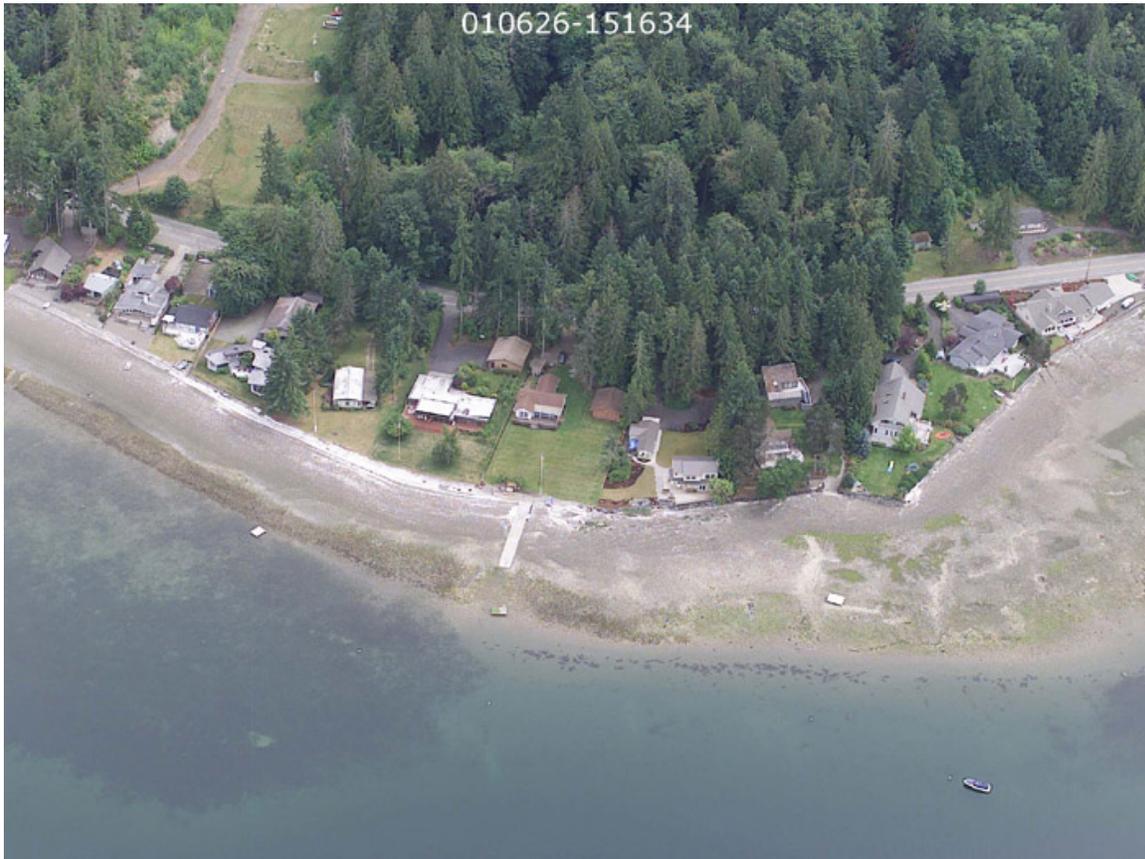
Figure 53. 2001 WDOE oblique photo showing the site of the historical Granite Marsh habitat complex, now filled over for residential development.

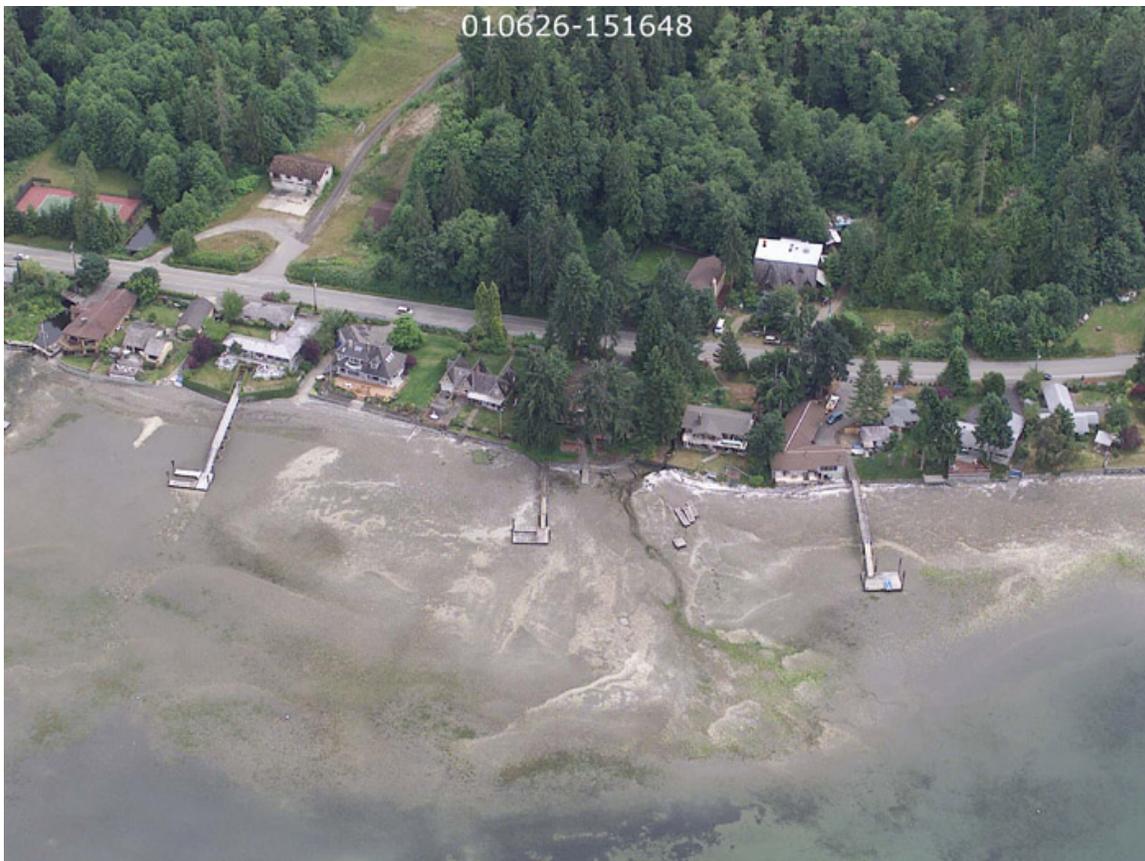
Figure 54. 2001 WDOE oblique photo showing the site of the West Granite Spit in the 1884 T sheet, which was located near the center of the image where a small stream runs past a house and enters Hood Canal.

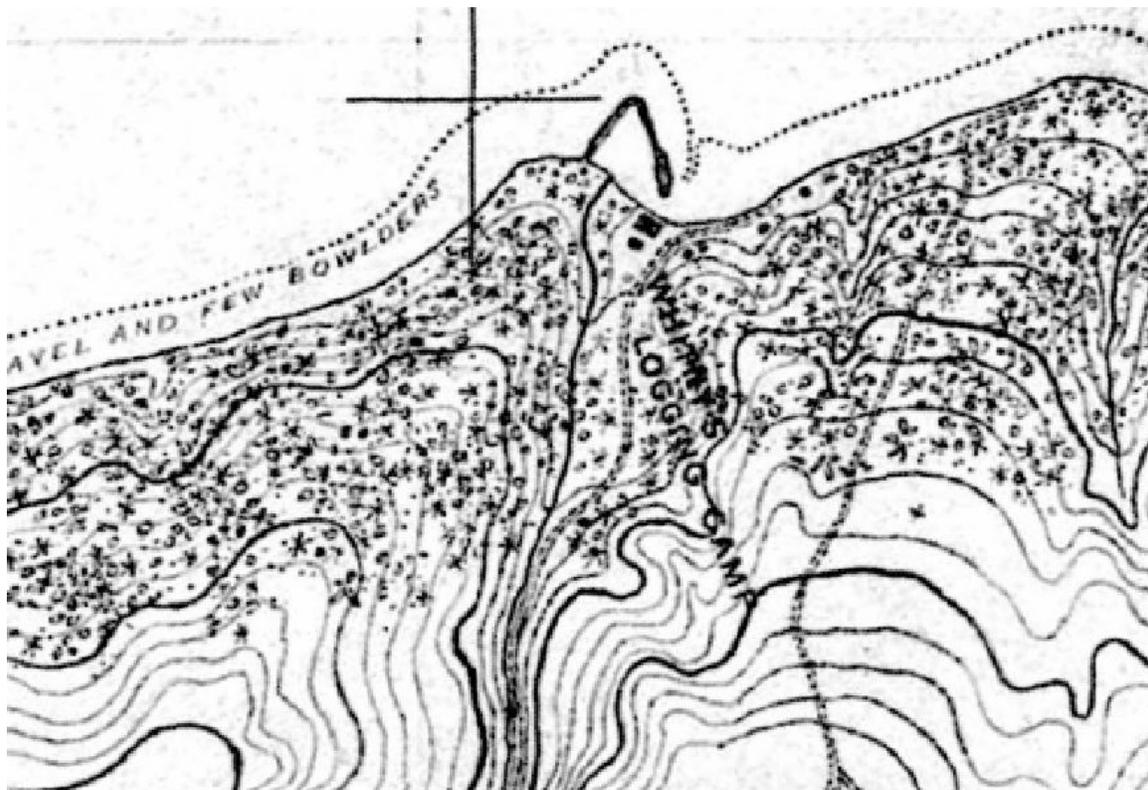
Figure 55. 1884 T sheet showing the Forest Beach Creek habitat complex, and a jetty-like structure at the creek mouth probably associated with the logging camp present at the time, perhaps used to corral logs near the mouth of the creek.

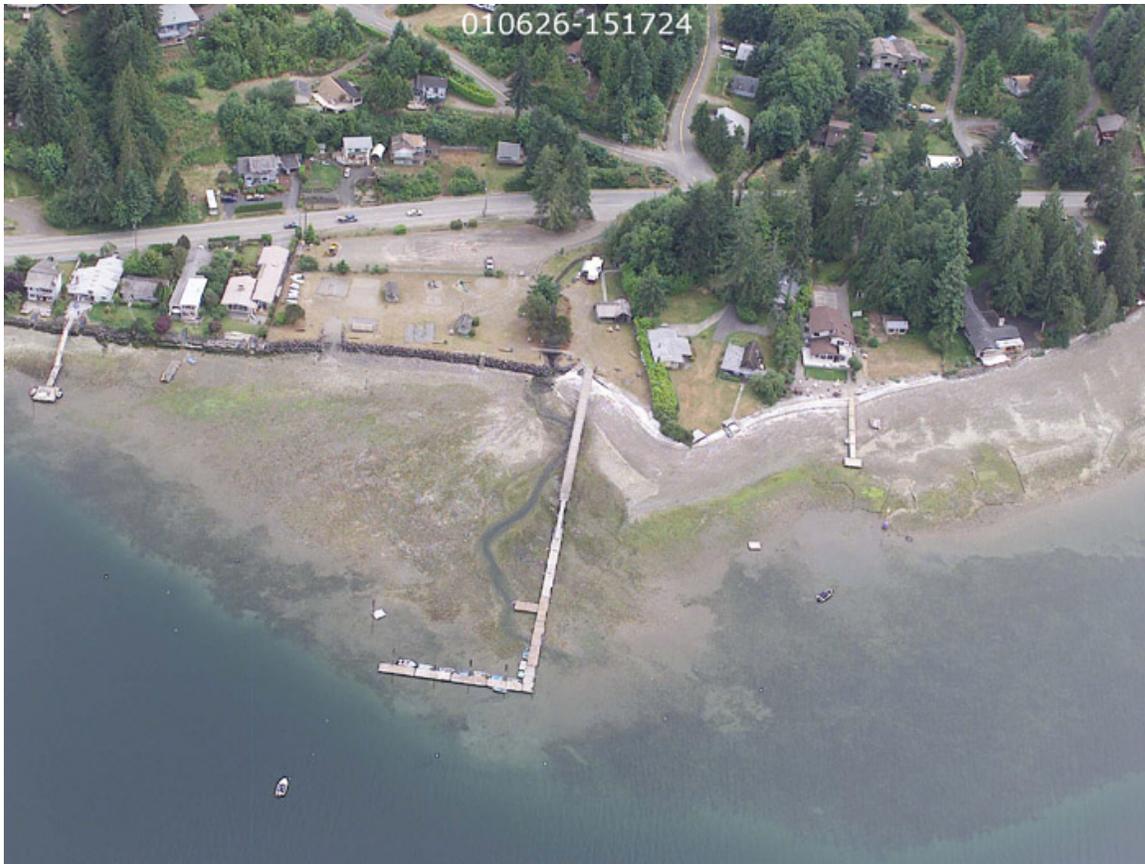
Figure 56. 2001 WDOE oblique photo of the Forest Beach Creek stream delta. Notice the level of shoreline armoring at the mouth and immediately left of the creek mouth.

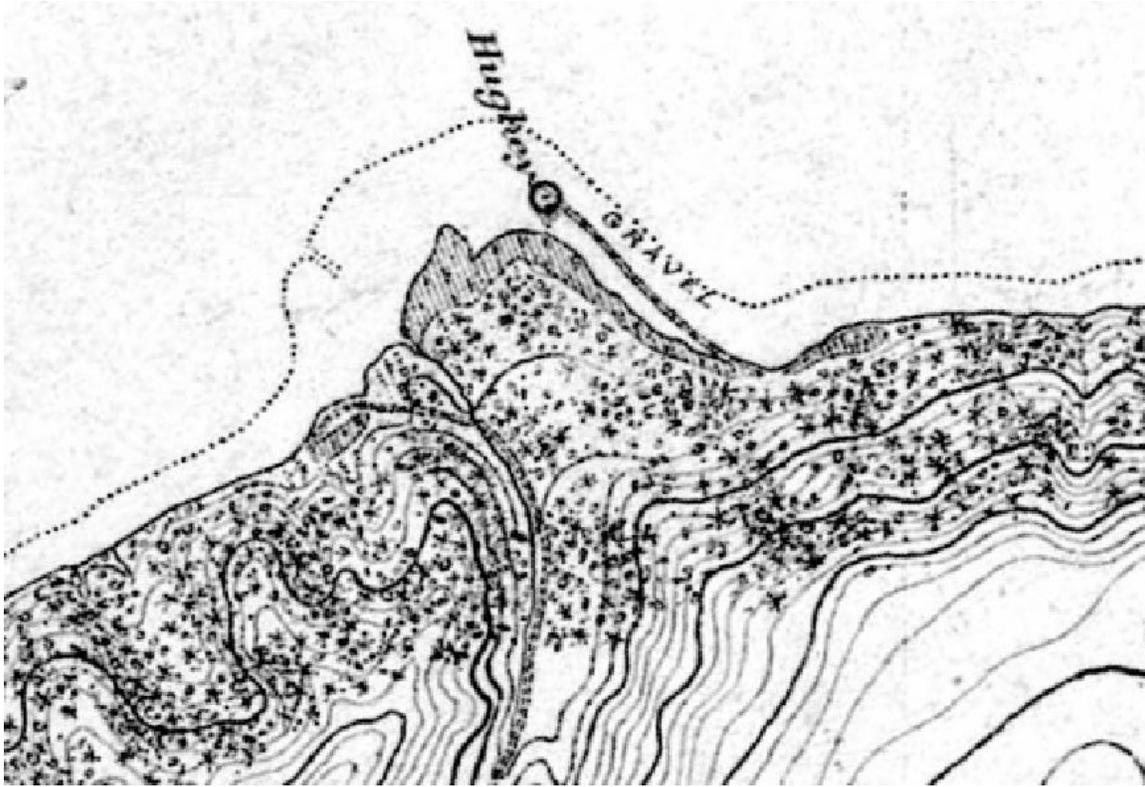
Figure 57. 1884 T sheet showing the Twanoh Creek habitat complex.

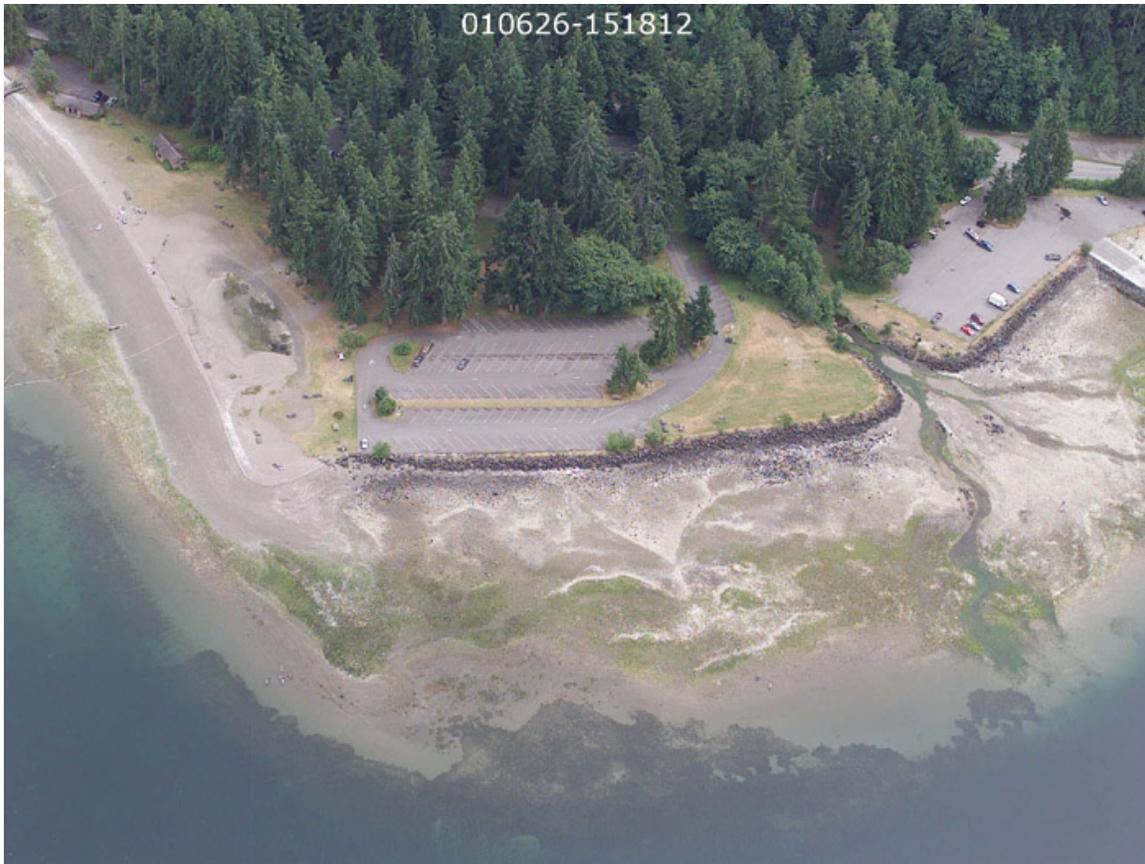
Figure 58. 2001 WDOE oblique photo of the Twanoh Creek habitat complex. The former salt marsh associated with this creek has been entirely filled over, primarily for a parking lot for the Twanoh State Park. Note the upper end of a boat ramp at the far right of the image.

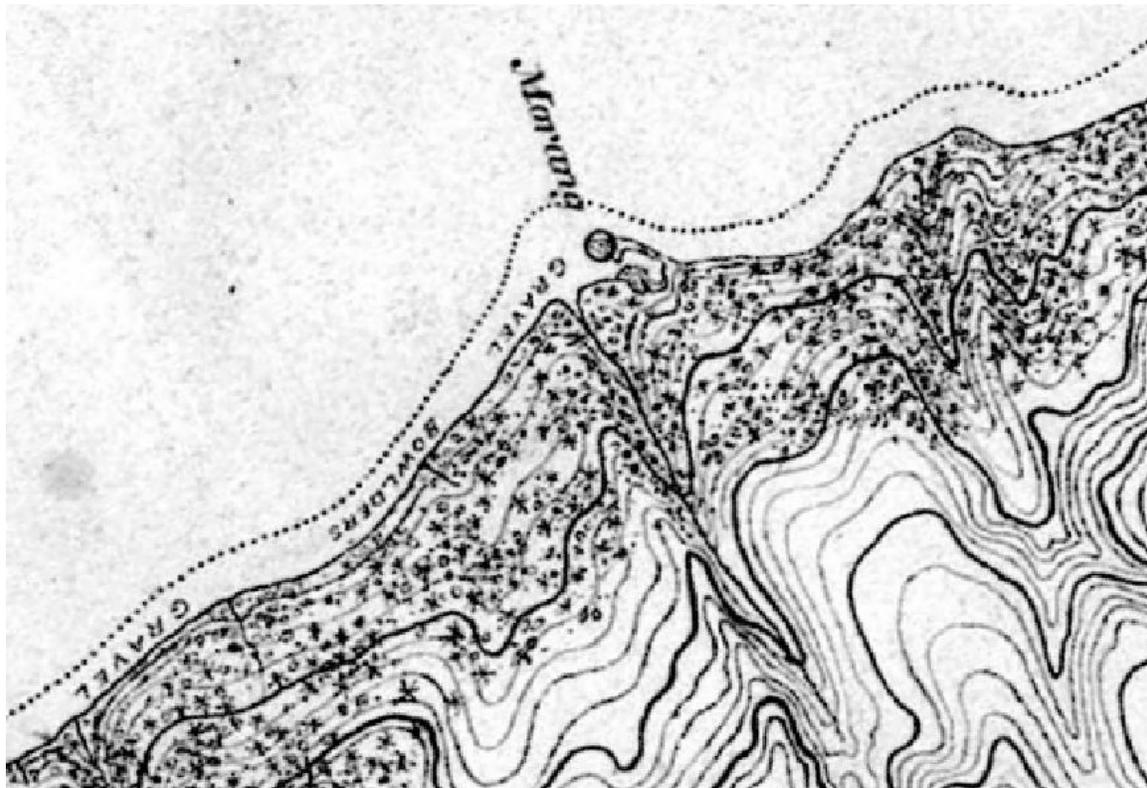
Figure 59. 1884 T sheet showing the small Morang Spit habitat complex.

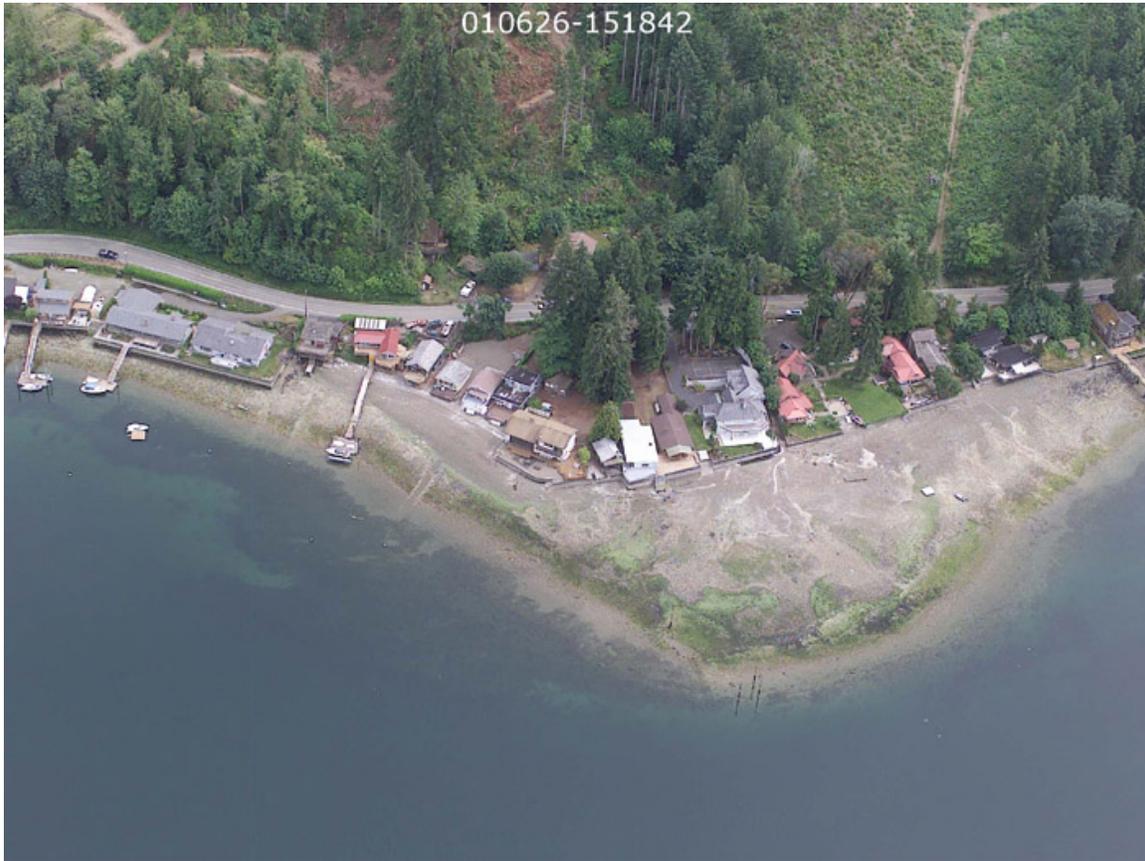
Figure 60. 2001 WDOE oblique photo of the site of the historical Morang Spit complex. The small spit and associated lagoon and marsh is not evident in air photos from recent decades (1977, 1993, 2001), apparently filled over for residential development and associated bulkheading.

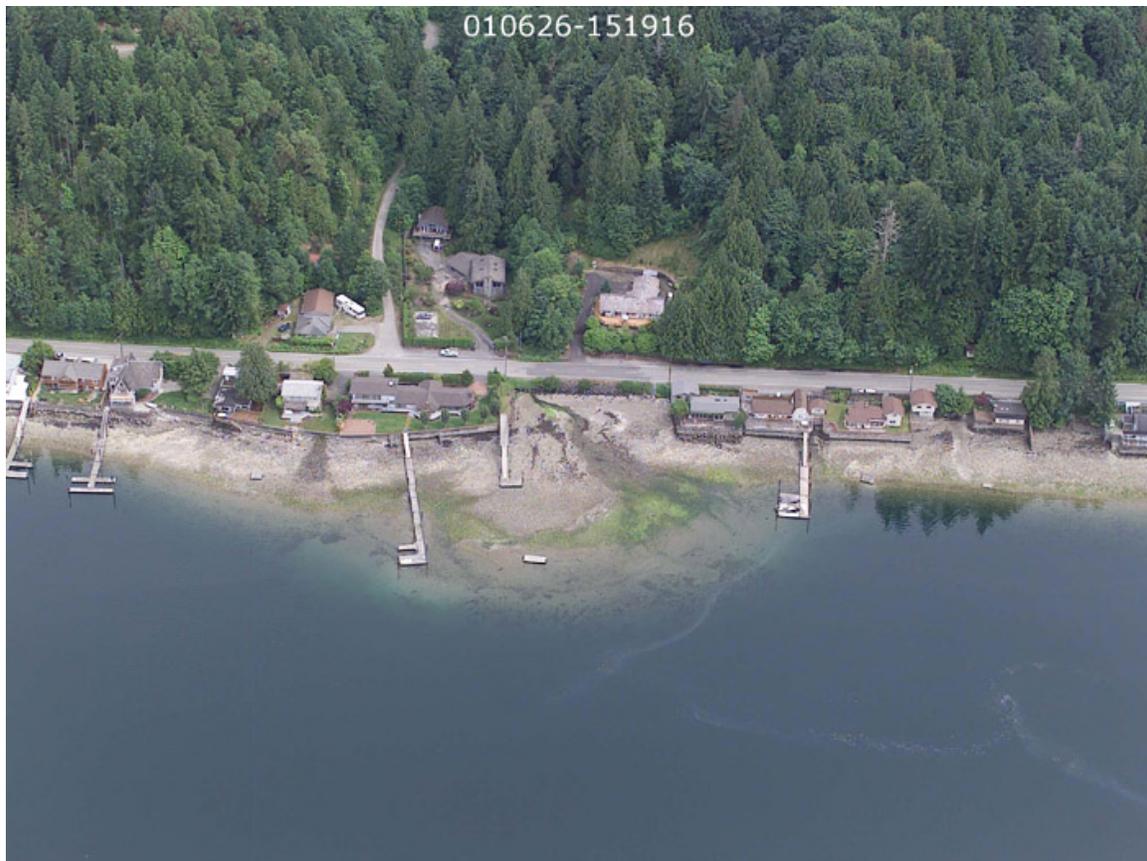
Figure 61. 2001 WDOE oblique photo showing the West Morang Creek stream-delta (center of image).

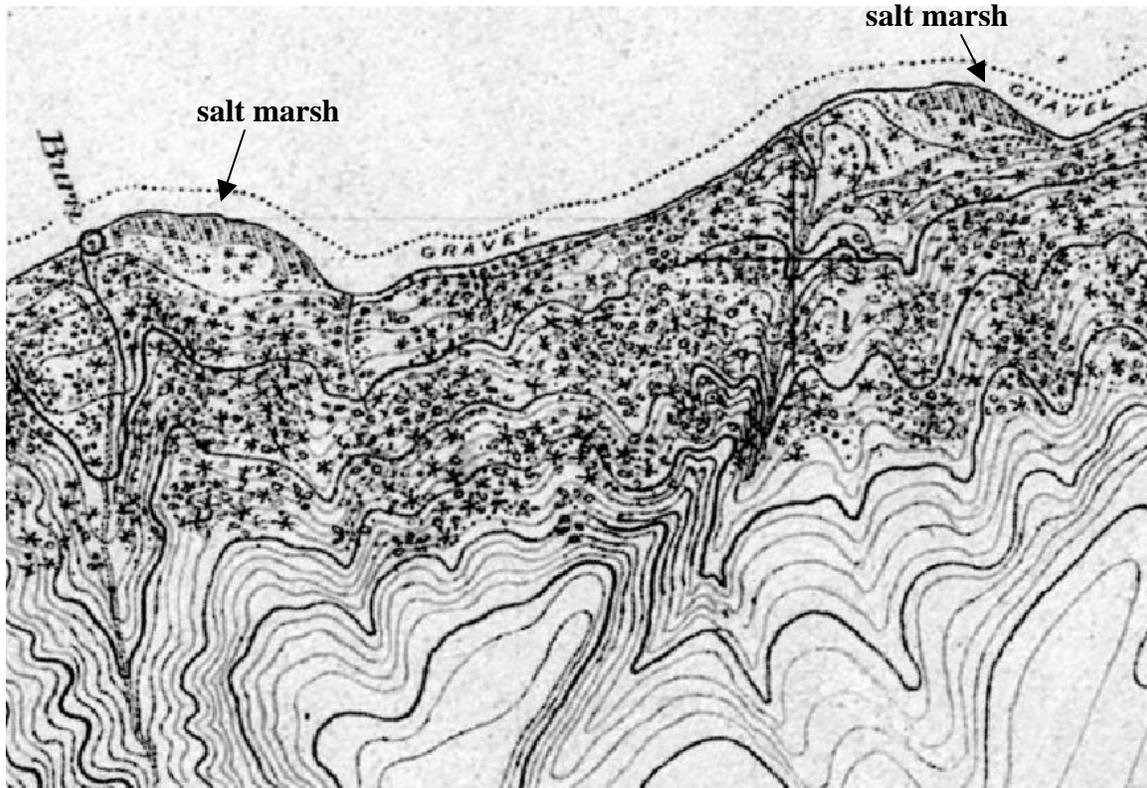
Figure 62. 1884 T sheet showing the East Burn Marsh (right side of image) and Burn Marsh (left side) habitat complexes.

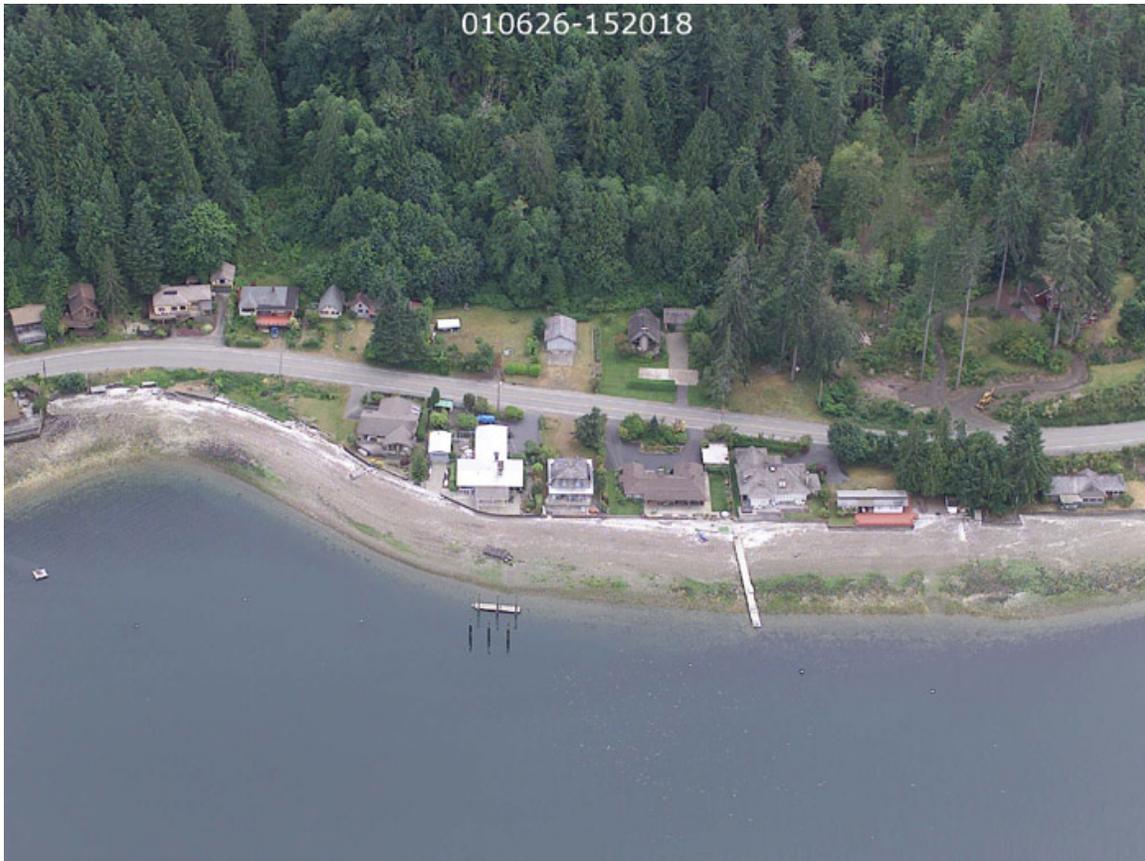
Figure 63. 2001 WDOE oblique photo showing the site of the historical East Burn Marsh, now filled by residential development.

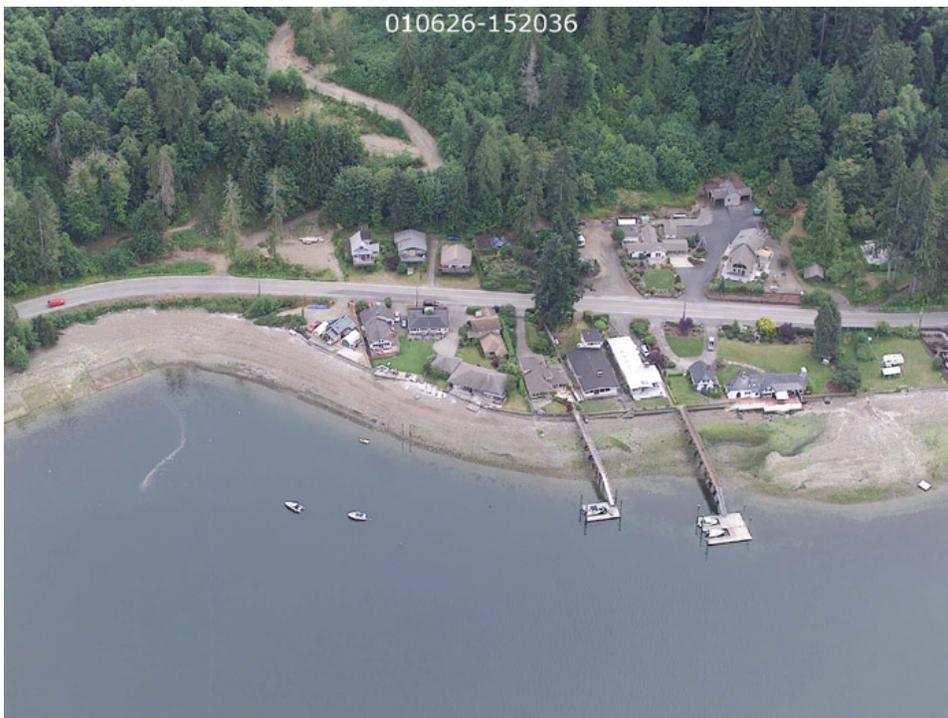
Figure 64. 2001 WDOE oblique photo showing the site of the former Burn Marsh complex, now filled by homes.
